**BUILDING 52 DEMOLITION WASTE  
MANAGEMENT STRATEGY REPORT  
1 RIVER STREET  
HASTINGS-ON-HUDSON, NEW YORK**

By Haley & Aldrich of New York  
Rochester, New York

For ARCO Environmental Remediation Limited  
Naperville, Illinois

File No. 28612-339  
June 2015

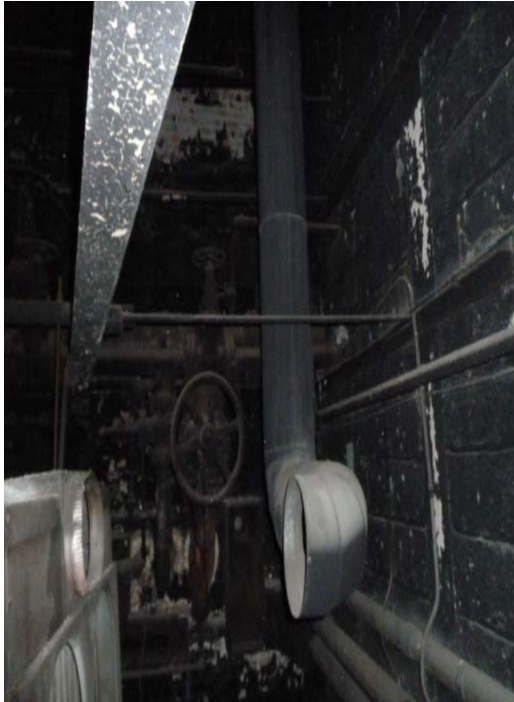
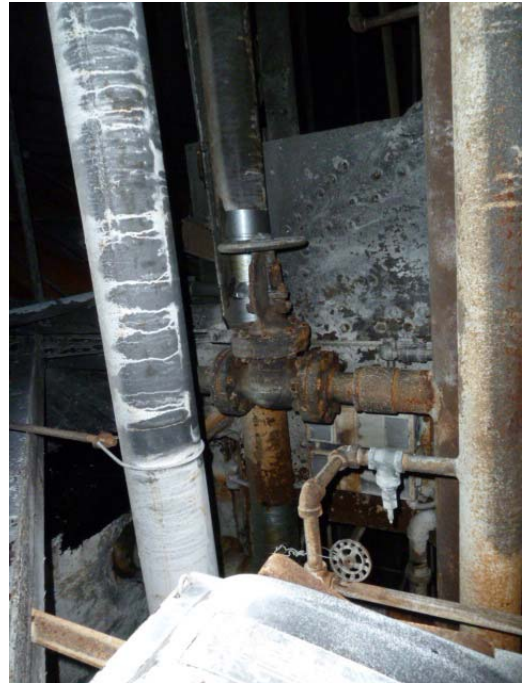
Photos #1 and #2: Steam Valves

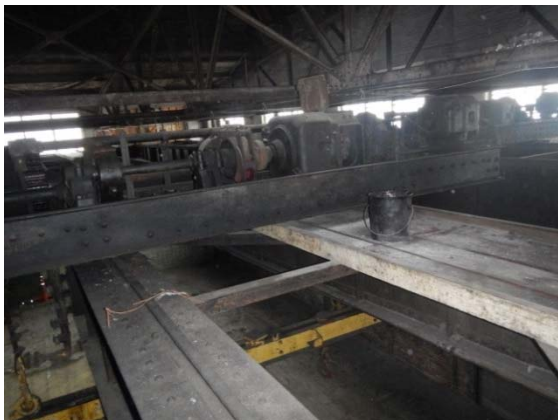
Photo #3: Bucket with Unknown Contents

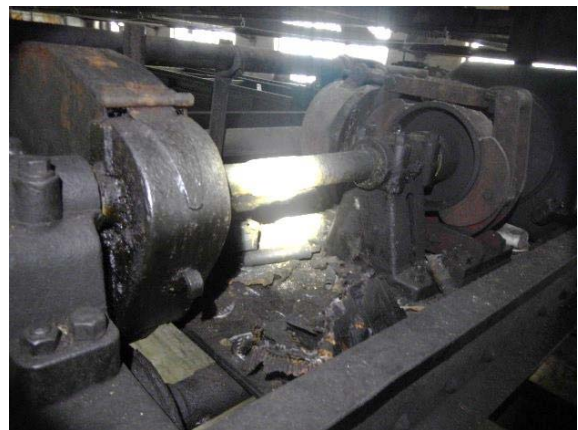
Photo #4: Hoist Motor and Gears with Debris

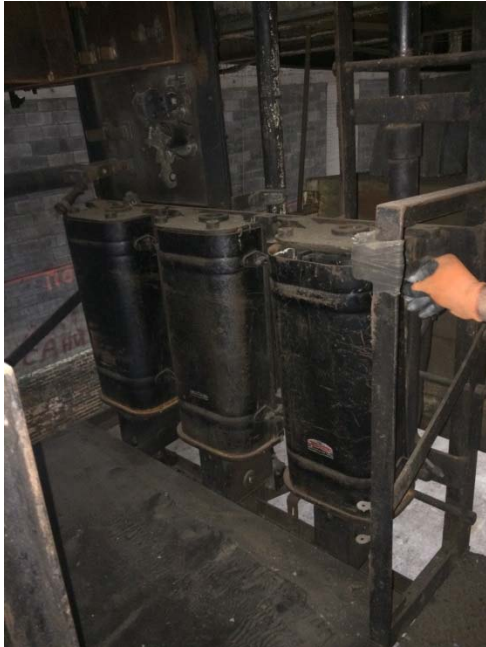
Photo #5: Electrical Panels Containing Asbestos Heat Shield and Transite

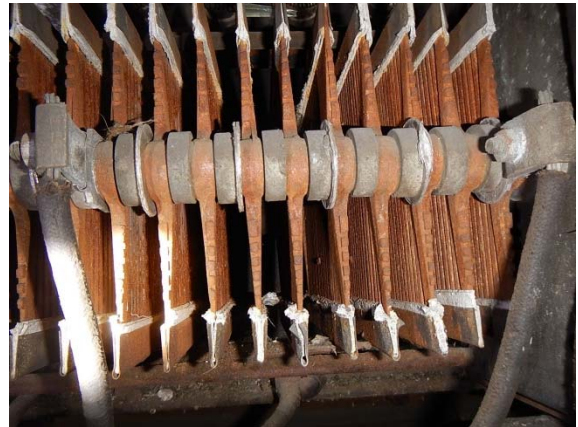
Photo #6: Unknown Electrical Components (Probable ACM)

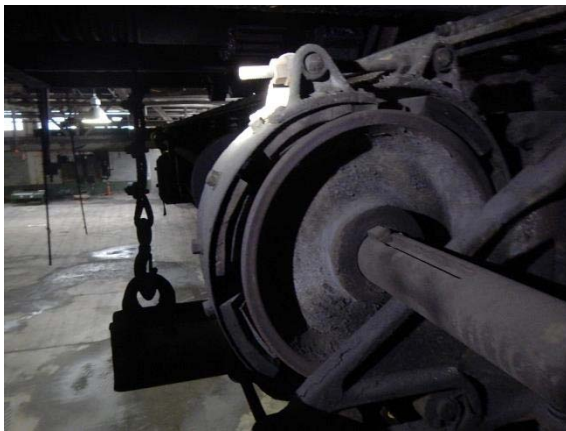
Photo #7: Crane Brake (Possible ACM)

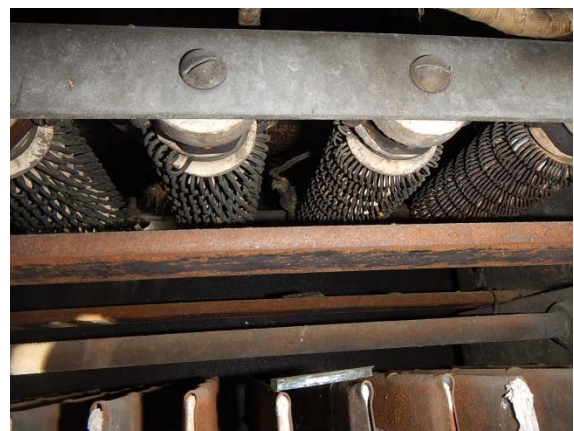
Photo #8: Unknown Electrical Components (Possible ACM)

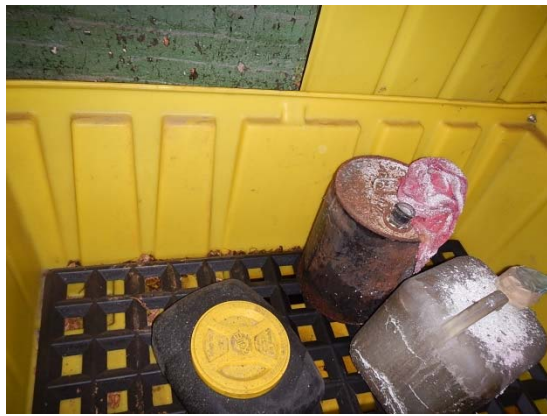
Photo #11: Containers with Unknown Contents

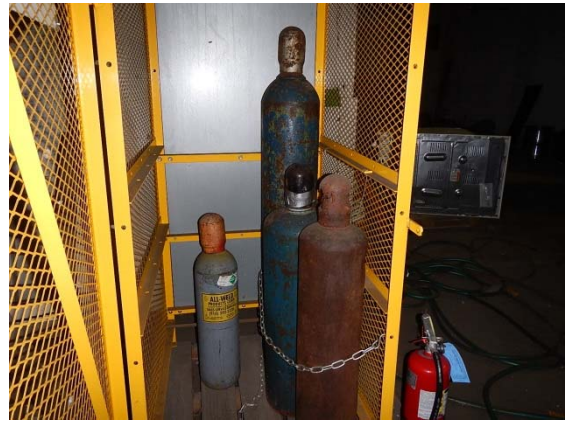
Photo #12: Compressed gas cylinders

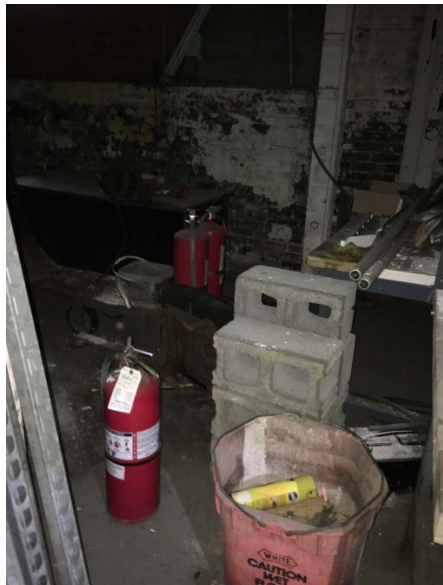
Photo #13: Fire Extinguishers, Florescent Light Bulbs, and Car Battery

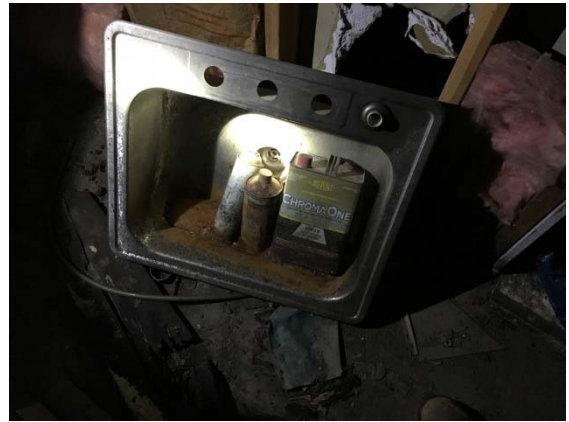
Photo #27: Misc. Chemical Containers

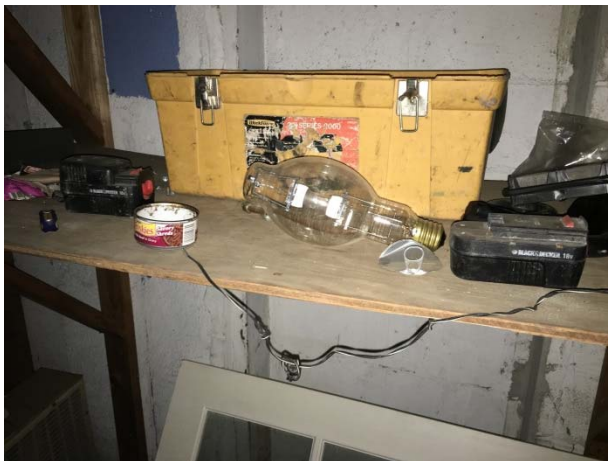
Photo #28: Loose Light Bulb and Batteries

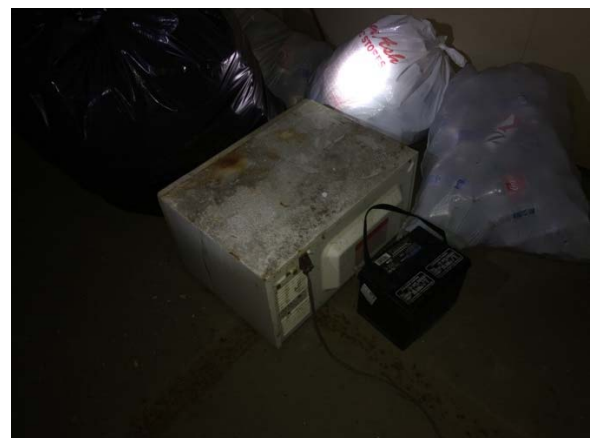
Photo #29: Microwave and Car Battery

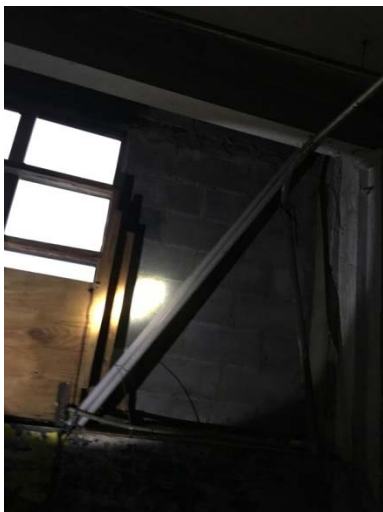
Photo #30: Loose 8 ft Florescent Bulbs

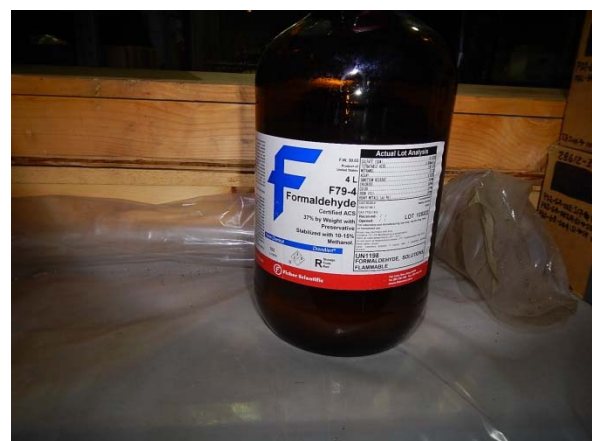
Photo #31: Formaldehyde
