RE: Draft Water Tower Preservation Plan, Harbor at Hastings Site

**PRE-DRAFT
WATER TOWER PRESERVATION PLAN**

**Harbor at Hastings Site
1 River Street
Hastings-on-Hudson, New York**

February 2019

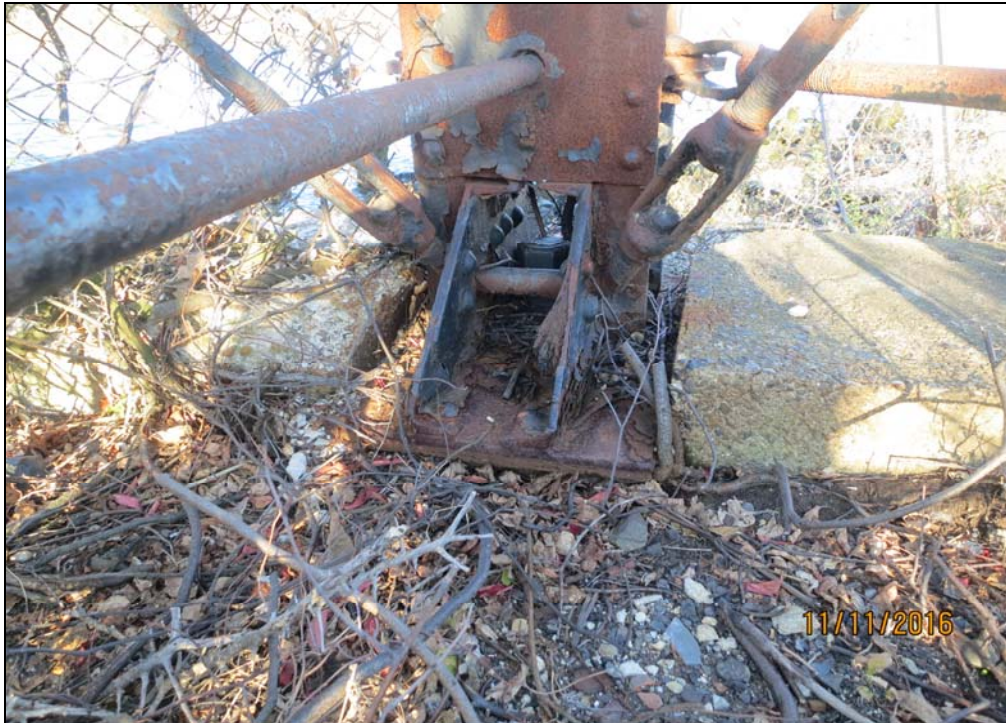
The tower anchors are in overall good condition with the northwest and southwest anchors exhibiting moderate pack rust at the stiffener plates and moderate corrosion on the base plate (Photos Nos. 3 & 4). The anchors for the northeast and southeast posts are partially buried by the soil and exhibit moderate corrosion on the stiffener plates (Photos Nos. 5 & 6). The horizontal rods located at the level of the anchor base have been removed or have become loose (Photo No. 4); however, the current state of these rods does not compromise the structural integrity of the water tower.

Photo No. 3: Northwest post anchor exhibiting moderate pack rust at the stiffener plates and moderate corrosion on the base plate. Note concrete foundation.

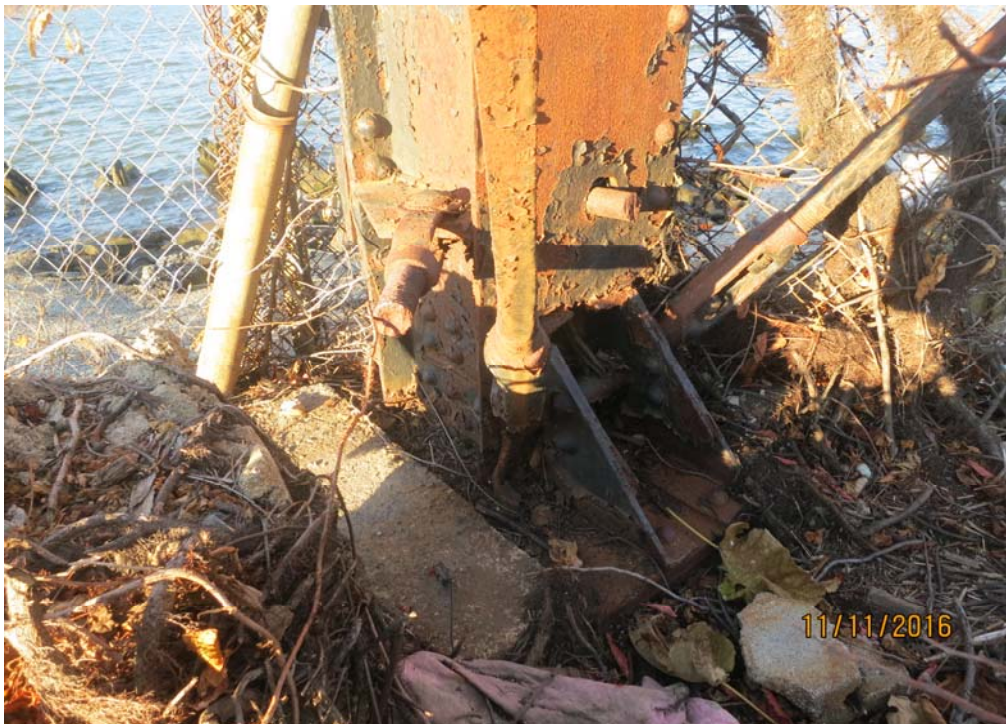
Photo No. 4: Southwest post anchor exhibiting moderate pack rust at the stiffener plates and moderate corrosion on the base plate.

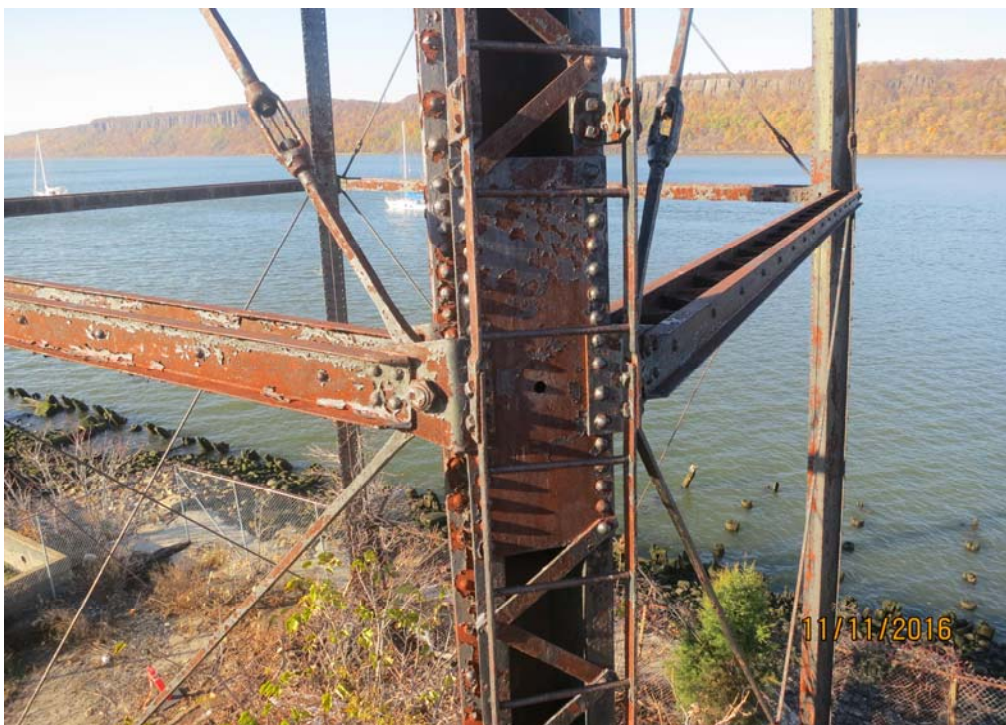
Photo No. 8: Typical post splice connection plates, struts bracing channels and cross rods exhibiting minor corrosion.
