PROJECT SCOPE

This project consists of the inspection and condition assessment of the water tower located on the Atlantic Richfield Co. (AR) Harbor-at-Hastings Site (site), located in the Village of Hastings-on-Hudson, NY. The existing water tower must either be dismantled or demolished to accommodate construction activities for the Superfund remediation of the former Anaconda Wire and Cable Co., including excavation of PCB- and metal-contaminated soils to depths of 9 to 12 feet below grade and restoration of a sloped shoreline.

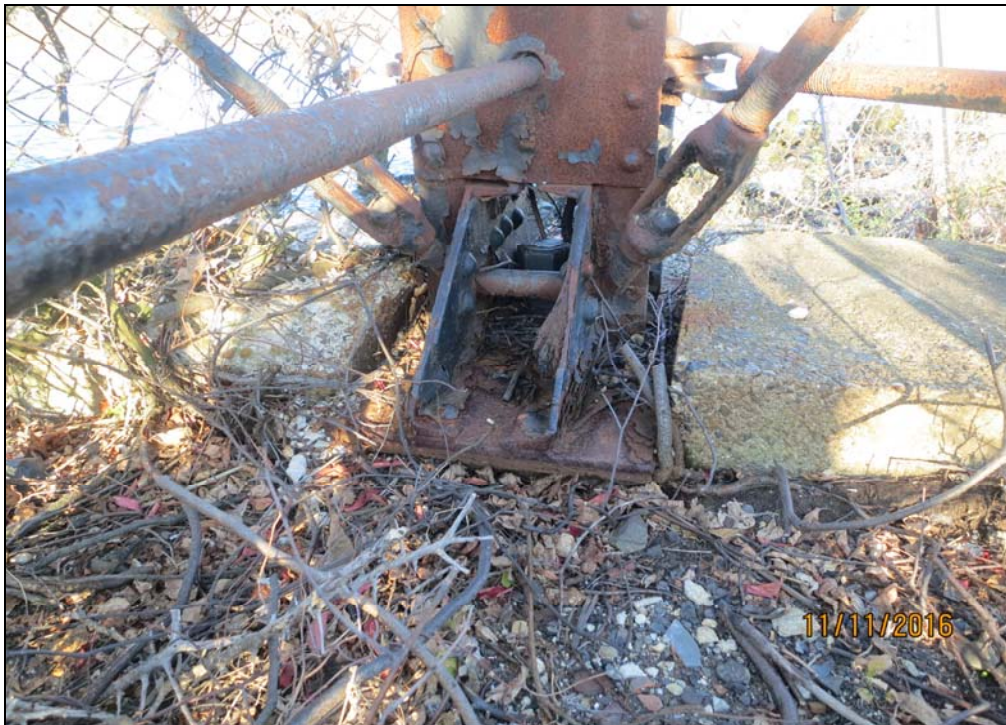
The tower anchors are in overall good condition with the northwest and southwest anchors exhibiting moderate pack rust at the stiffener plates and moderate corrosion on the base plate (Photos Nos. 3 & 4). The anchors for the northeast and southeast posts are partially buried by the soil and exhibit moderate corrosion on the stiffener plates (Photos Nos. 5 & 6). The horizontal rods located at the level of the anchor base have been removed or have become loose (Photo No. 4); however, the current state of these rods does not compromise the structural integrity of the water tower.

Photo No. 3: Northwest post anchor exhibiting moderate pack rust at the stiffener plates and moderate corrosion on the base plate. Note concrete foundation.

- A lead paint survey of the water tower structure and lead paint abatement in compliance with all applicable regulations, as necessary, for dismantling, restoration, and re-installation.
- Identification and application of an appropriate finish to preserve the water tower structural elements from additional corrosion after re-installation.
- Construction of a new water tower foundation and cleaning and painting of all four anchors up to 3 feet from each anchor base plate.

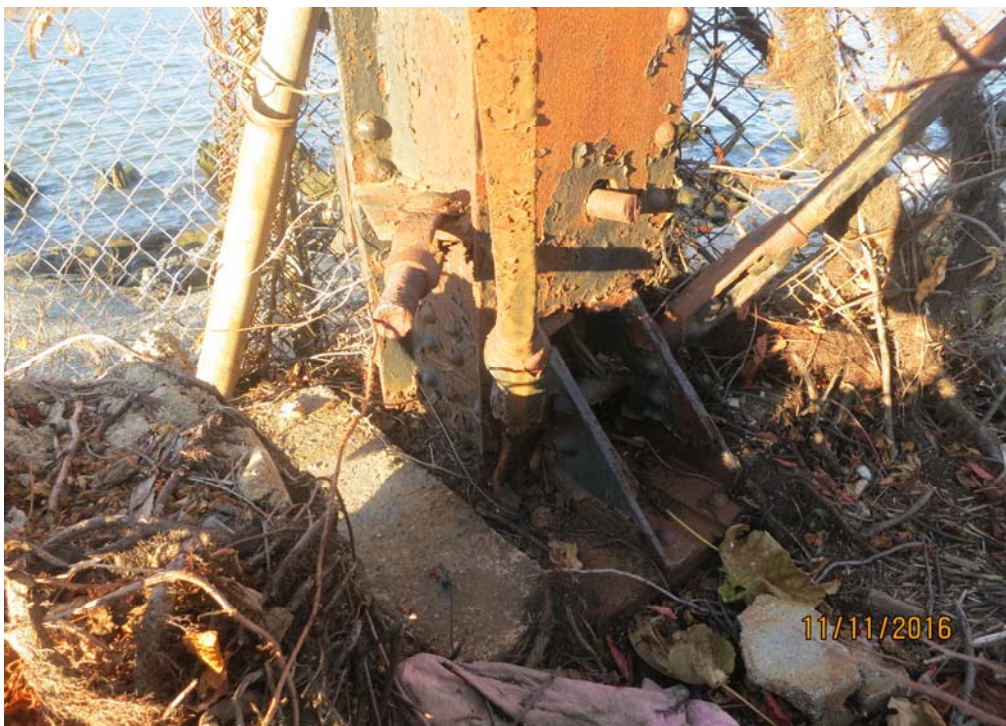
Photo No. 4: Southwest post anchor exhibiting moderate pack rust at the stiffener plates and moderate corrosion on the base plate.

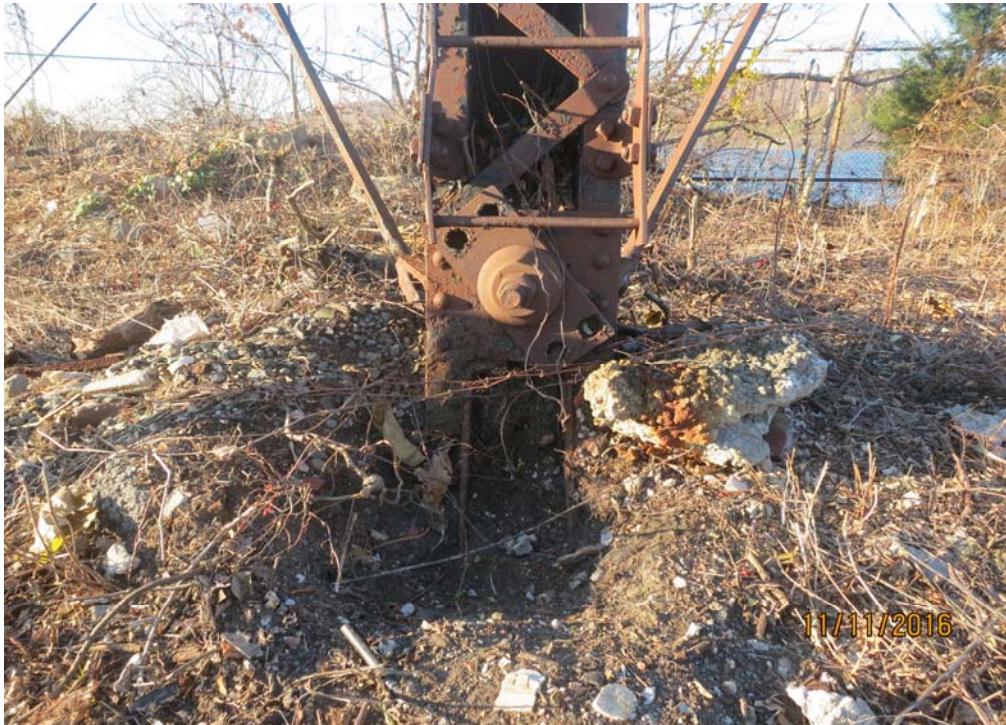
Photo No. 5: Northeast post anchor partially buried and exhibiting moderate corrosion on the stiffener plates.

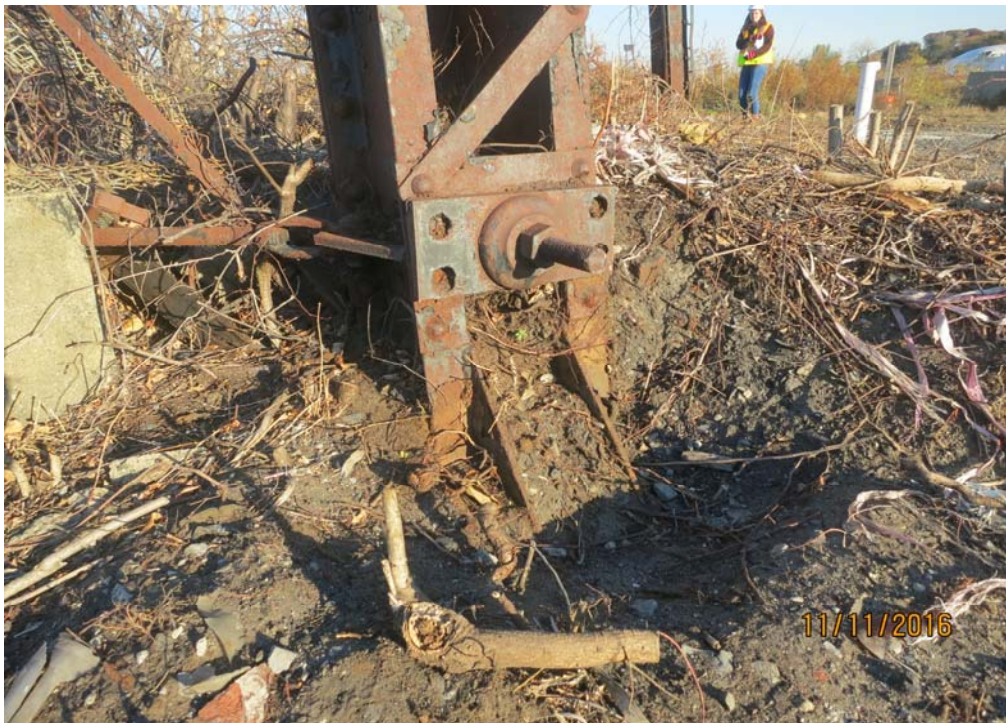
Photo No. 6: Southeast post anchor partially buried and exhibiting moderate corrosion on the stiffener plates.

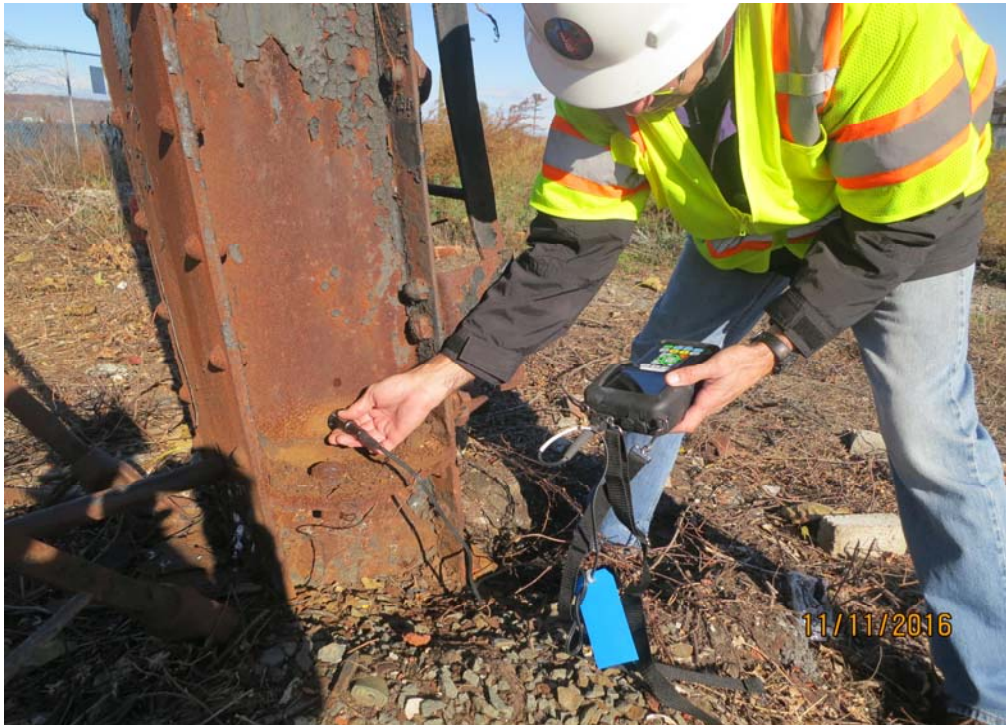
northeast post is exhibiting moderate corrosion on one of the channels near the base of the post. The layers of corrosion were removed to record the thickness of the channel web, which revealed approximately 10 percent section loss of the web area (Photo No. 7). The post splice connection plates, struts and bracing channels, and cross rods are all in good condition, exhibiting only minor corrosion (Photo No. 8) and the connection to the tank is also in good condition (Photo No. 9). The tank is in overall good condition, exhibiting minor corrosion with approximately 10 percent section loss on the tank's cylindrical plates (Photos Nos. 9 & 10).

Photo No. 7: Northeast post exhibiting moderate corrosion. The layer of corrosion was removed from a testing location to record the thickness of the channel web, revealing approximately 10 percent loss of web area.

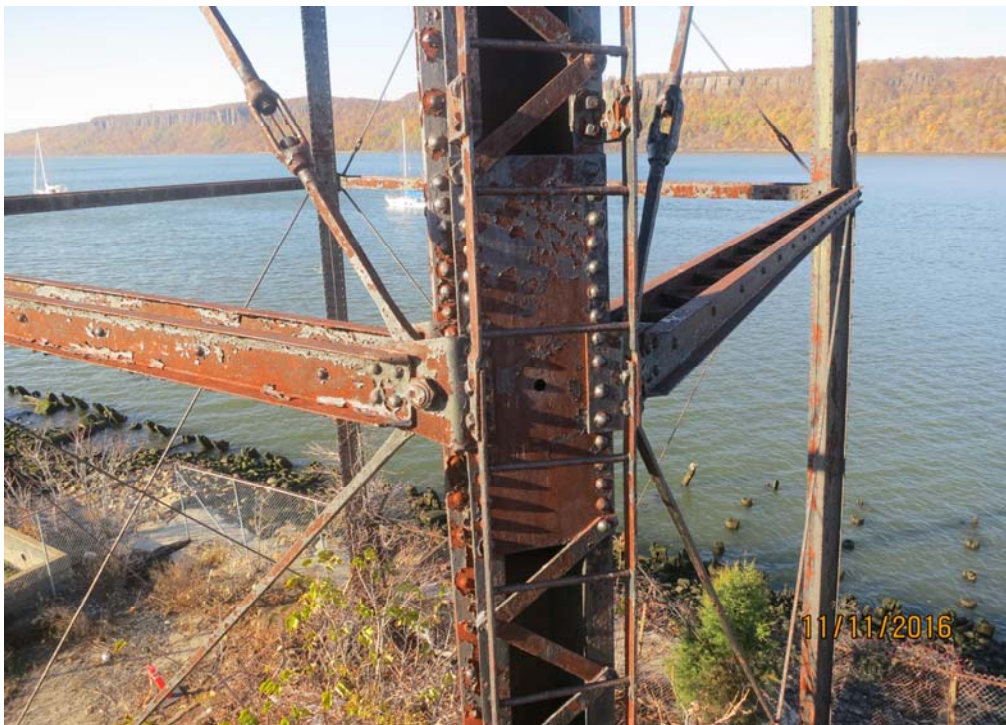
Photo No. 8: Typical post splice connection plates, struts bracing channels and cross rods exhibiting minor corrosion.

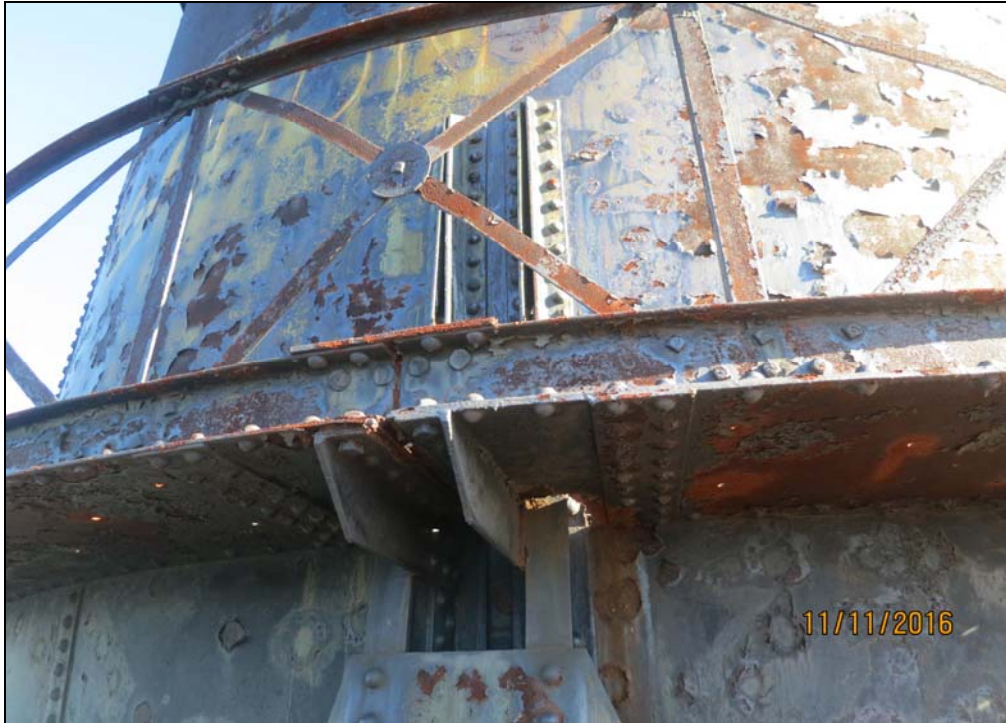
Photo No. 9: View of connection between tank and post in good condition.

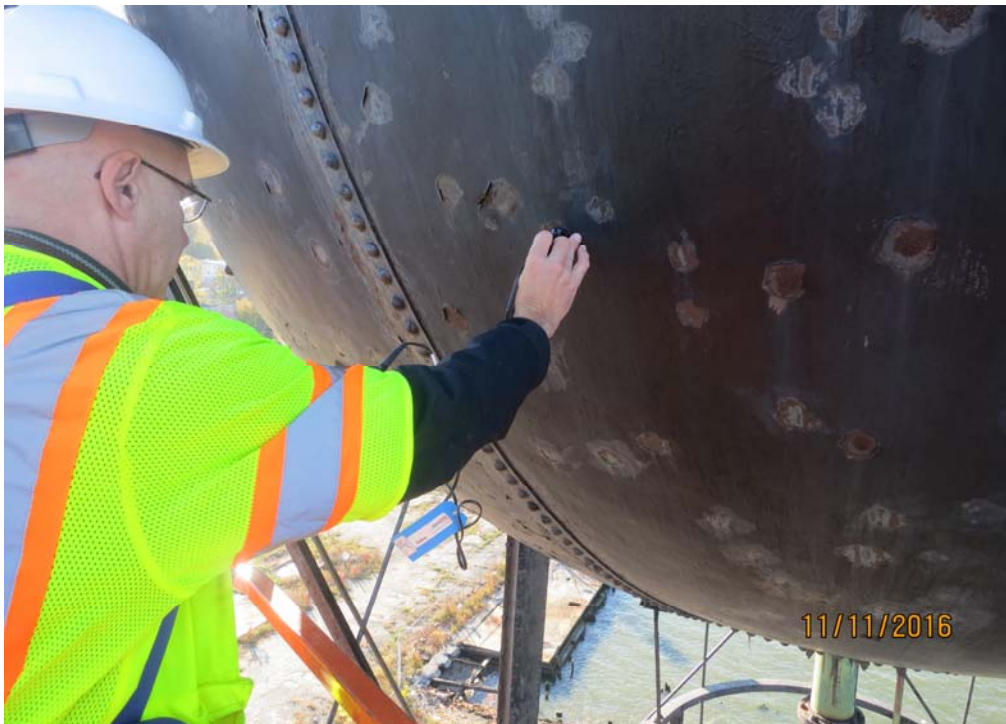
Photo No. 10: View of tank lower section exhibiting minor corrosion.
Note recording of tank plate thickness using the ultrasonic measuring device.
