**RE: Former Building 52 Slab Epoxy Maintenance**  
**Former Anaconda Plant (a.k.a. Harbor at Hastings Site) Site No. 3-60-022**  
**1 River Street**  
**Hastings-On-Hudson, New York**

The purpose of this letter is to provide a summary of the scope, methods, and materials for the epoxy maintenance work to be completed on the Former Building 52 concrete slab at the referenced site.

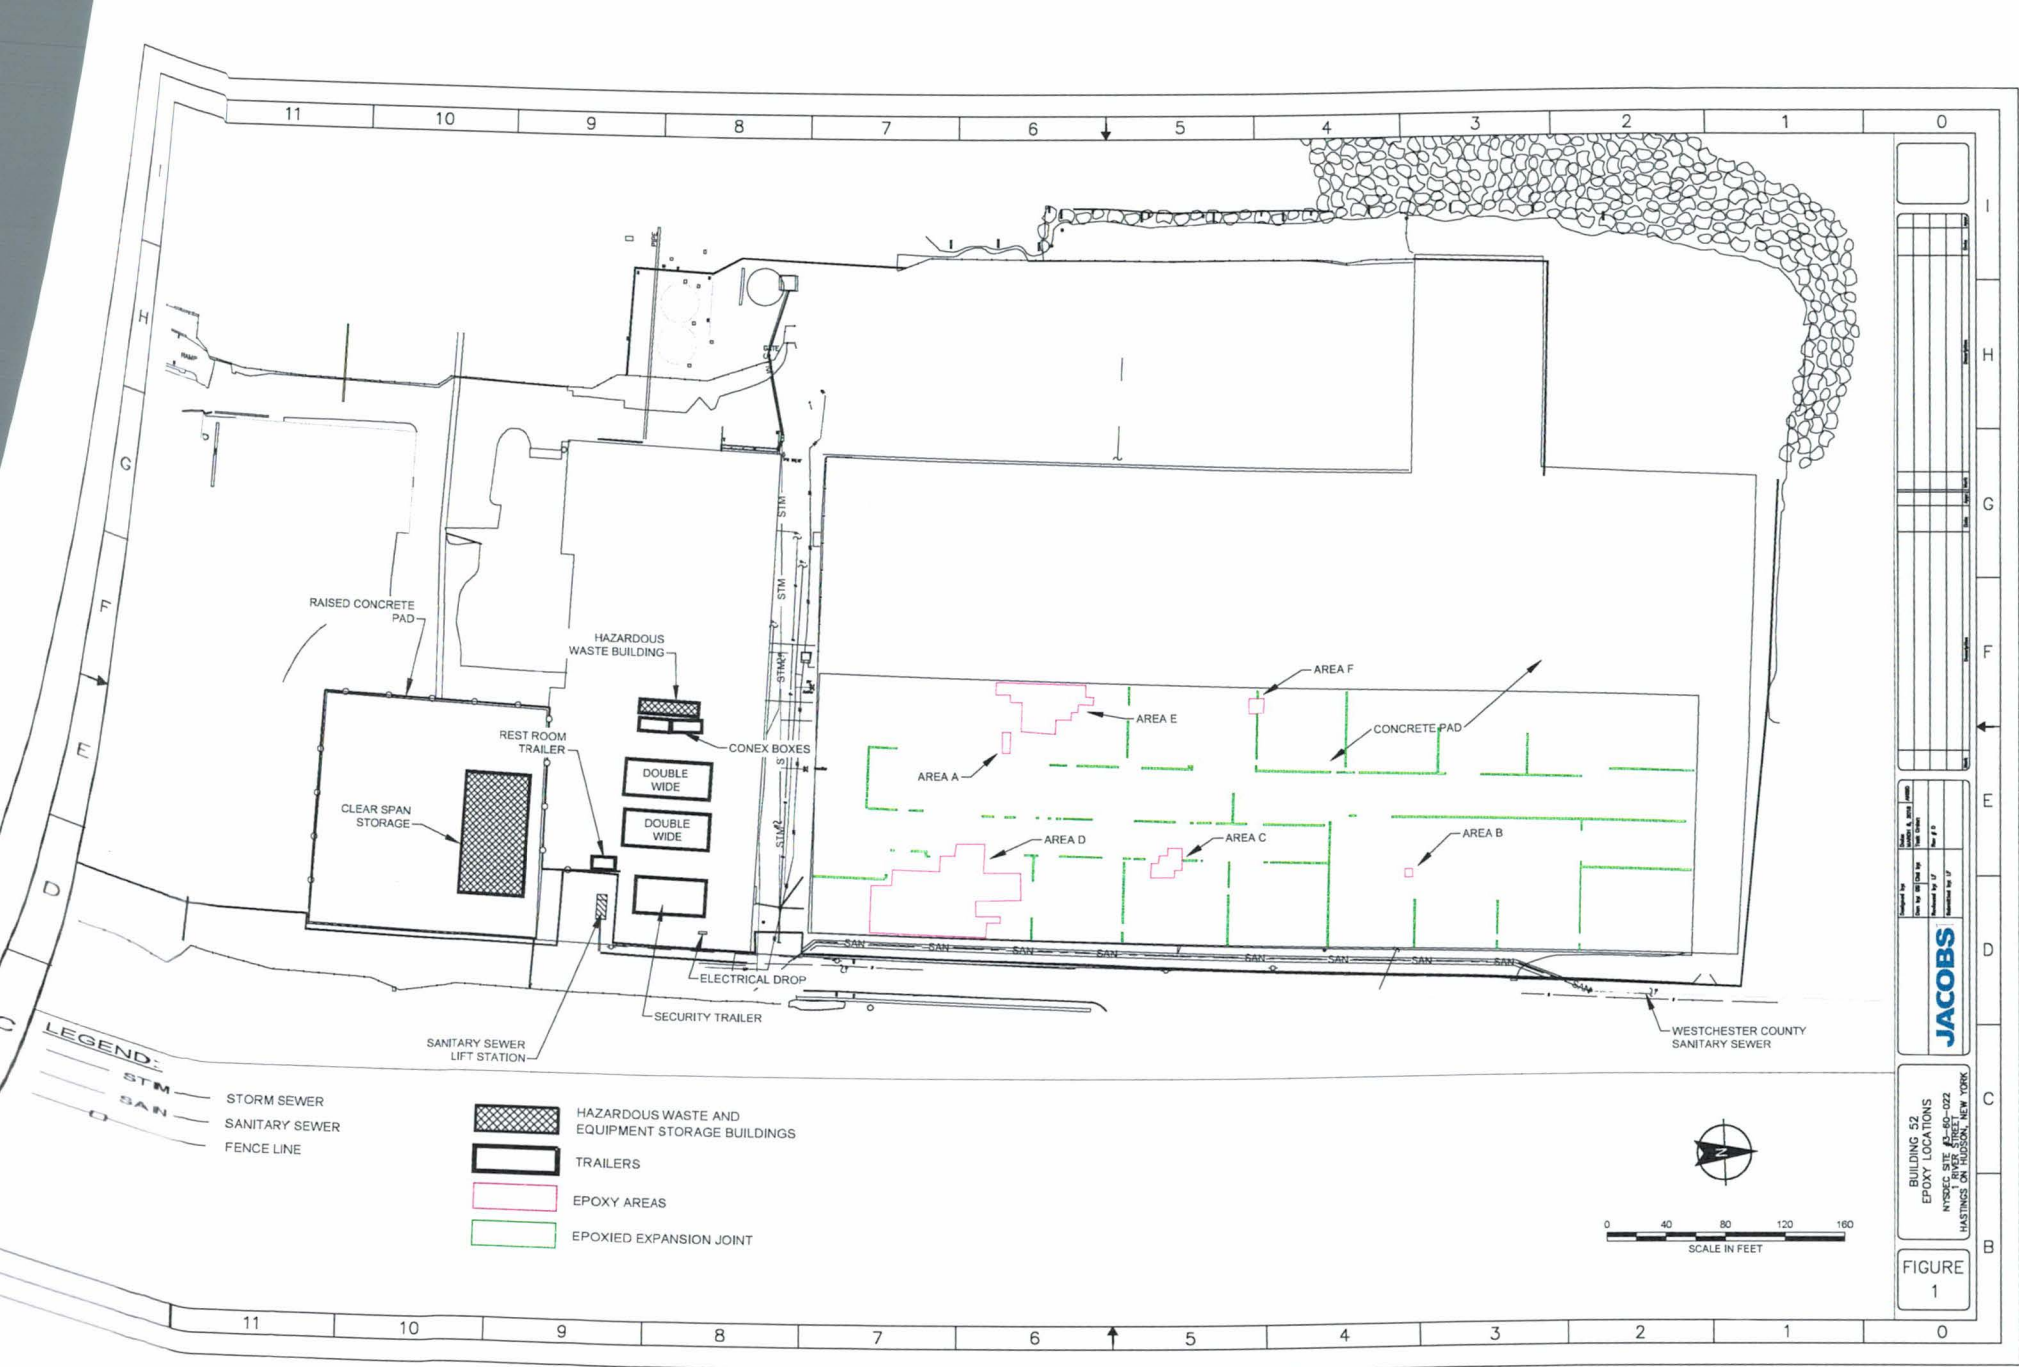
Enclosure: Figure 1

**Areas A, B, C, D, and F:** Epoxy outgassing has occurred and caused small bubbles to form on the epoxy surface. Some of these outgassing bubbles have broken and the concrete is visible; these will be patched as described below.

**Area B:** Area B has some "shadowing" where the first, red epoxy coat is showing through the second, medium-grey epoxy coat. This is indicative of the second coat being applied too thinly, below the minimum application spread of 16 mil thickness.

**Area E:** There is an approximately 10-foot by 10-foot area at the north end of Area D which is still tacky and not fully cured. This is likely due to an incorrect ratio of resin to hardener when the epoxy was applied.

**Areas A, B, C, D, and F:** Affected off-gassed areas will be swept clean and wiped with a solvent (acetone and / or xylene). The solvent will be allowed to wick off leaving a clean, dry, de-glossed surface. Dur-A-Glaze Cove resin will be mixed at a 2:1 ratio with Dur-A-Glaze #4 fast hardener, and 1 to 2 ounces of Superstick bond agent will be added per mixed gallon. This will create a knife-grade patch that will be packed into the small, open voids.

**Area B:** The shadowing area within Area B will be swept clean and wiped with a solvent (acetone and / or xylene). The solvent will be allowed to wick off leaving a clean, dry, de-glossed surface. Dur-A-Gard medium grey 100 percent solids epoxy resin and hardener will be mixed at a 2:1 ratio, and 1 to 2 ounces of Superstick bond agent will be added per mixed gallon. This mixture will be applied at a minimum spread rate of 100 square feet per gallon to a minimum thickness of 16 mils.

**Area E:** The uncured portion of Area E will be swept clean and wiped with a solvent (acetone and / or xylene). The solvent will be allowed to wick off leaving a clean, dry, de-glossed surface. Dur-A-Gard medium grey 100 percent solids epoxy resin and hardener will be mixed at a 2:1 ratio, and 1 to 2 ounces of Superstick bond agent will be added per mixed gallon. This mixture will be applied at a minimum spread rate of 100 square feet per gallon to a minimum thickness of 16 mils.
