Ground Penetrating Radar Report

Results of Geophysical Pilot Investigation Former Anaconda Wire & Cable Company 1 River Street, Hastings-on-Hudson, New York

April 29 and May 1, 2013

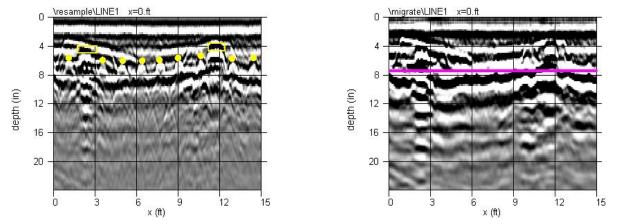
The concrete thickness at the location of the known void was measured to be 7 inches. The rebar spacing is approximately 6 inches for east-west oriented top and bottom layers and approximately 12 inches or larger for the north-south oriented middle layer. Our visual inspection revealed extended to the limit of our view in all directions. Exposed support beams beneath the floor hold it up. The velocity of the GPR's signal at this location was determined to be 0.33 feet per nanosecond, which was applied to process the GPR data collected during this project. It should be noted that the velocity decreases with increasing moisture content of the subsurface materials. Consequently, it affects the calculation of the concrete thickness. We anticipated that the presence of voids would create a high signal amplitude at the bottom of the concrete floor as compared to the concrete/soil contact. Unfortunately, this calibration area has extensive voids therefore we were unable to collect GPR data over the transition from known voids to known no voids.

Figure 1. GPR data profiles collected from east to west over the location of the known void. Gain was applied to the data for increasing the signal strength (left), and migrated data (right). Yellow circles are rebar, yellow rectangles are support beams, and the void is below pink line (bottom of the concrete floor).

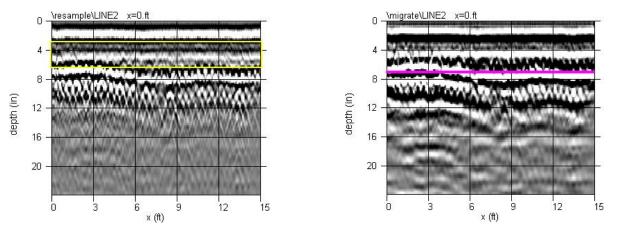
Figure 2. GPR data profiles collected from south to north over the location of the known void. Gain was applied to the data for increasing the signal strength (left), and migrated data (right). Yellow rectangle is top and bottom layers of rebar, and the void is below pink line.

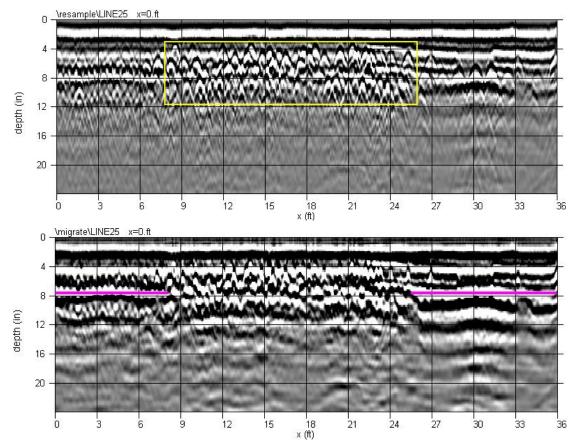
Figure 3. GPR data profiles collected from north to south over the location of the known void. The GPR profiles indicated the area of rebar within the yellow rectangle (top) disturbs the image below (bottom). Pink lines below indicate voids.

The GPR data profiles collected over rebar spacing of 12-inch or larger indicate the reflections of voids more strongly than the ones collected over the smaller rebar spacing (see Figure 1 and 2). Several GPR data profiles also revealed that the combination of the smaller rebar spacing and uneven buried depth influences the detection of the voids (see Figure 3).

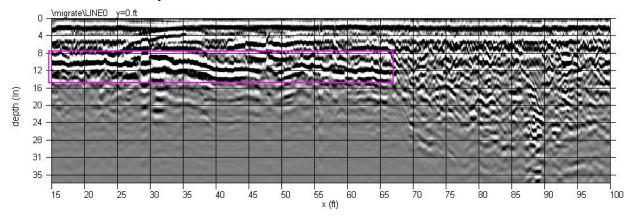
Line 0N was collected along the southern edge of the area in an east-west direction between station 15E and 100E (see Figure 4 below). The thickness of the concrete is around 10 to 12 inches between 15E and 67E where suspected voids may exist beneath the concrete. The area east of 67E is covered by bricks.

Figure 4. GPR data profile of Line 0N collected in east-west direction. The western end of the line is on the left (15 ft) and the eastern end of the line is on the right (100 ft). The pink rectangle indicates strong reflections that could be associated with suspected voids beneath the concrete.

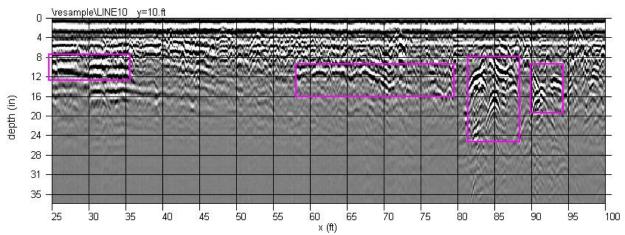
Line 10N was collected in an east-west direction between station 25E and 100E (see Figure 5 below). The locations of suspected voids are 25E to 36E and 58E to 79E. Unknown features are also detected within brick filled area between 82E and 94E. The thickness of the concrete is inconclusive, but is probably around 10 to 12-inches based upon the depth of the suspected voids.

Figure 5. GPR data profile of Line 10N collected in east-west direction. The western end of the line is on the left (25 ft) and the eastern end of the line is on the right (100 ft). The pink rectangles indicate strong reflections that could be associated with suspected voids beneath the concrete and unknown features within brick filled area.

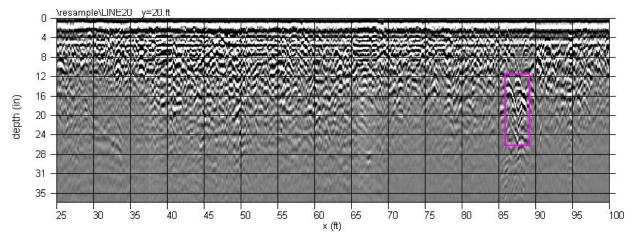
Line 20N was collected in an east-west direction between station 25E and 100E (see Figure 6 below). The locations of suspected voids as well as the thickness of the concrete are inconclusive, however, an unknown feature was detected between 86E and 89E; similar to the one seen in Line 10N.

Figure 6. GPR data profile of Line 20N collected east-west. The western end of the line is on the left (25 ft) and the eastern end of the line is on the right (100 ft). The pink rectangle indicates unknown features within brick covered area.

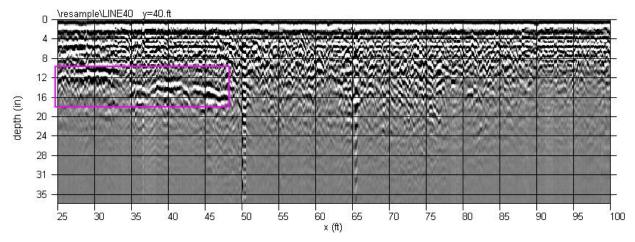
Line 40N was collected in an east-west direction between station 25E and 100E (see Figure 7 below). The location of suspected voids is between 25E and 48E. The thickness of the concrete is inconclusive, but probably around 10 to 12-inch thick based upon the depth of suspected voids.

Figure 7. GPR data profile of Line 40N collected east-west. The western end of the line is on the left (25 ft) and the eastern end of the line is on the right (100 ft). The pink rectangle indicates suspected voids.

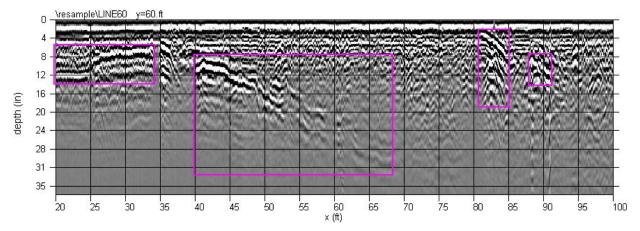
Line 60N was collected in an east-west direction between station 20E and 100E (see Figure 8 below). The thickness of the concrete is around 16 to 18 inches beneath an access driveway between 20E and 34E where suspected voids or de-lamination within the concrete may exist (hyperbolic reflections of rebar are visible in the profile). Other suspected voids are 40E to 68E within the former building foundation. Unknown features are also detected from 81E to 85E and 88E to 91E.

Figure 8. GPR data profile of Line 60N collected east-west. The western end of the line is on the left (20 ft) and the eastern end of the line is on the right (100 ft). The pink rectangles indicate the strong reflections that could be associated with suspected voids and unknown features.

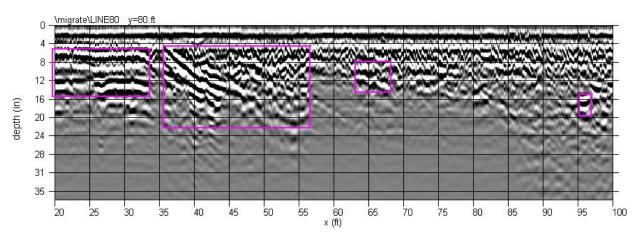
Line 80N was collected in an east-west direction between station 20E and 100E (see Figure 9 below). The thickness of the concrete should be similar to Line 60N beneath the driveway and about 18 to 24 inches between 56E and 70E (hyperbolic reflections of rebar are visible in the profile). The locations of suspected voids are 20E to 34E within an access driveway and 36E to 56E, 63E to 68E, and 95E to 96E within the former building foundation.

Figure 9. GPR data profile of Line 80N collected east-west. The western end of the line is on the left (20 ft) and the eastern end of the line is on the right (100 ft). The pink rectangles indicate the strong reflections that could be associated with the suspected voids.

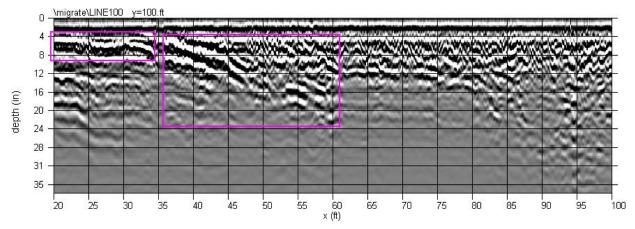
Line 100N was collected in an east-west direction between station 20E and 100E (see Figure 10 below). The thickness of the concrete is around 16 inches beneath the driveway where delamination may exist around 4 inches below grade between 20E and 34E. A layer of rebar is also detected around 20 to 24 inches between 61E and 80E. The locations of suspected voids are 20E to 34E within an access driveway and 36E to 61E within the former building foundation.

Figure 10. GPR data profile of Line 100N collected east-west. The western end of the line is on the left (20 ft) and the eastern end of the line is on the right (100 ft). The pink rectangles indicate the strong reflections that could be associated with suspected voids.

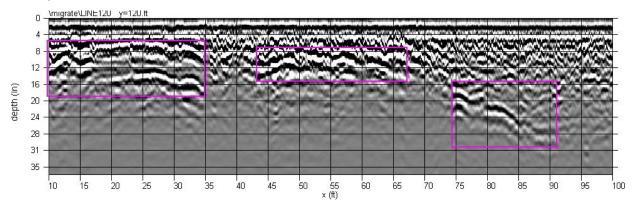
Line 120N was collected in an east-west direction between station 10E and 100E (see Figure 11 below). The thickness of the concrete varies around 18 to 26 inches between 74E and 95E as hyperbolic reflections of rebar are visible. The locations of suspected voids are 10E to 35E, 43E to 67E, and 74E to 91E.

Figure 11. GPR data profile of Line 120N collected east-west. The western end of the line is on the left (10 ft) and the eastern end of the line is on the right (100 ft). The pink rectangles indicate strong reflections that could be associated with the suspected voids.

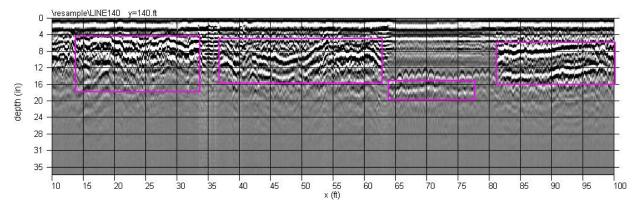
Line 140N was collected in an east-west direction between station 10E and 100E (see Figure 12 below). The thickness of the concrete within an octagonal foundation is 14 to 16 inches between 64E and 81E. The locations of de-lamination and/or suspected voids are 14E to 34E, 36E to 63E, 64E to 78E, and 81E to 100E.

Figure 12. GPR data profile of Line 140N collected east-west. The western end of the line is on the left (10 ft) and the eastern end of the line is on the right (100 ft). The pink rectangles indicate strong reflections that could be associated with suspected voids.

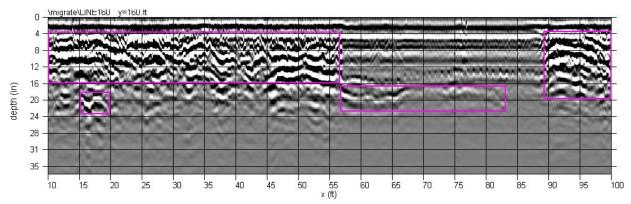
Line 160N was collected in an east-west direction between station 10E and 100E (see Figure 13 below). The thickness of the concrete within an octagonal foundation is 14 to 16 inches between 57E and 89E. The locations of de-lamination and/or suspected voids are detected throughout the line.

Figure 13. GPR data profile of Line 160N collected east-west. The western end of the line is on the left (10 ft) and the eastern end of the line is on the right (100 ft). The pink rectangles indicate strong reflections that could be associated with de-laminations and/or suspected voids.

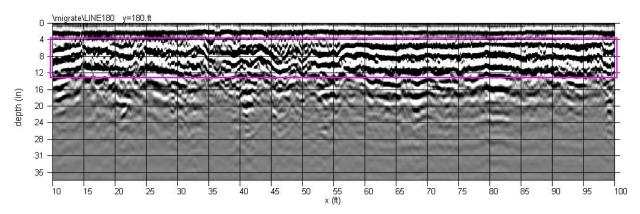
Line 180N was collected in an east-west direction between station 10E and 100E (see Figure 14 below). The thickness of the concrete is inconclusive, and locations of possible de-lamination and/or suspected voids are detected throughout the line.

Figure 14. GPR data profile of Line 180N collected east-west. The western end of the line is on the left (10 ft) and the eastern end of the line is on the right (100 ft). The pink rectangles indicate strong reflections that could be associated with de-laminations and/or suspected voids.

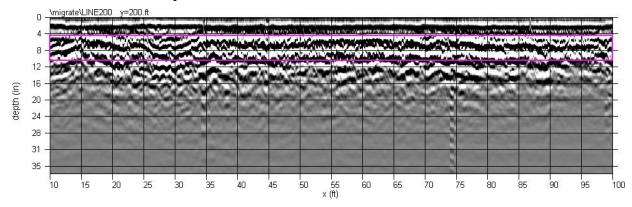
Line 200N was collected in an east-west direction between station 10E and 100E (see Figure 15 below). The thickness of the concrete as well as the locations of voids is inconclusive due to poor penetration of GPR's signal, which could be caused by tight rebar spacing and/or delamination at a shallow depth.

Figure 15. GPR data profile of Line 200N collected east-west. The western end of the line is on the left (10 ft) and the eastern end of the line is on the right (100 ft). The pink rectangles could be associated with de-laminations and/or suspected voids.

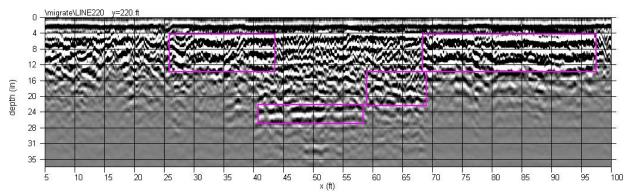
Line 220N was collected in an east-west direction between station 5E and 100E (see Figure 16 below). The thickness of the concrete is inconclusive. The locations of suspected de-laminations and/or voids are between 26E and 98E.

Figure 16. GPR data profile of Line 220N collected east-west. The western end of the line is on the left (5 ft) and the eastern end of the line is on the right (100 ft). The pink rectangles indicate the strong reflections that could be associated with de-laminations and/or suspected voids.

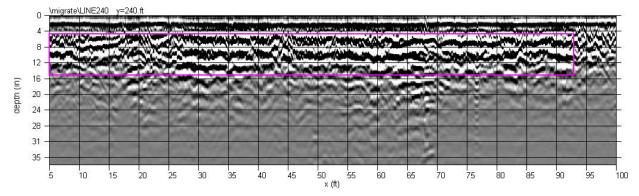
Line 240N was collected in an east-west direction between station 5E and 100E (see Figure 17 below). The thickness of the concrete is inconclusive, and the de-lamination and/or suspected voids may exist at a shallow depth throughout the line.

Figure 17. GPR data profile of Line 240N collected east-west. The western end of the line is on the left (5 ft) and the eastern end of the line is on the right (100 ft). The pink rectangles indicate strong reflections that could be associated with de-laminations and/or suspected voids.

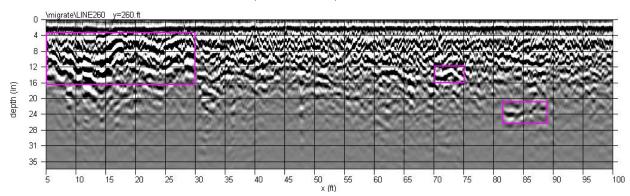
Line 260N was collected in an east-west direction between station 5E and 100E (see Figure 18 below). The thickness of the concrete is inconclusive. The locations of suspected de-laminations and/or voids are 5E to 30E, 70E to 75E, and 82E to 89E.

Figure 18. GPR data profile of Line 260N collected east-west. The western end of the line is on the left (5 ft) and the eastern end of the line is on the right (100 ft). The pink rectangles indicate strong reflections that could be associated with de-laminations and/or suspected voids.

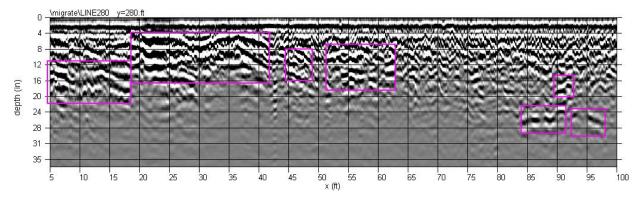
Line 280N was collected in an east-west direction between station 5E and 100E (see Figure 19 below). The thickness of the concrete is around 16 to 20 inches between 5E and 18E. The locations of de-laminations and/or suspected voids are 5E to 42E, 44E to 49E, 51E to 63E, and 84E to 98E.

Figure 19. GPR data profile of Line 280N collected east-west. The western end of the line is on the left (5 ft) and the eastern end of the line is on the right (100 ft). The pink rectangles indicate strong reflections that could be associated with de-laminations and/or suspected voids.

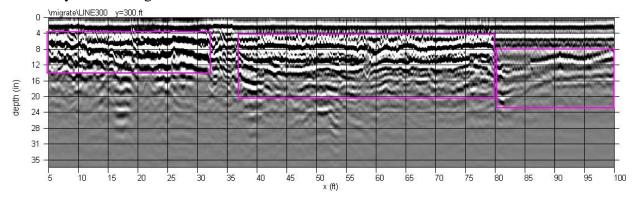
Line 300N was collected in an east-west direction between station 5E and 100E (see Figure 20 below). The thickness of the concrete within a former building foundation is at least 8 to 10 inches from 36E to 80E, and 10 to 14 inches from 80E to 100E. De-lamination and/or suspected voids may exist throughout the line.

Figure 20. GPR data profile of Line 300N collected east-west. The western end of the line is on the left (5 ft) and the eastern end of the line is on the right (100 ft). The pink rectangles indicate strong reflections that could be associated with de-laminations and/or suspected voids.

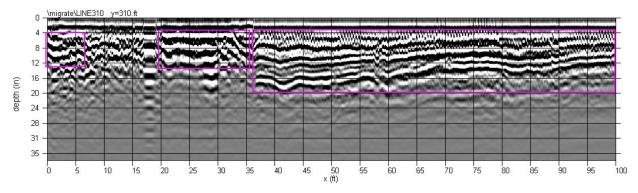
Line 310N was collected in an east-west direction between station 0E and 100E (see Figure 21 below). The thickness of the concrete within a former building foundation is at least 8 to 10 inches from 36E to 100E. De-lamination and/or suspected voids may exist throughout the line.

Figure 21. GPR data profile of Line 310N collected east-west. The western end of the line is on the left (0 ft) and the eastern end of the line is on the right (100 ft). The pink rectangles indicate the strong reflections that could be associated with de-laminations and/or suspected voids.

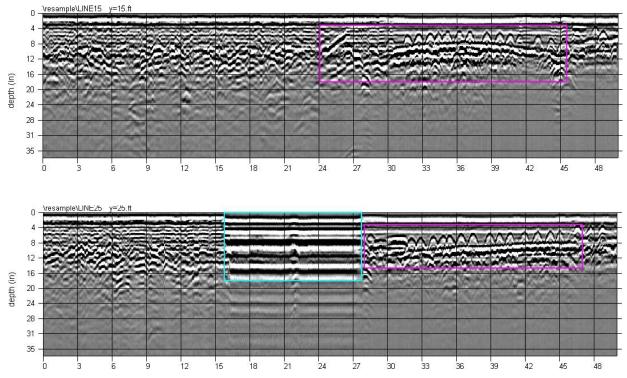
Eleven east-west transects and two north-south transects were collected within an approximately 50 by 50-foot area encompassing large metal plates, which were placed over a vault. The primary target of this area was to delineate the extent of the vault using GPR. The area of investigation was surrounded by chain-link fences, which restricted our ability to collect GPR data. The ground surface to the west side of the plates is covered with gravel. Each GPR profile was inspected for indication of suspected voids, which may intern represent the extent of the vault (see Plate 5). The map revealed that the vault was estimated to be approximately 25 by 30 feet in size. The average concrete thickness of this area is estimated to be about 8 inches.

Figure 23. GPR data profiles of Line 15N (top) and 25N (bottom) collected east-west. The western ends of the lines are on the left (0 ft) and the eastern ends of the lines are on the right (50 ft). The pink rectangles indicate strong reflections that may indicate the vault. The blue rectangle is the GPR data profile collected over the metal plate.

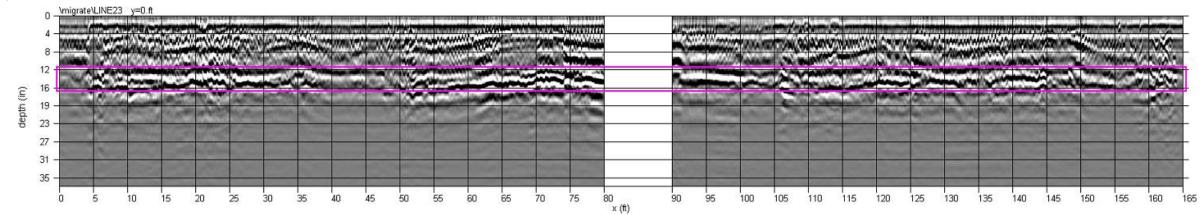
Line A

GPR data profiles collected in Area 1. The western end of each line is on the left (0 ft) and the eastern end of each line is on the right (165 ft). The pink rectangles indicate the areas of strong reflections that could be interpreted as suspected locations of voids.

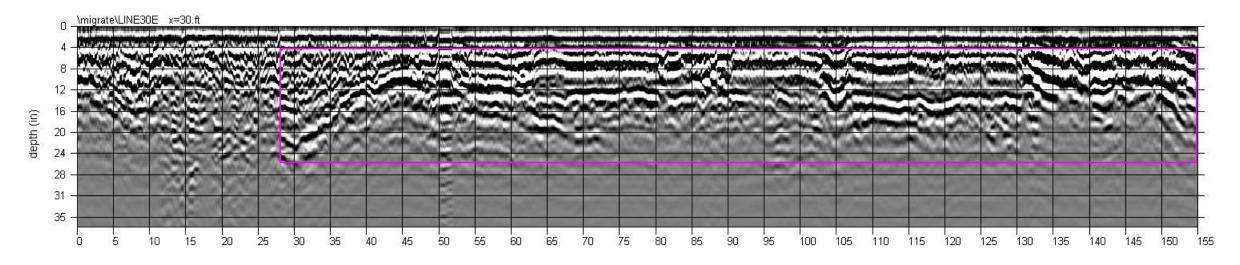
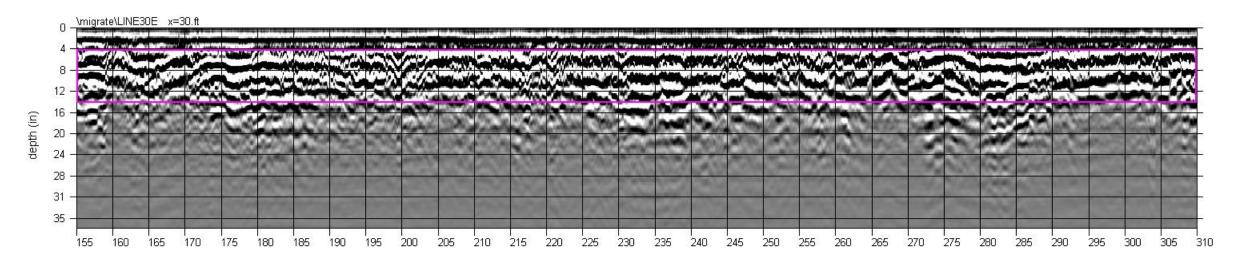
Two north-south transects were collected along 30E and 70E on the grid (see Appendix B). The length of each transect is 310 feet. The locations of suspected voids are highlighted with pink rectangles. After reviewing all profiles, the locations of suspected voids as well as de-laminations and anomalous features were plotted on the map (Plate 2).

GPR data profiles collected in Area 3. The southern end of the line is 0N and the northern end of the line is 310N. The pink rectangles indicate the areas of strong reflections that could be interpreted as suspected locations of voids.

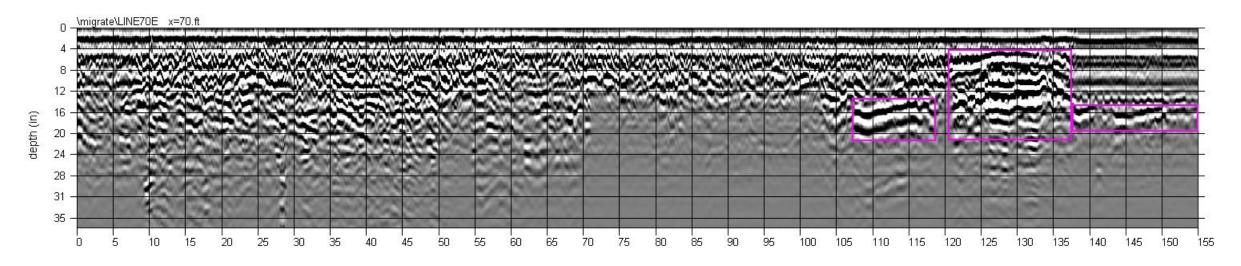
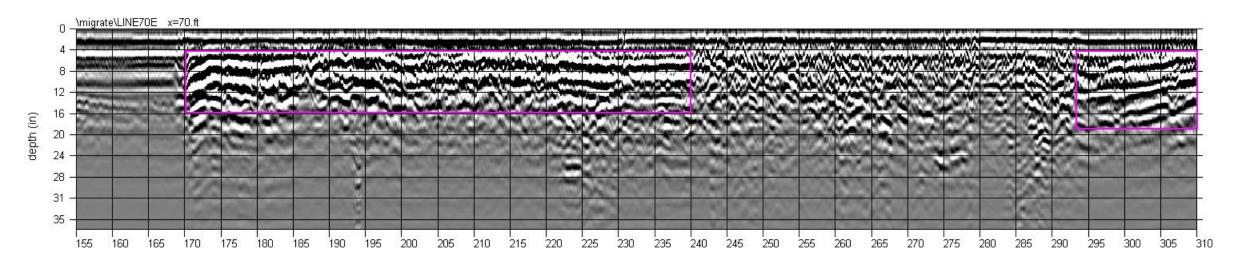
GPR data profiles collected in Area 3. The southern end of the line is 0N and the northern end of the line is 310N. The pink rectangles indicate the areas of strong reflections that could be interpreted as suspected locations of voids.
