## VILLAGE OF HASTINGS-ON-HUDSON COMMUNITY FOREST MANAGEMENT PLAN

**SAVATREE CONSULTING GROUP**

January 28, 2022

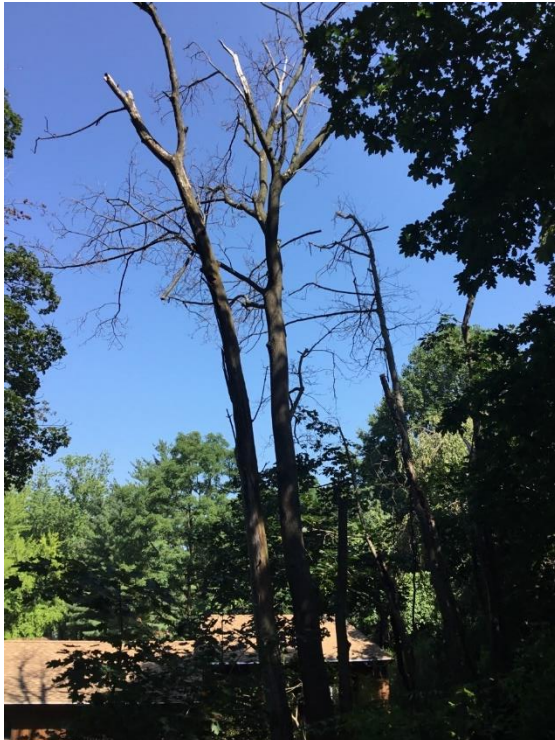
*Photo 1 – Photo taken during the inventory showing Trees 1721 and 1722. These are standing dead trees located at north border of Zinsser Park in proximity to a residence on Wagner Place. The tree on the right (1721) leans toward the house and is rated as High risk. The trees on the left (1722) leans parallel to the wooded edge and is Moderate risk. Both trees are High priority removals.*
