APPLICATION FOR BUILDING PERMIT

Building 52, located at 1 River Street, Hastings on Hudson, NY, is to be demolished while the concrete slab will remain intact. See attached narrative for details.

DECOMMISSIONING AND DEMOLITION OF BUILDING 52 NYSDEC SITE #3-60-022 1 RIVER STREET HASTINGS-ON-HUDSON, **NEW YORK**

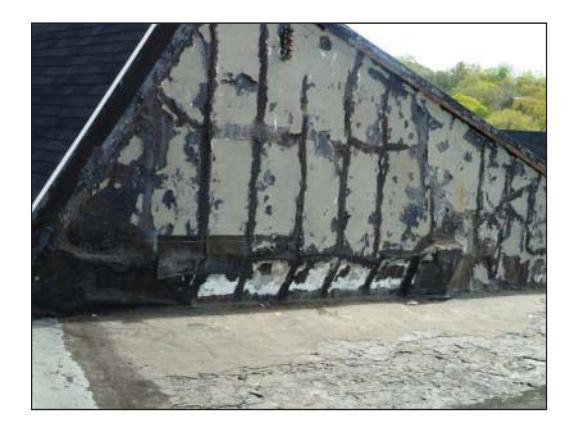
concrete, which was a common material buildings constructed in New York during this era. Visible, exposed, corroded mesh was also observed on the roof deck within areas of damaged concrete exposing the reinforcement to precipitation. At least one location contained a large crack (up to one inch wide and approximately ten feet long) in the roof slab.

Analysis of concrete testing data indicates the concrete roof deck cannot adequately protect against ongoing corrosion of interior steel reinforcing due to the lack of an alkaline buffer often present in steel-reinforced concrete applications. Due to the small diameter of the reinforcing, ongoing exposure to precipitation will promote corrosion and a potential serious long term adverse effect on the strength of the roof.

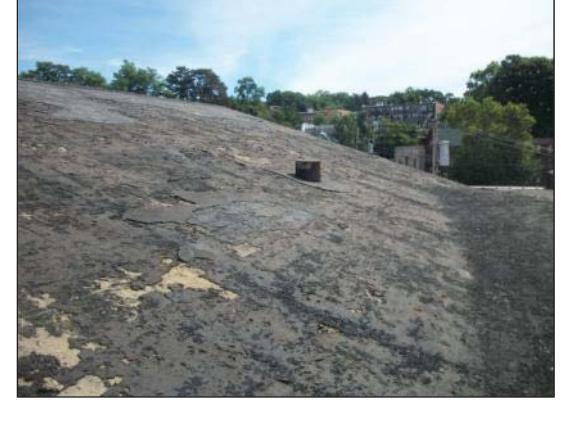
Triangular end walls of the monitors are in very poor condition and have deteriorated beyond repair, which can be observed from the finished floor. Failures of the end walls include loss of coatings, cracking, and deformation of the wall surface. There are several areas within the building in which concrete originating from the monitor end walls is observed on the floor due to de-bonded concrete from the metal lath, creating an unsafe condition. Access to areas beneath monitor end walls has been restricted due to an ongoing safety hazard.

The roof membrane is in poor condition and is missing in many locations on the southern portion of the building. Failure of the top layer of the membrane occurs across extensive areas near the middle of the building and at the southern end of the building. At a number of locations, roofing membrane is missing and the concrete deck is completely exposed and many active roof leaks are present. Infiltration of water through the roof deck will accelerate corrosion of reinforcement and reduce the structural capacity of the structure.

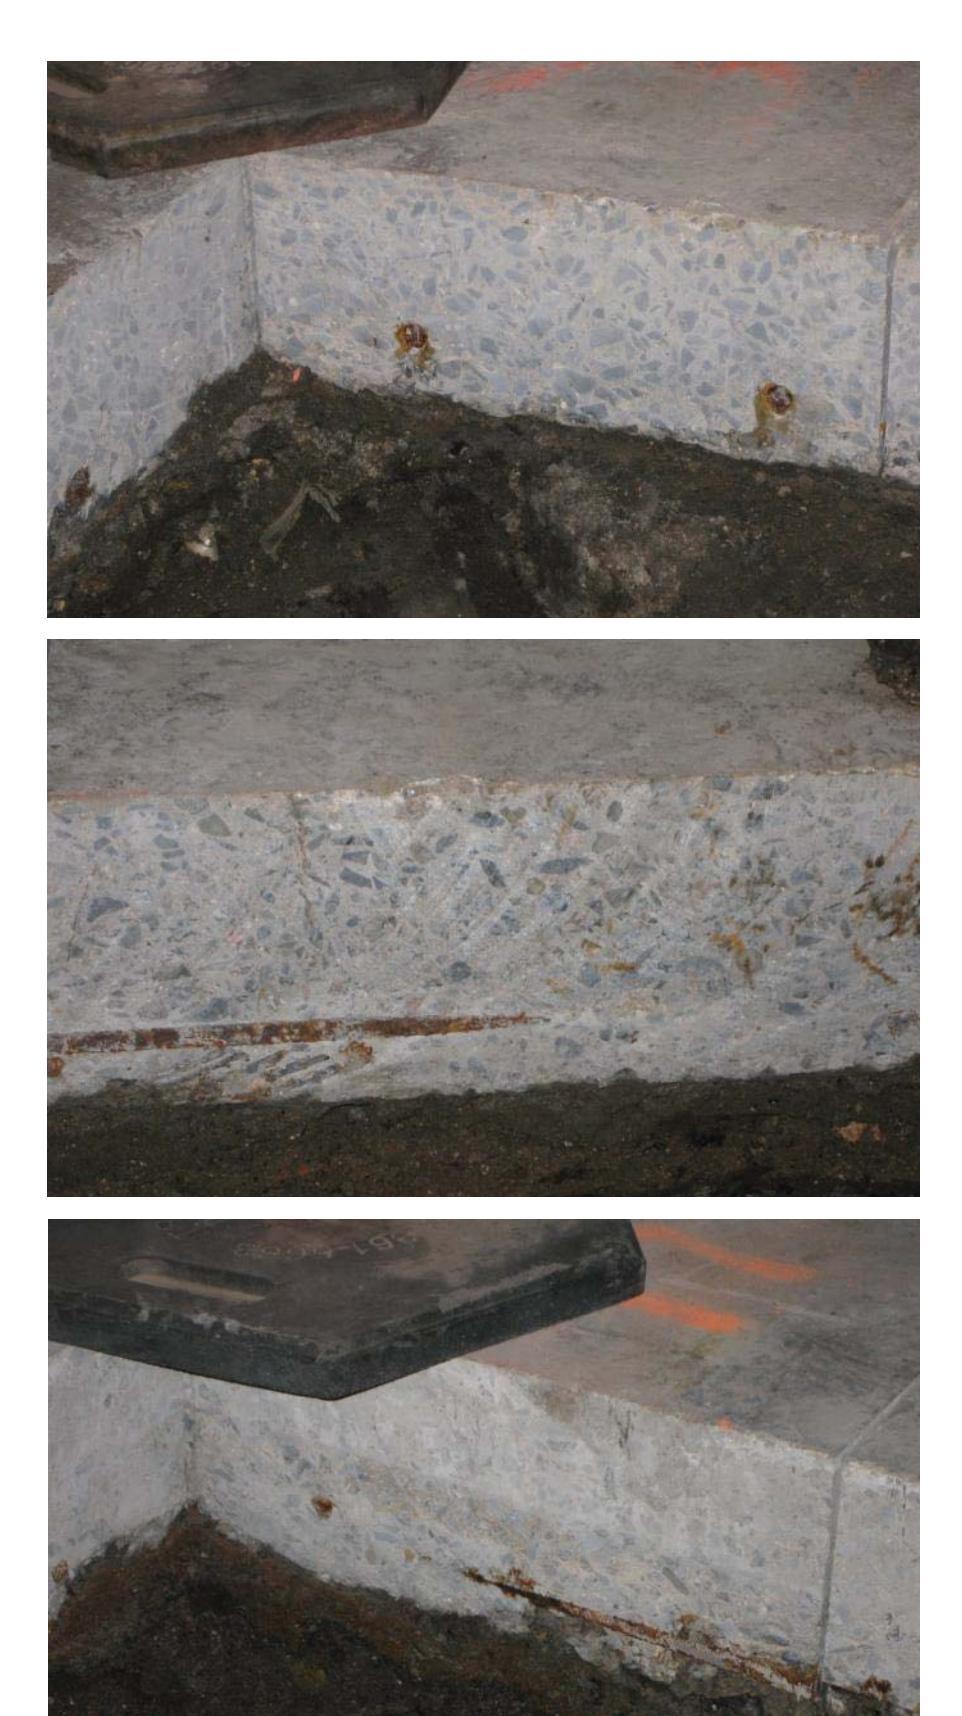
At all probe locations, the concrete appeared to be in good condition. In general, there were no noticeable voids or cracks, nor were there any signs of separation between the paste and aggregate. Probe #4 showed the most signs of poor concrete placement with some voids and separation in the layer of concrete below the reinforcing [**photo 5**]. The reinforcing typically showed little signs of corrosion, however, at probe 4 the reinforcing had corroded slightly more. This may be a localized problem due to the above-mentioned concrete voids/separation.

Photo 3 (top): Floor probe #2 cross section with reinforcing

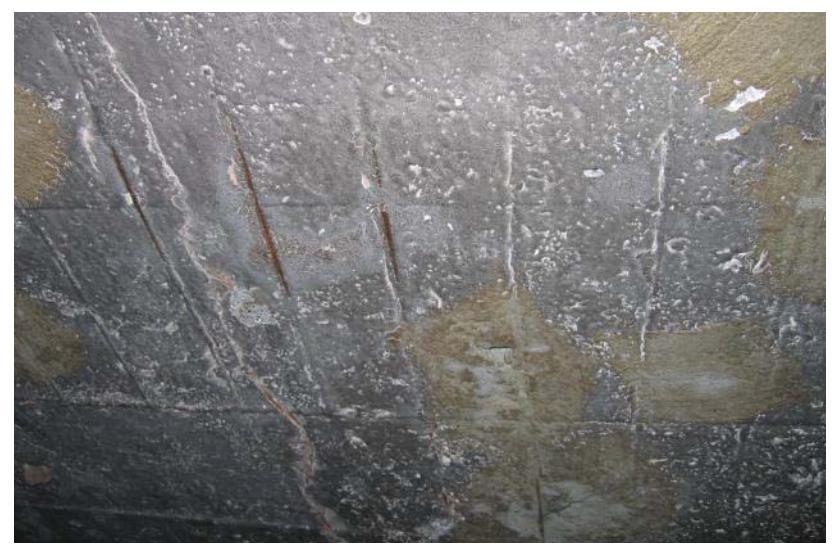
Photo 7: Underside of roof slab - mesh close to surface and corroded

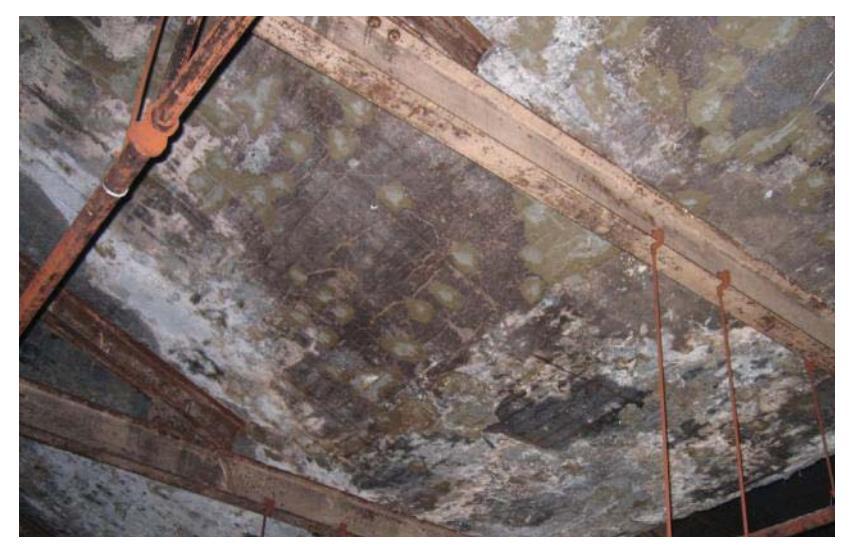
Photo 8: Underside of roof slab - corroded mesh

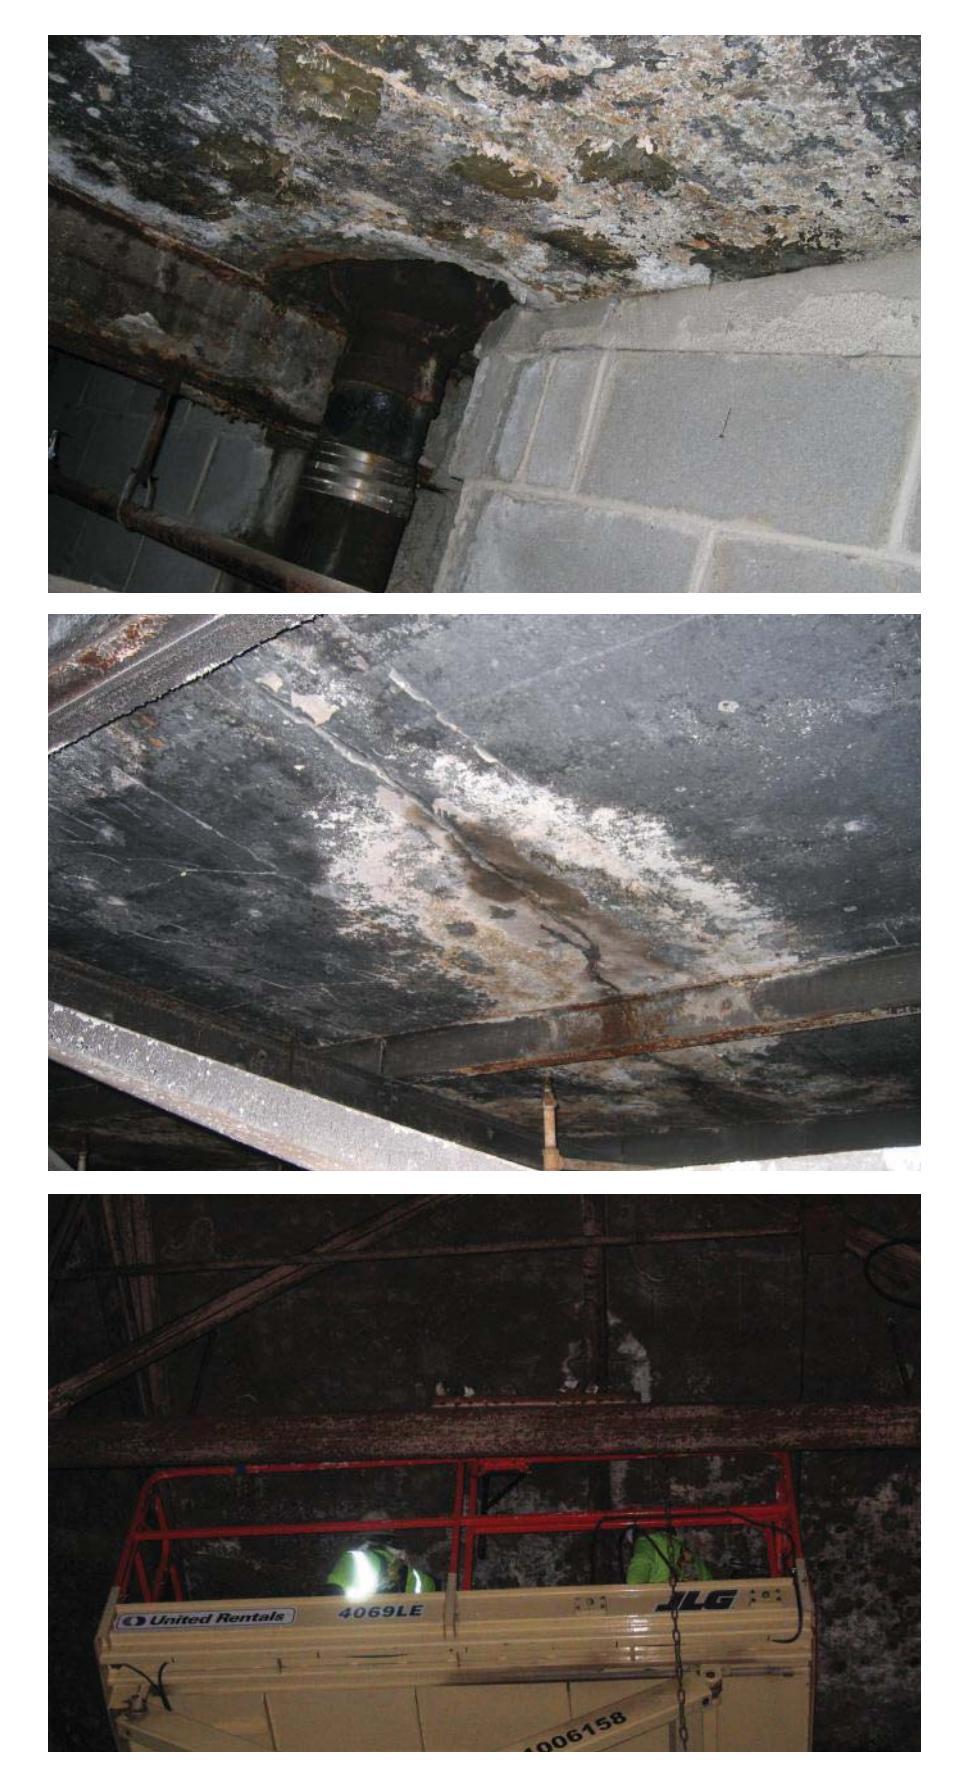
Photo 9 (top): Underside of roof slab - moisture by drain

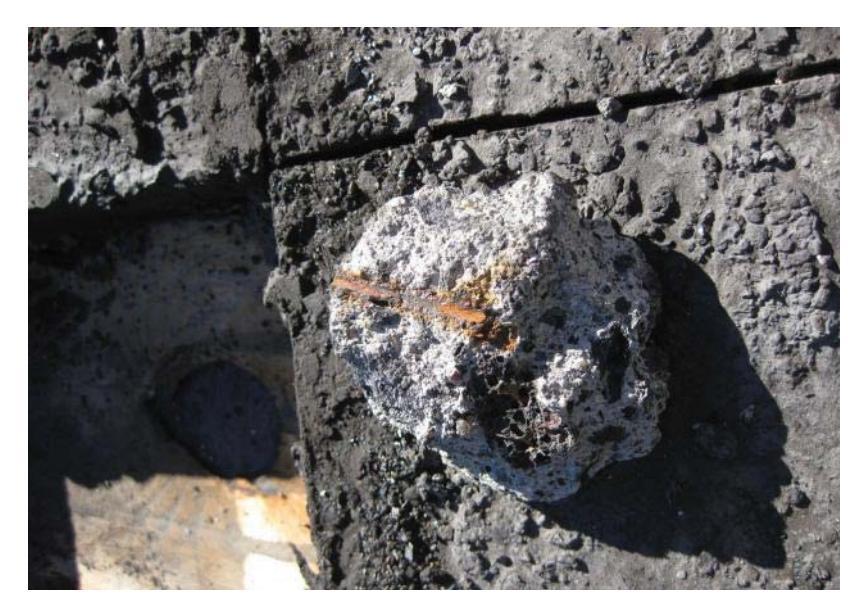
Photo 13: Roof probe #2 - corrosion on reinforcing

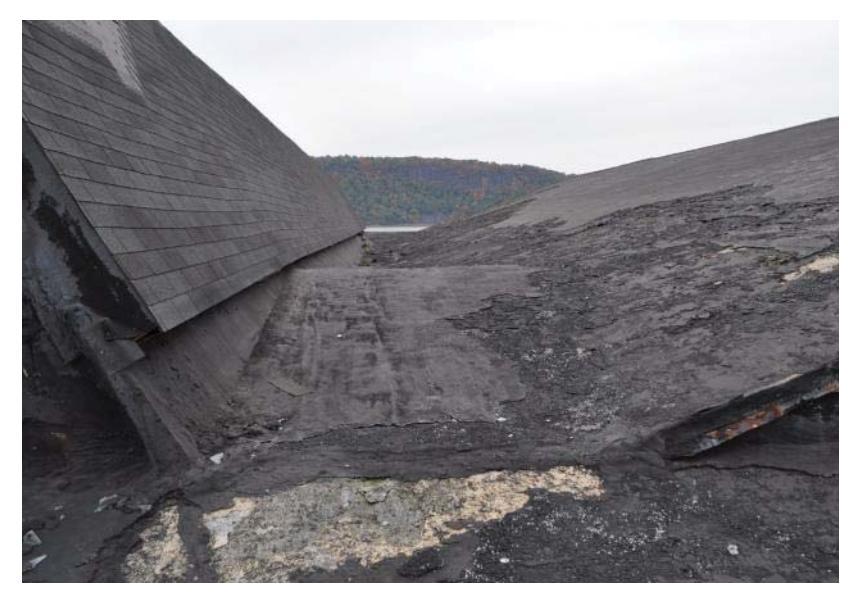
Photo 15: Roof membrane failure, column line 19, looking west.

The choices for replacement roofing membranes should be limited to those that can be applied over tapered insulation to provide a lightweight, effective and durable protection against the elements. While a number of systems are available (modified-bitumen, built-up asphalt, spray-applied foam, and single-ply) we believe single-ply membranes offer the most value for money spent. Large sheets that minimize the number of field seams can be fully adhered to the cover board. Of the various forms of single ply membranes, thermoplastic membranes (TPO and PVC) offer welded seams, a white reflective color, and wide availability among applicators. We had good experience with a TPO membrane manufactured by Carlisle Syntec Systems.

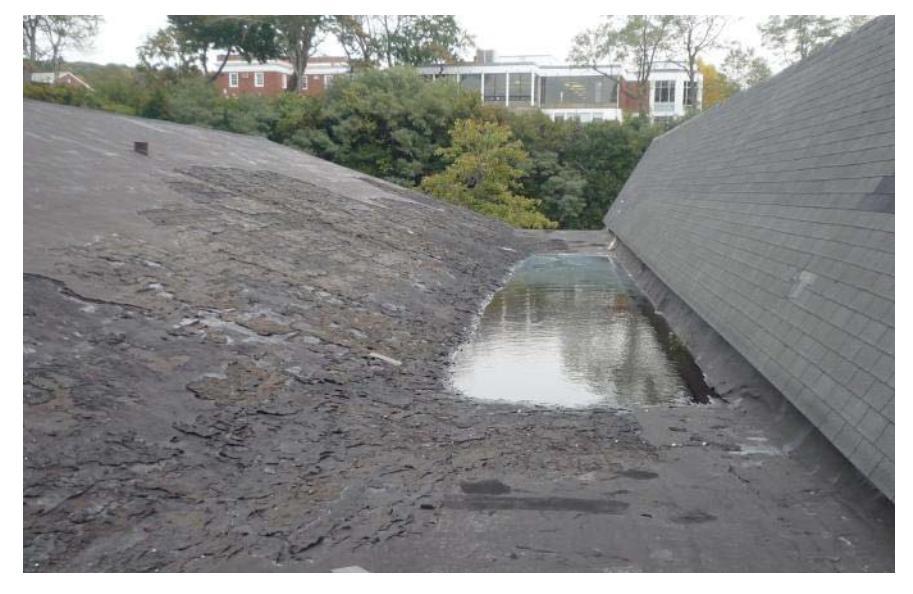
Photo 19 (top): Coping at east façade wall. Note overflow opening and presence of standing water.

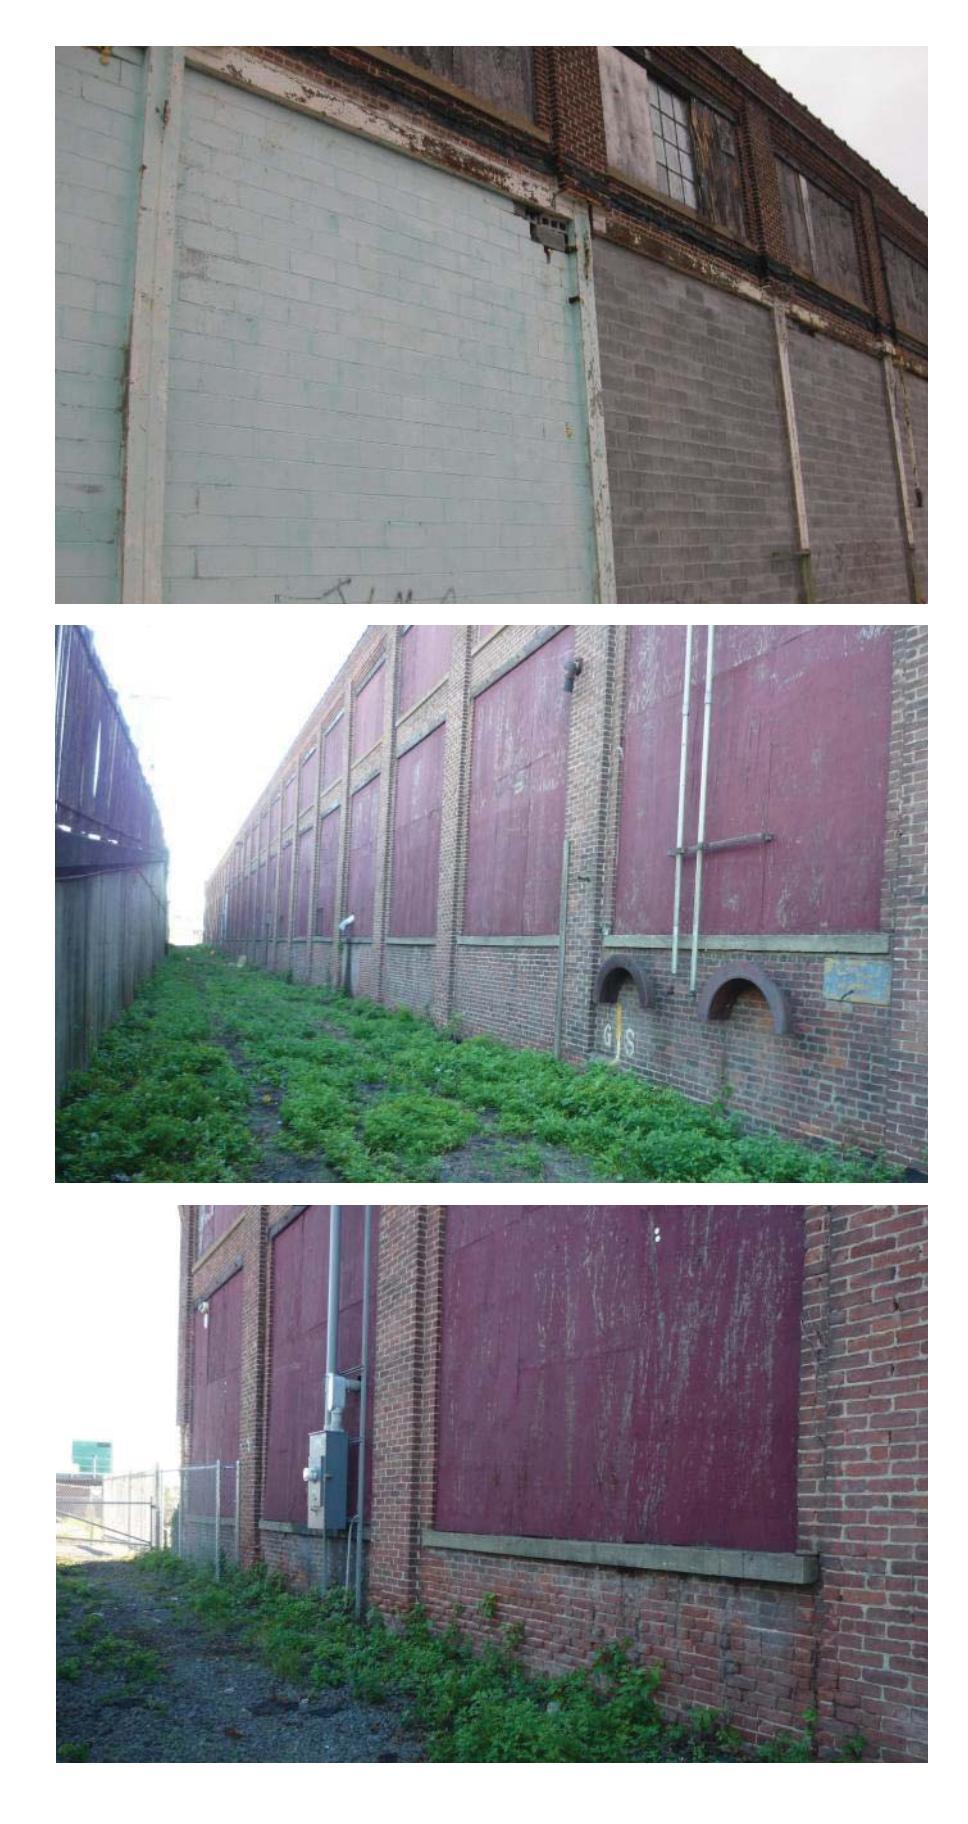
Photo 26 (top): Exposed steel columns at west wall

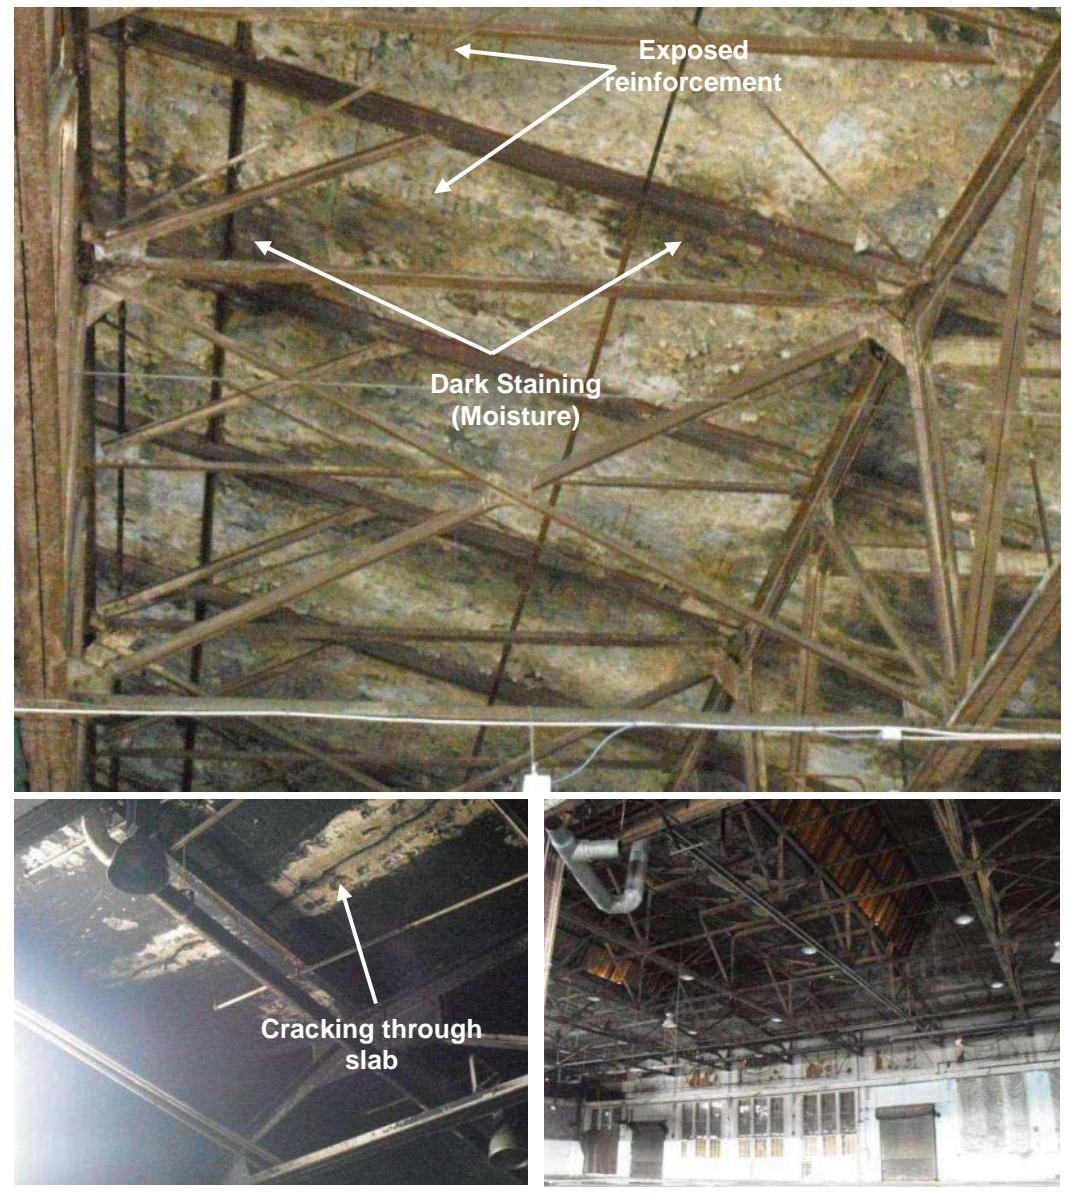
Images of Roof Soffit *Top* – Showing spalling concrete and exposed reinforcement *Bottom Left* – showing cracking through slab and section coated in black paint *Bottom Right* – showing complex truss arrangement through which scanning took place

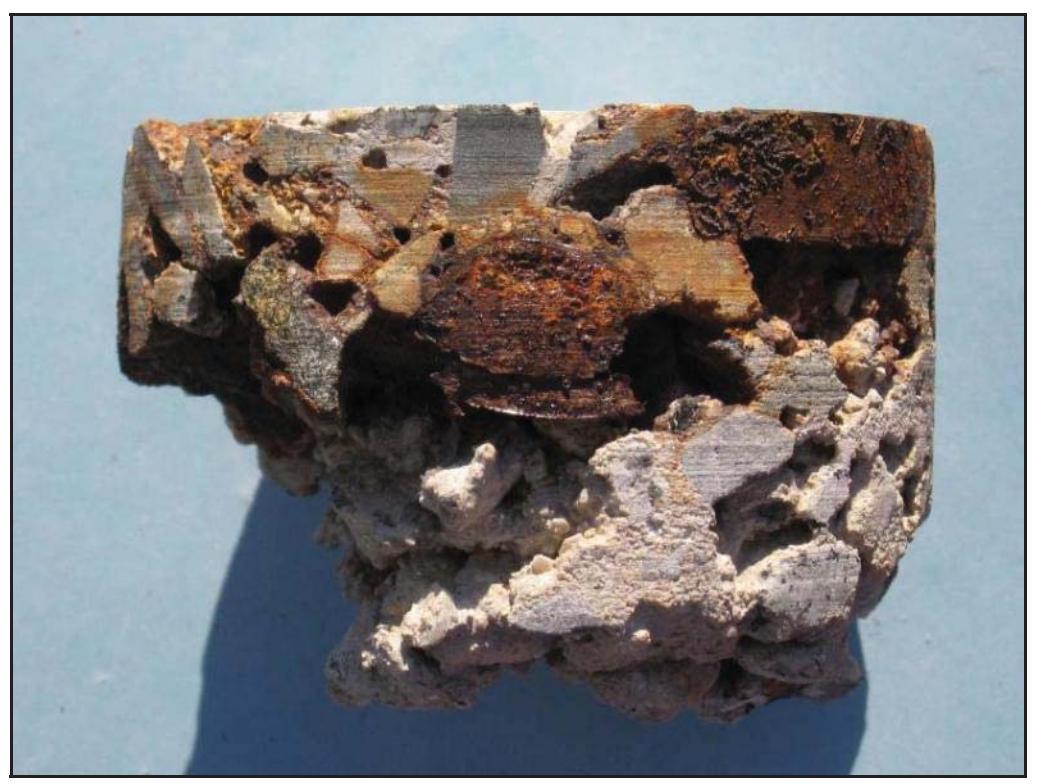
Photo 20. Poor consolidation of concrete observed around reinforcing steel bars.

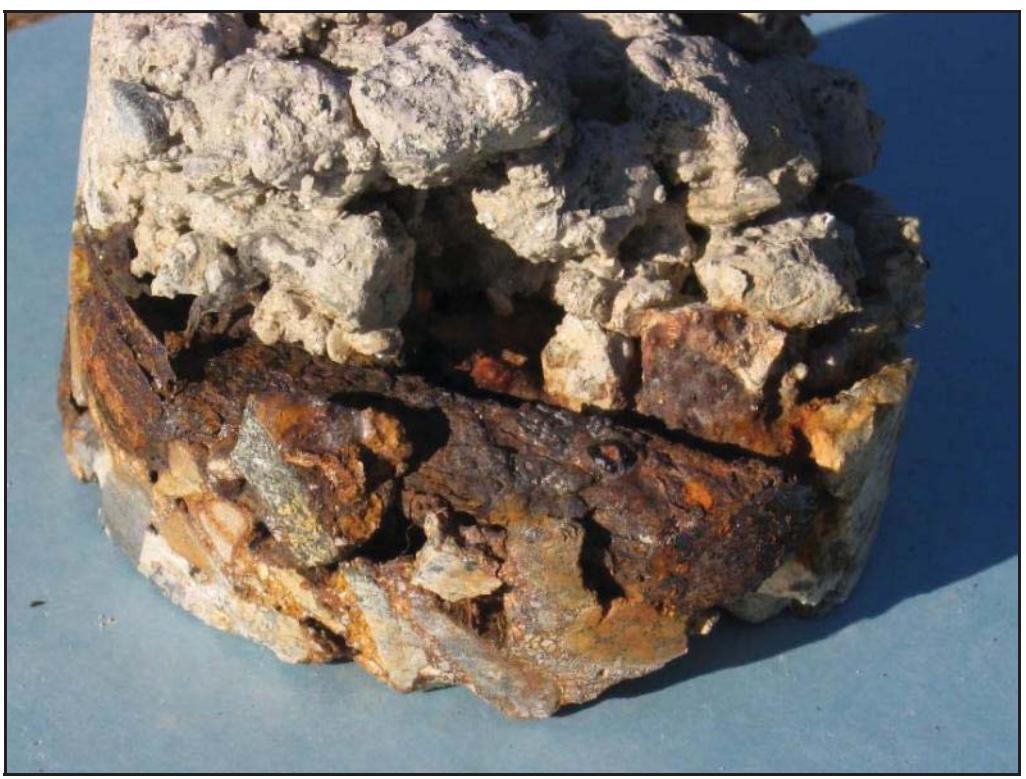
Photo 21. Excessively corroded rebar observed at bottom of core.

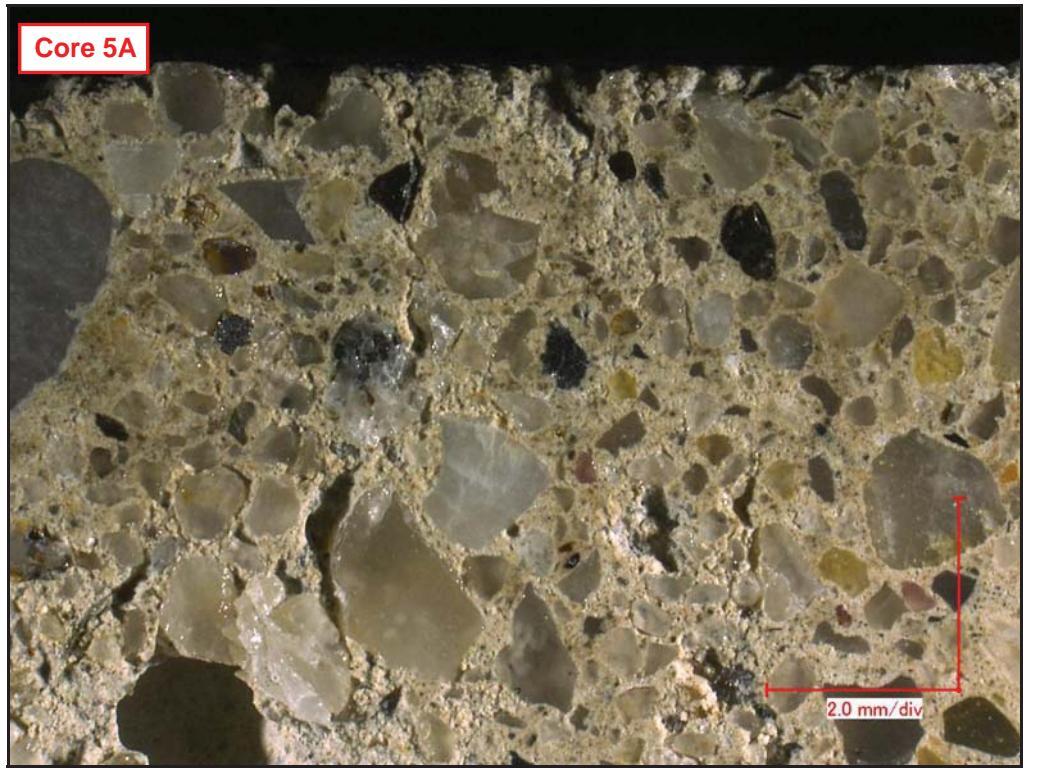
Photomicrograph 25. Vertical cracks observed in Core 5A.

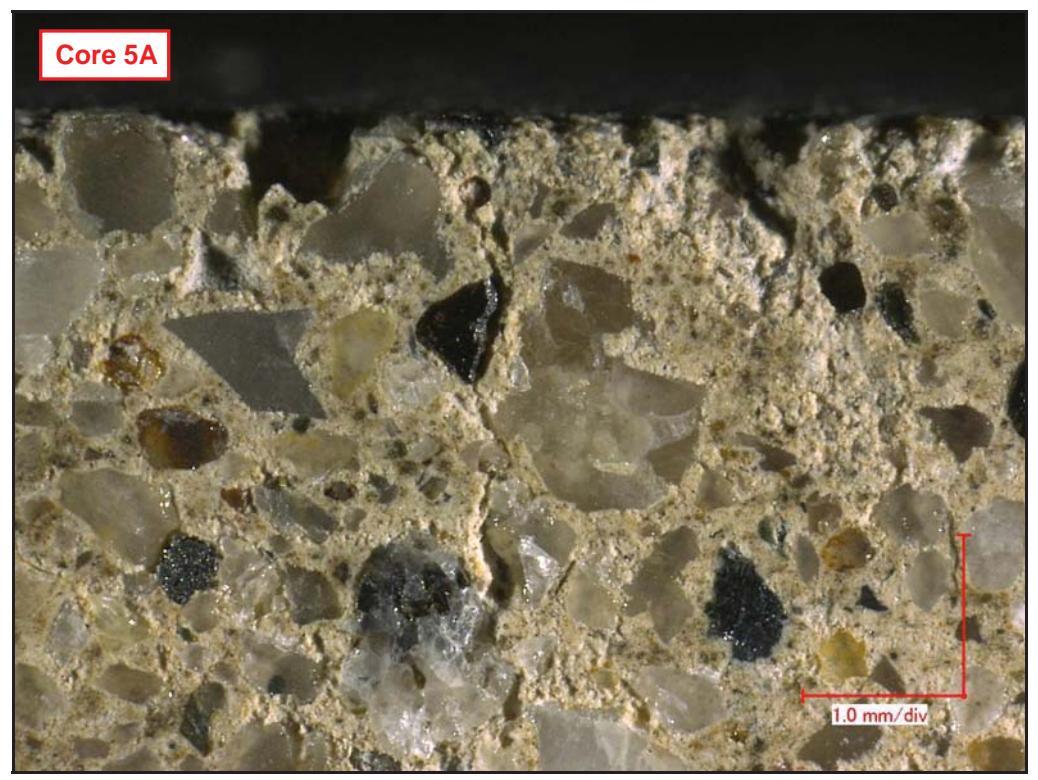
Photomicrograph 26. Vertical cracks observed in Core 5A.

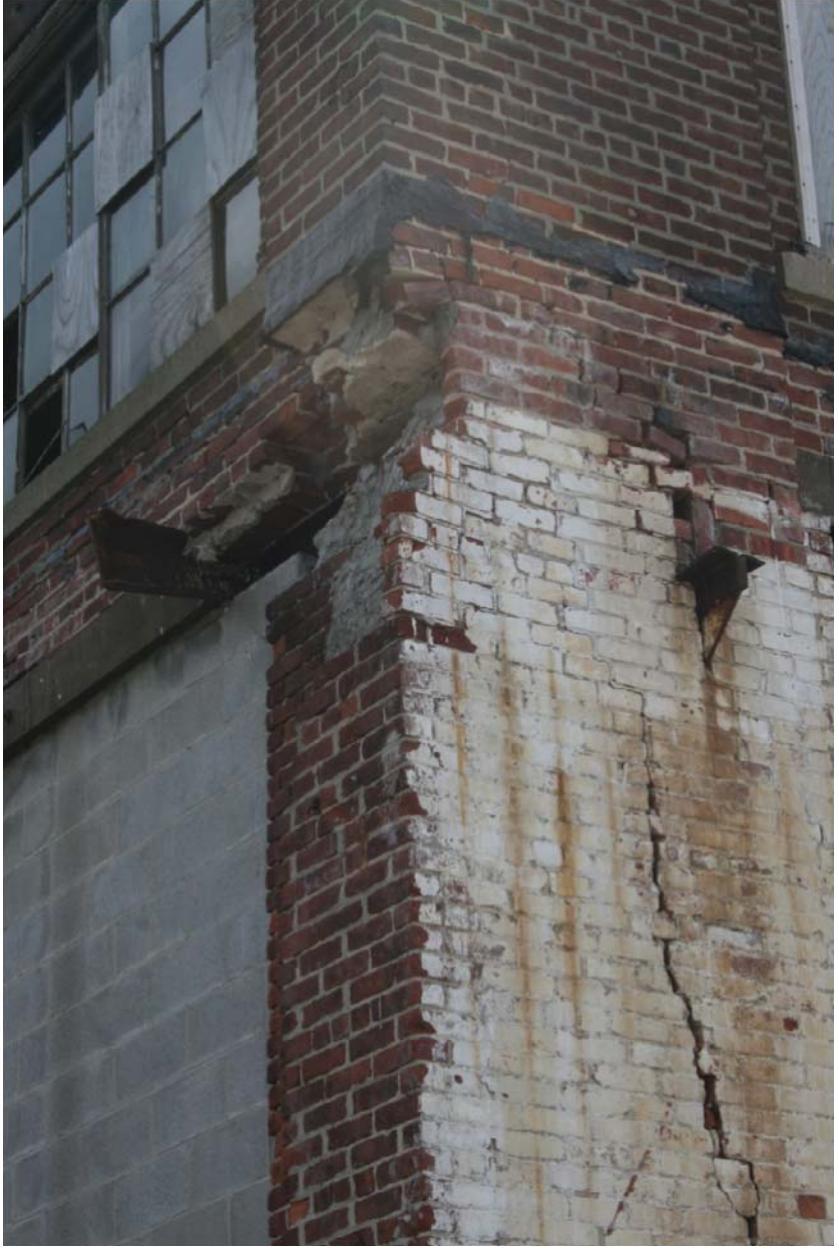
Image 7: Detail of damage to north and west elevations of Building 52
