Re:  
Resubdivision of 196 Warburton Avenue to develop 1-family residence.

RESUBDIVISION  
to 196 Warburton Ave.  
Hastings-on-Hudson,  
New York, 10706

Re: Subdivision Application of Dean L. Wetherell and Marie T. de Bethune  
Wetherell, 196 Warburton Avenue, Hastings-on-Hudson, NY 10706.

Site drainage - October 30 Soil Test Pit

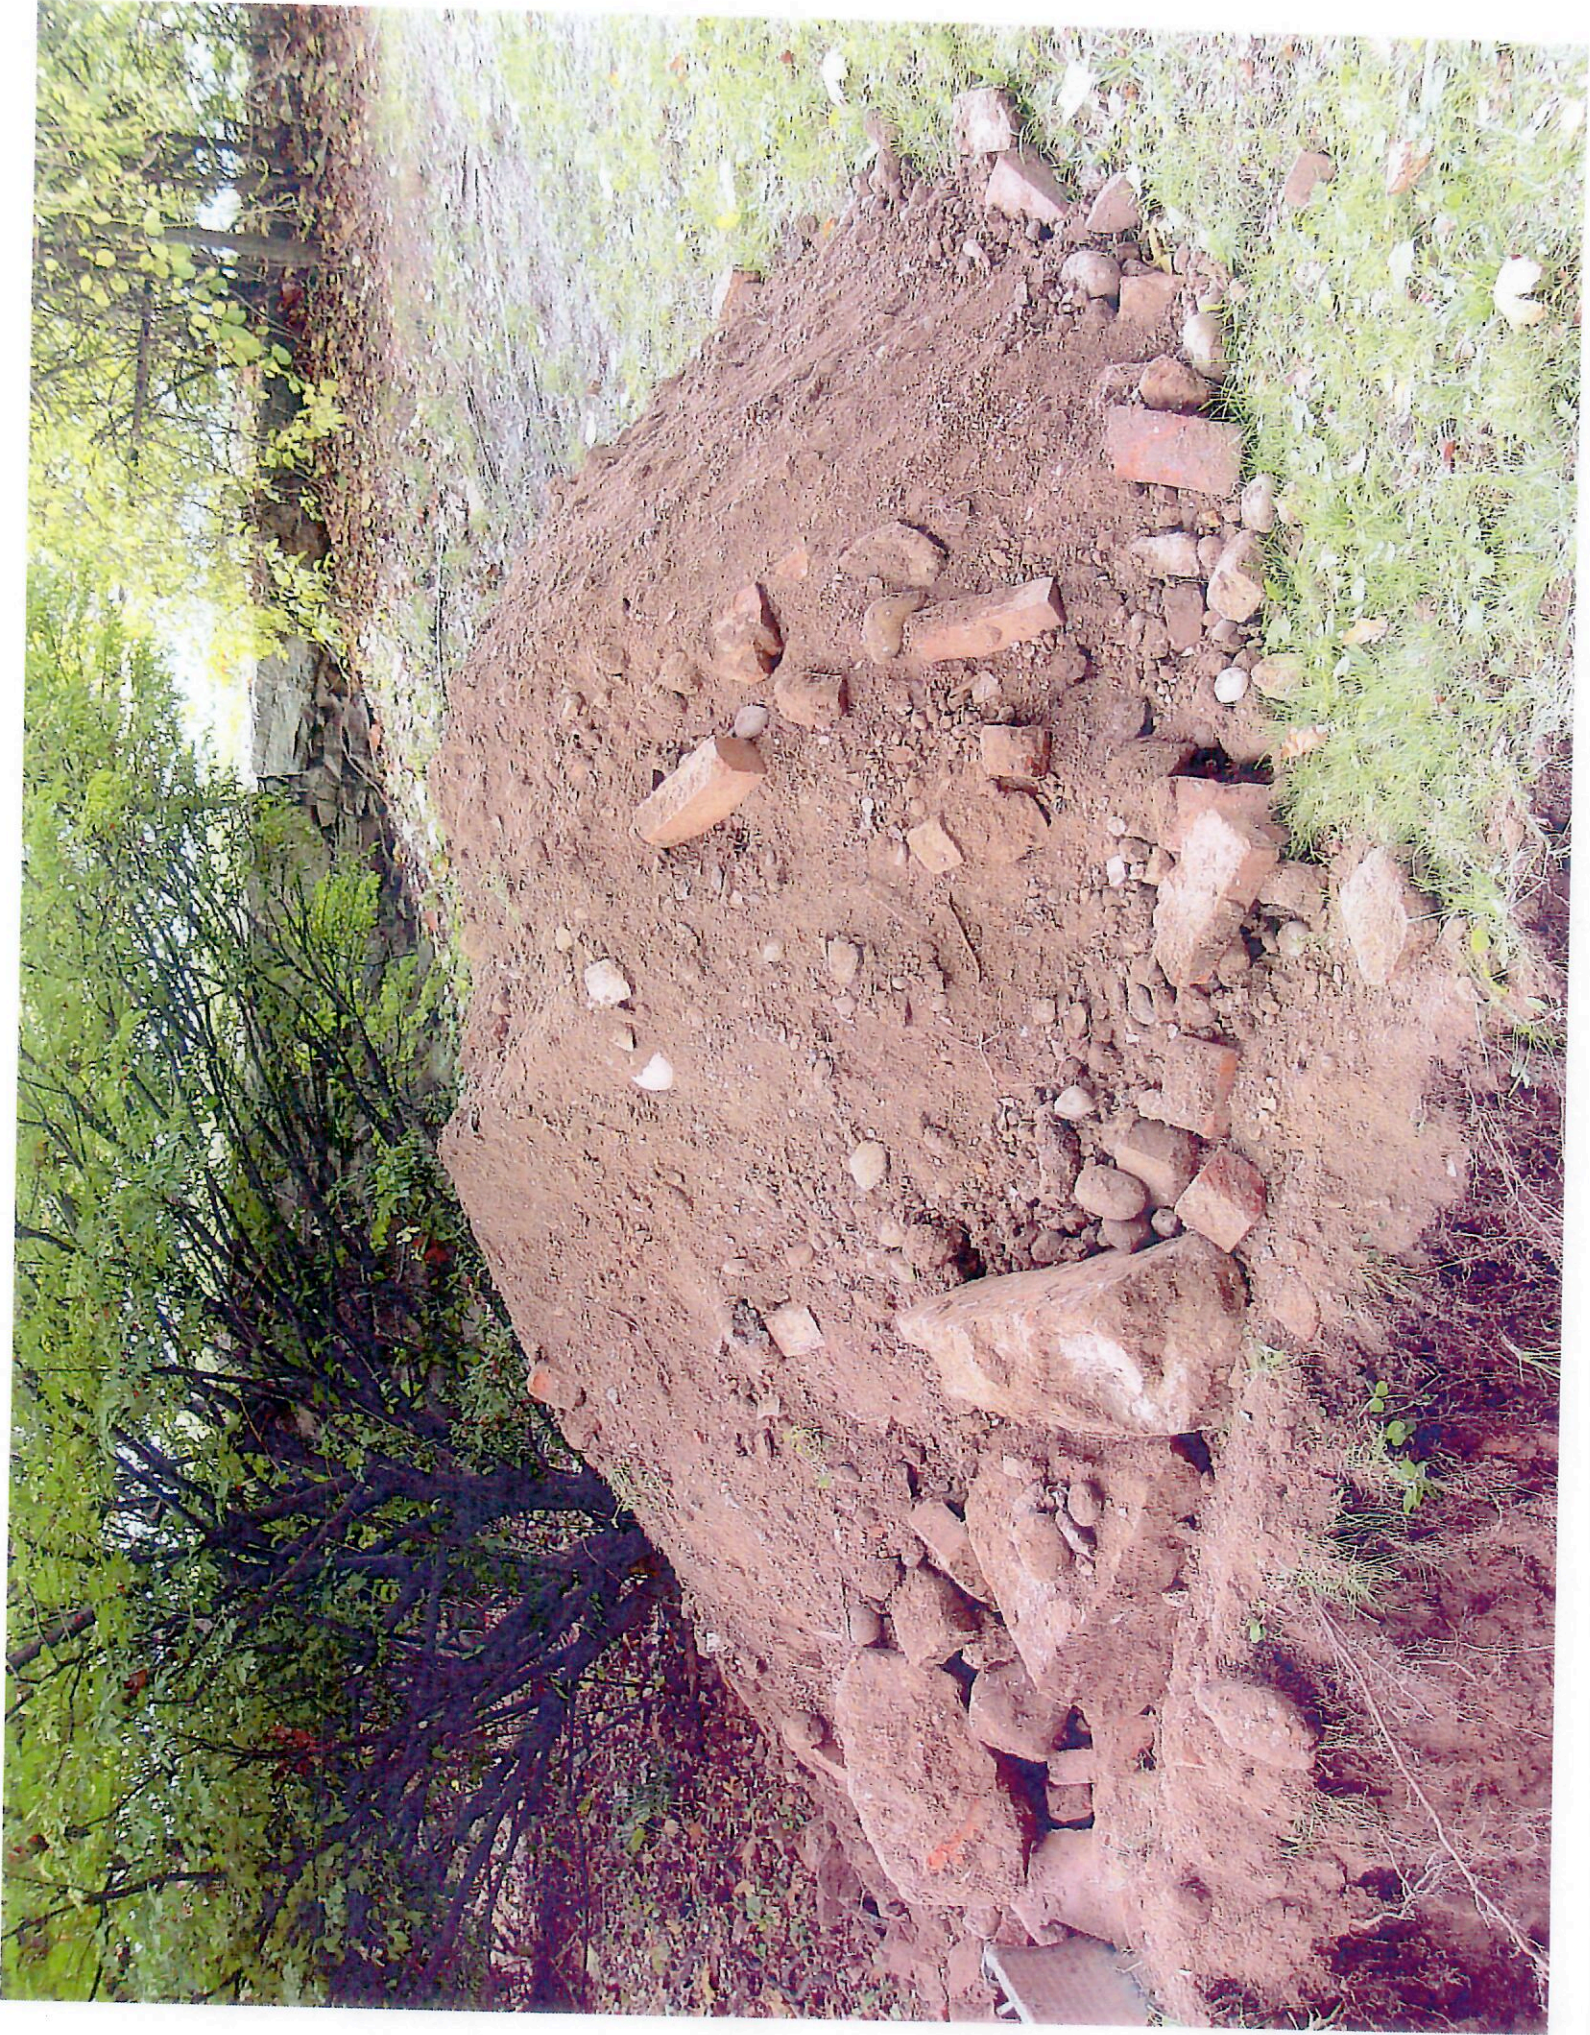
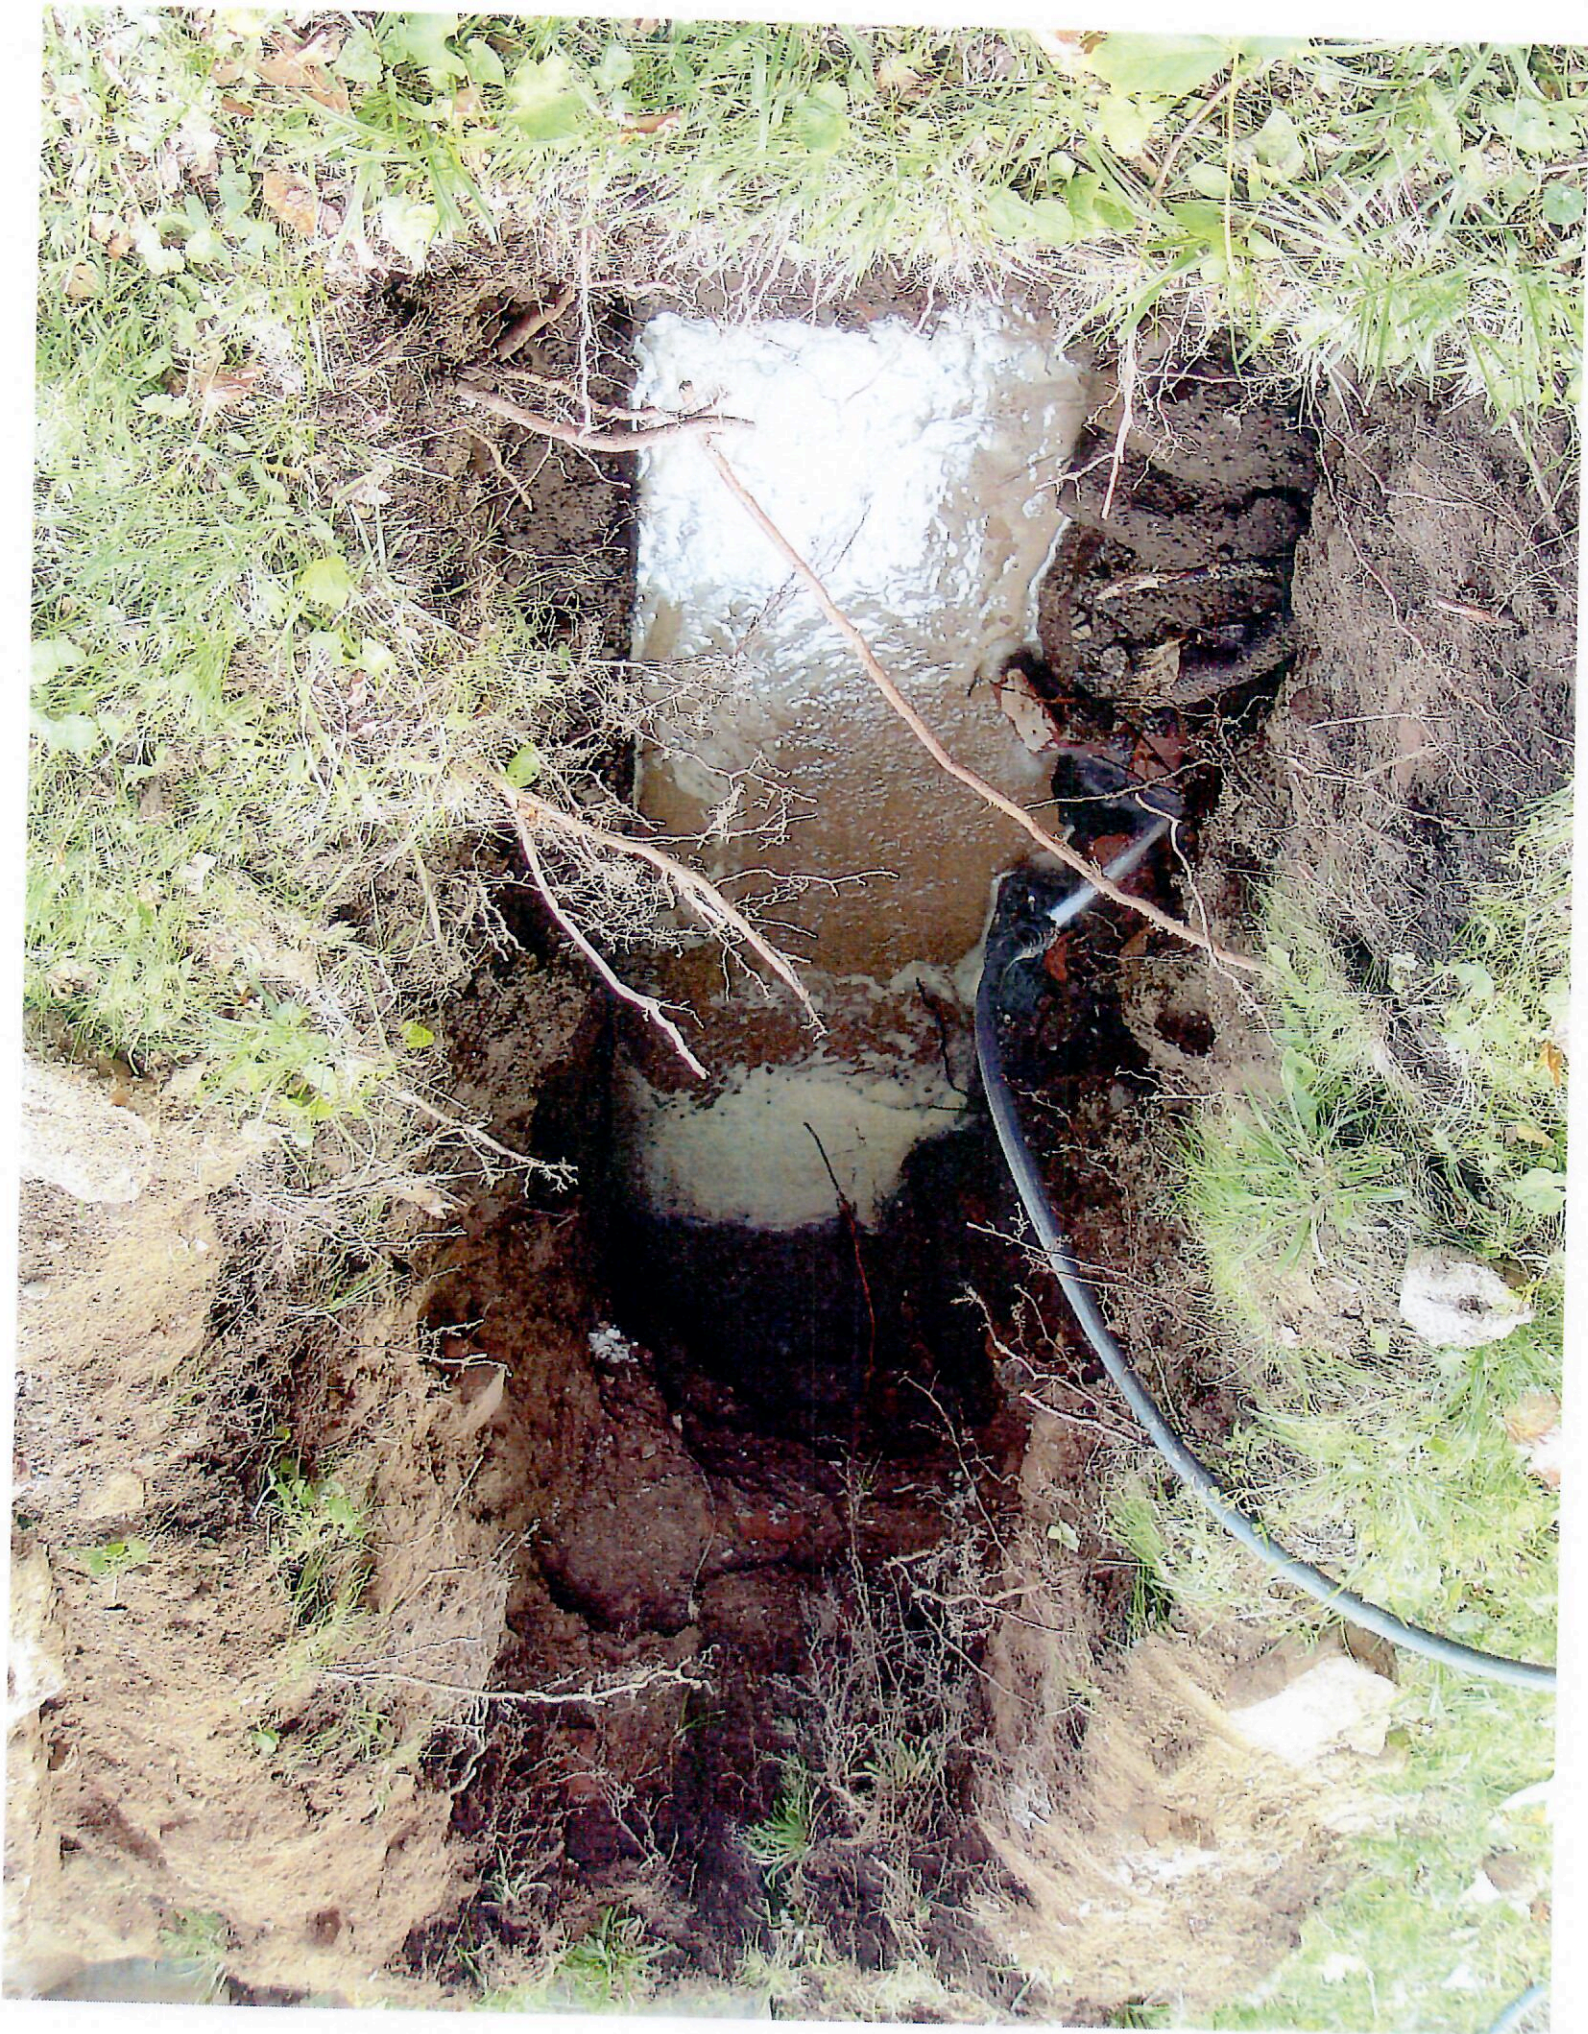
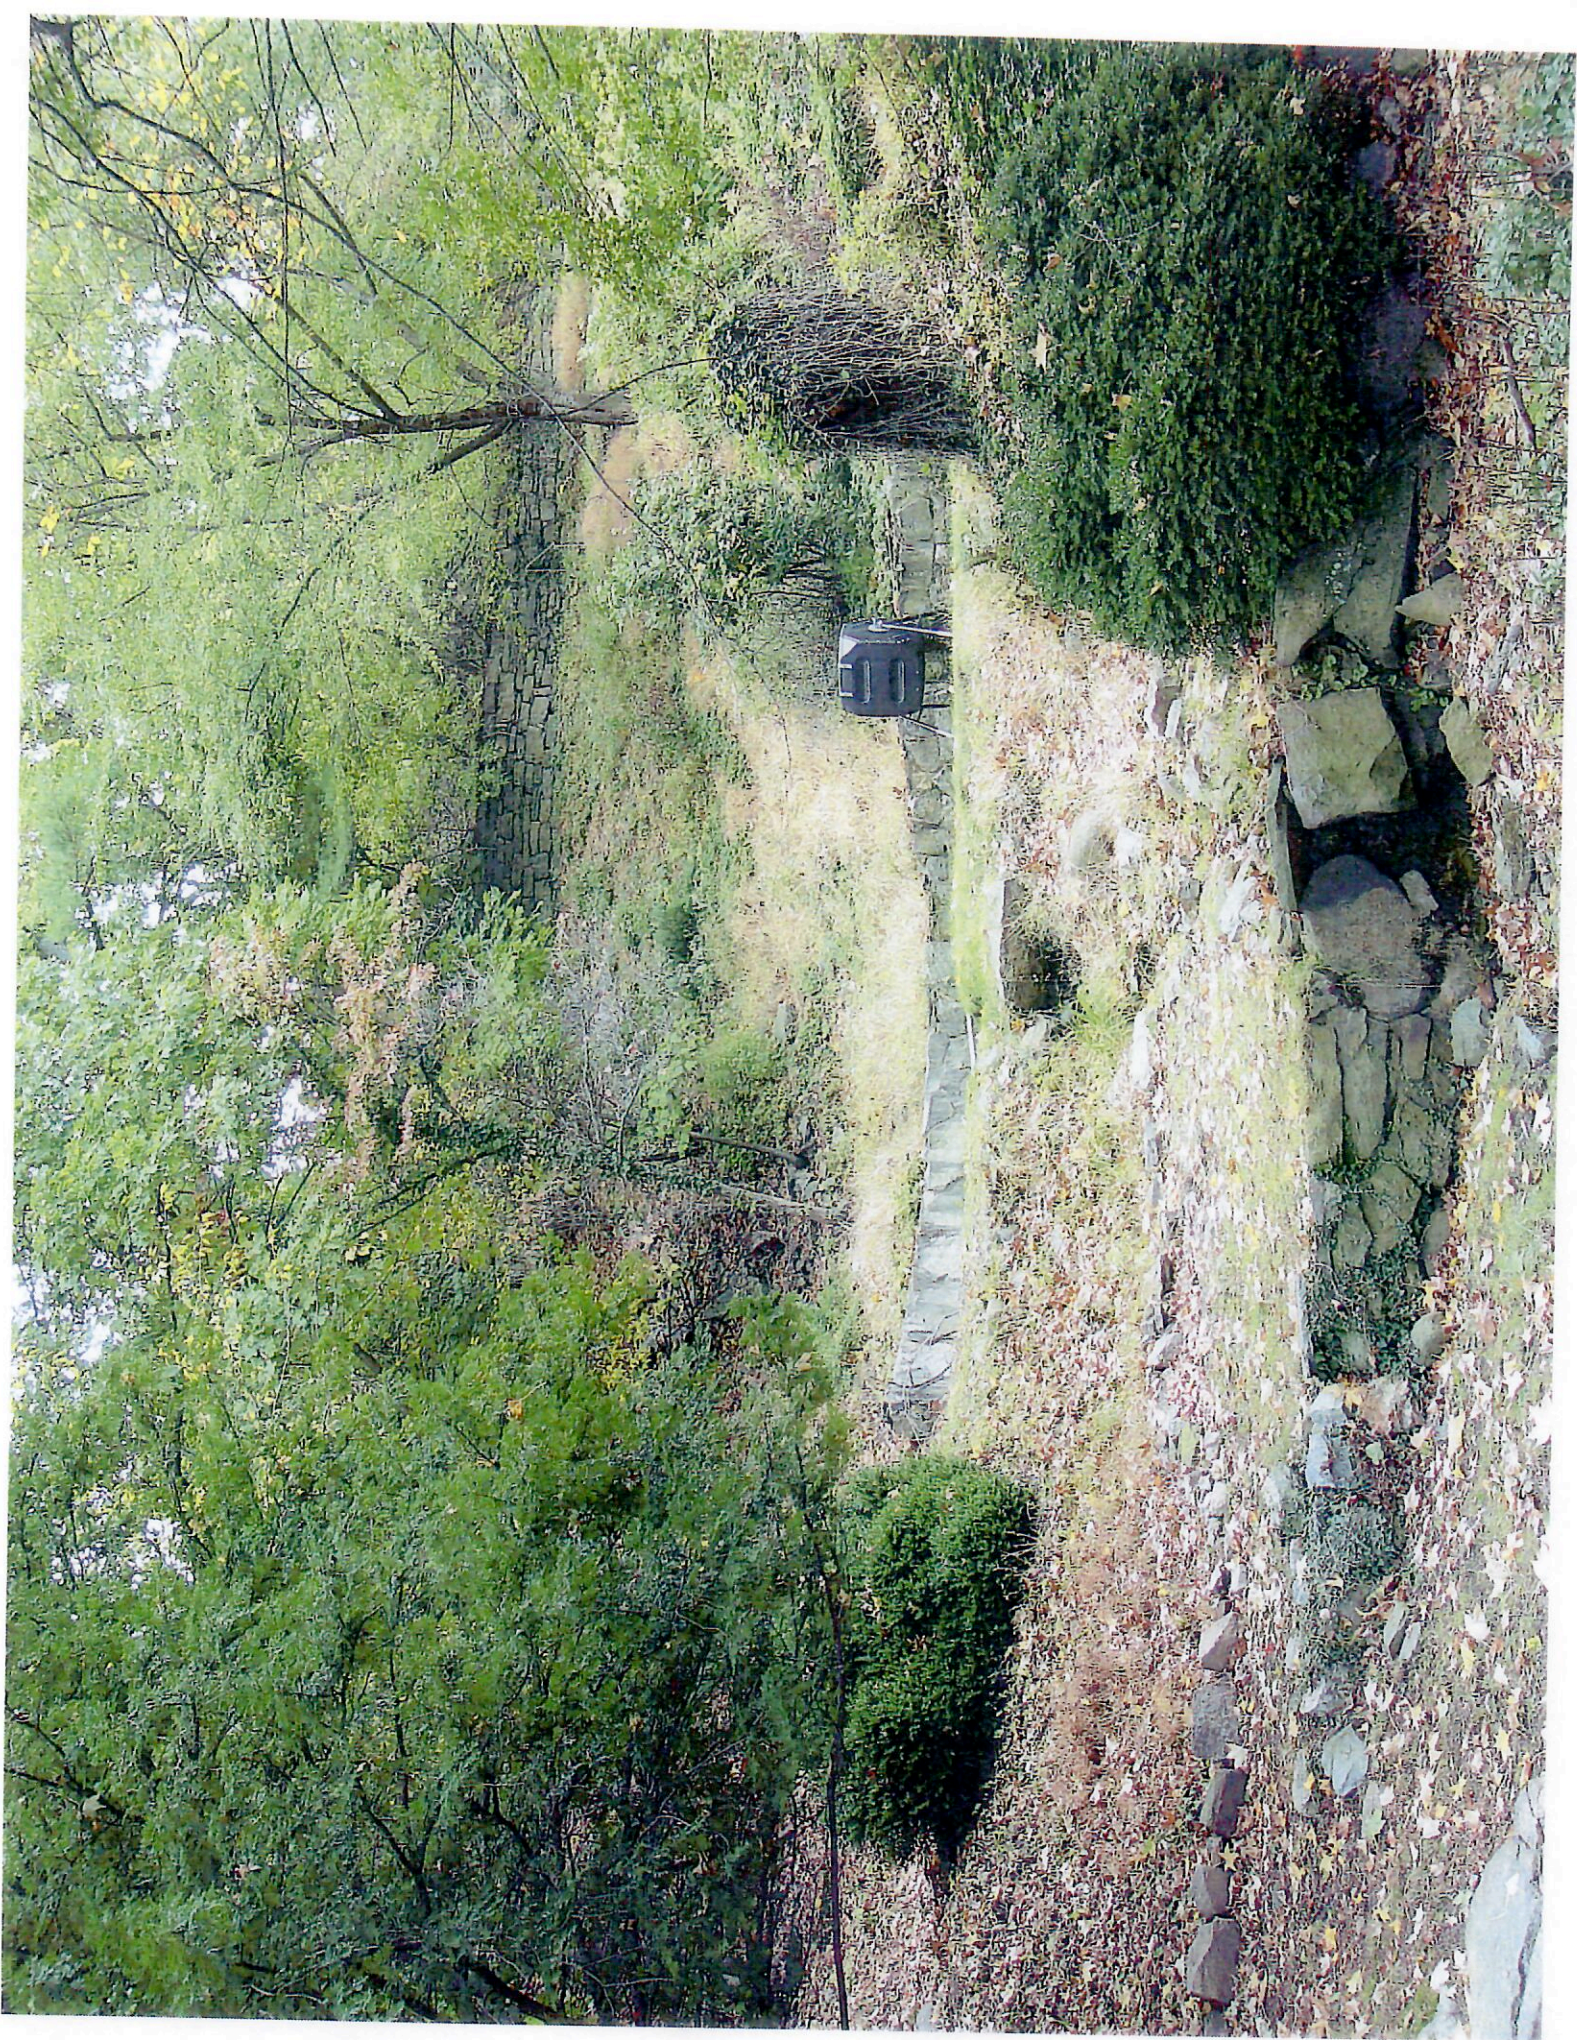
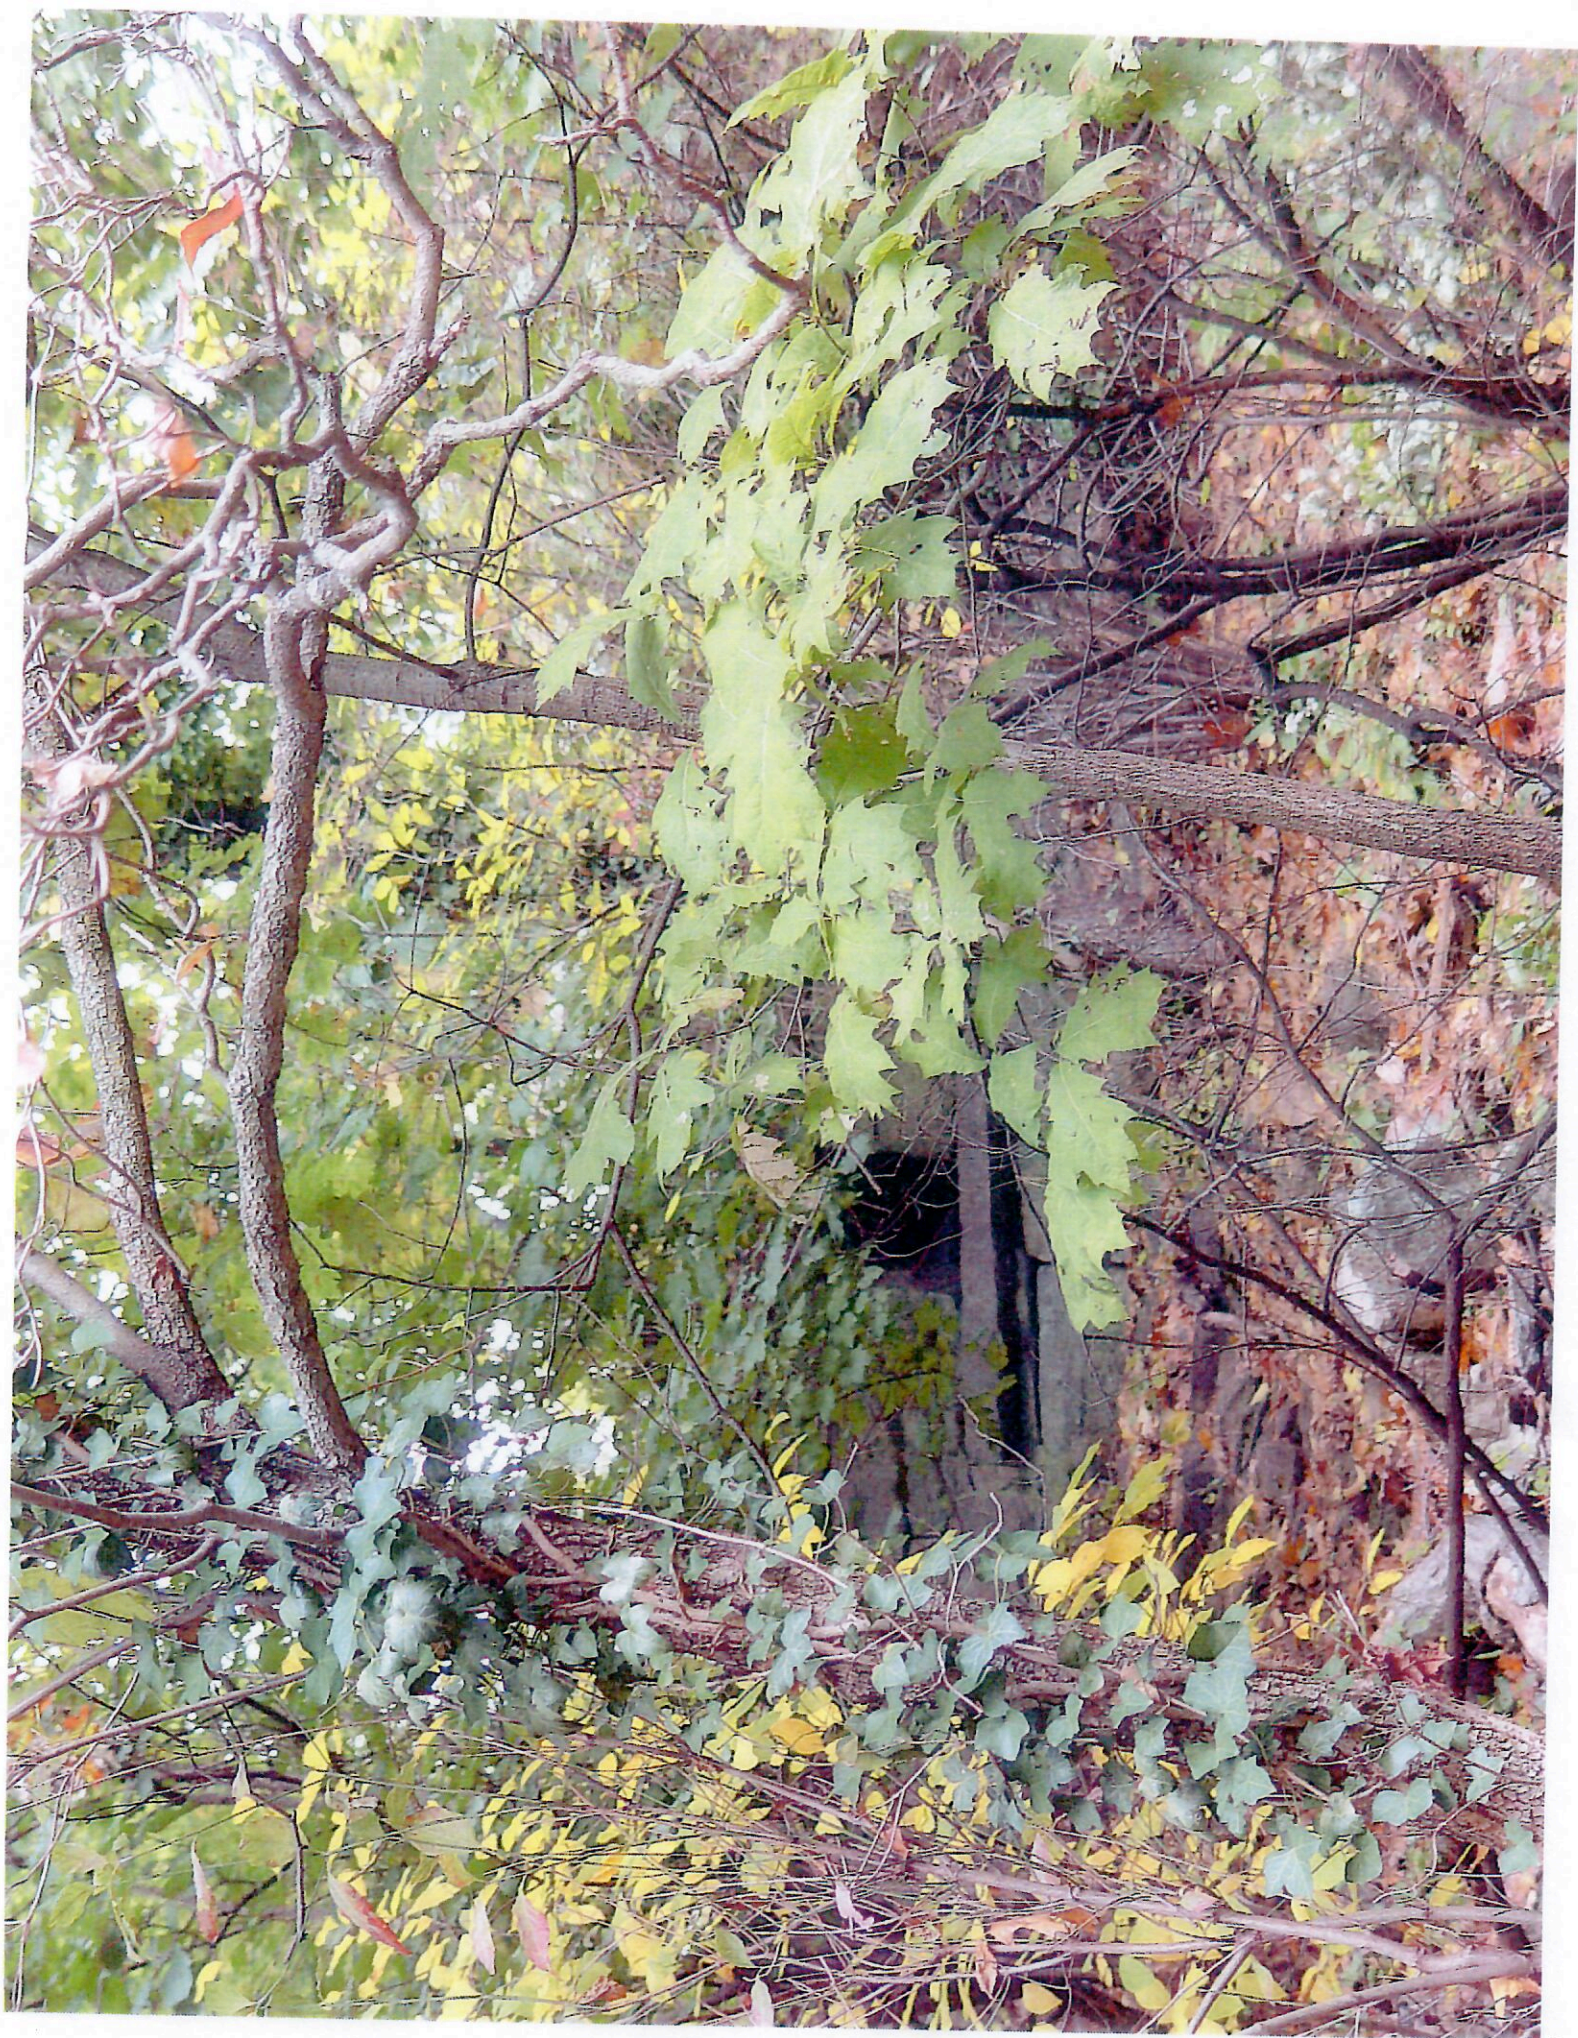
On October 30 Th. a test pit was made on the lot in the depressed area with a small backhoe to a depth of 6.8 feet and an in-place test to determine how well the soil will drain was made by putting a hose into the test pit. Water filled the test pit to a depth of approximately thirteen inches (13") and remained at that level as the hose continued to run constantly and the test pit did not fill and kept taking water.

The soil excavated from the test pit is a clean granular fill with a few bricks and rock with no signs of deleterious matter and not very dense.

We attach several photos taken at the time the test pit was made and a marked-up plan showing the existing and proposed drainage features. Should you have any further questions on this matter, please do not hesitate to call.

We determined the rate to the test pit by filling a bucket with the hose to be a flow rate of 6.1 Gallons per minute. The soil is accepting water at a very high rate and using the dimensions of the test pit we calculate a soil adsorption rate (SAR) of 72.5 cf/sf/day (Cubic Feet per Square Foot Per day), which for soils in this area is a very high SAR. Soils rates for the glacially loaded soils in the Rivertowns range between a low of 1.0 to a high of 13.0 cf/sf/day.
