**VILLAGE OF HASTINGS-ON-HUDSON  
MUNICIPAL GREENHOUSE GAS (GHG)  
ANALYSIS AND ACTION PLAN  
ENERGY AUDIT REPORT**

**DRAFT REPORT FOR REVIEW AND COMMENT**

**MARCH 15, 2019**

**OLA CONSULTING ENGINEERS, PC**  
Hawthorne, NY

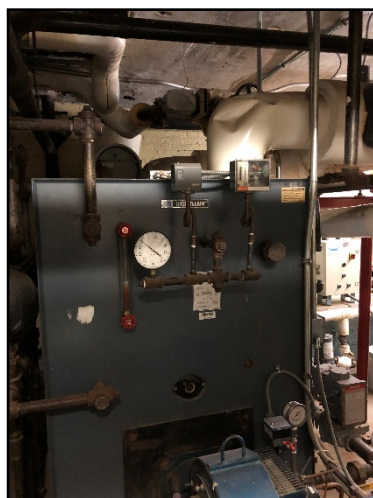
Heating for the Village Hall and Library is provided by one (1) dual-fuel fired (natural gas and #2 oil) low-pressure steam boiler. The boiler has a total capacity of 2,452 MBH and is manufactured by Weil McLain (Photo 4). The boiler burner appears to be original to the boiler and has a maximum capacity of 3,103 MBH on natural gas, and 21.5 GPH on oil. It was noted that the boiler is typically run on gas, was installed during a building renovation in 1998, and appears to be in fair condition. Building staff indicated that the boiler is enabled during all hours of the day during the heating season, due to the Hastings Police Department occupying part of the building. A summary of the heating plant is shown below in Table 5.

Photo 4. Steam boiler serving Village Hall

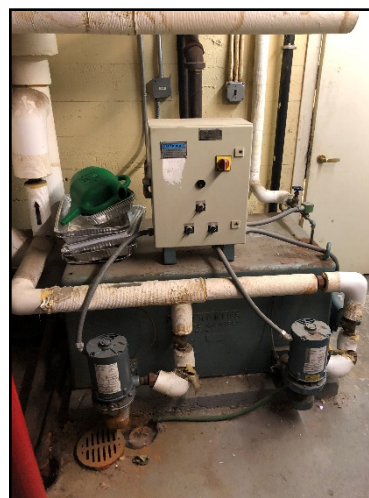
Photo 5. Steam condensate pumps

Low-pressure steam generated by the heating plant serves three (3) different heating zones between the two buildings. The steam system is a two-pipe, pumped return system. Steam condensate is returned to the boilers via a duplex condensate pump (Photo 5), which collects and pumps the condensate back into the boiler. Two of the zones serve the northern and southern halves of the Village Hall, while the third zone supplies hot water to the library via a steam-to-hot water heat exchanger. A description of the heating system for the library is provided below. Steam for the Village Hall is distributed to cast iron steam radiators throughout the building perimeter (Photo 6). Each zone is controlled by its own programmable Honeywell thermostat (Photo 7), which is located on the first floor. The thermostat controlling the northern half of the building is located in the Building Department, while the thermostat controlling the southern half is located in the adjacent Clerk's Office. The thermostats have the ability to automatically adjust temperature setpoint based on a programmed occupancy schedule.

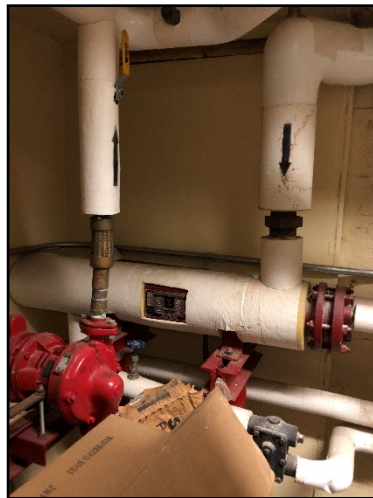
It was noted that there is a fourth heating zone, which supplies hot water to finned tube radiation in the Police Department locker rooms in the basement of the building by means of a separate heat exchanger and two (2) dedicated hot water pumps (Photos 8 and 9). However officers expressed their desire to keep the space cool, so this zone is no longer in use.

Photo 8. Heat exchanger serving Police locker rooms

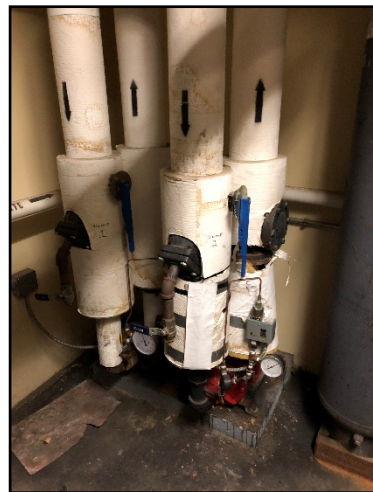
Photo 10. Hot water pumps serving Library

Heating for the library is provided by a steam-to-hot water heat exchanger and two (2) dedicated hot water pumps (Photo 10), served by the steam boiler plant at the Village Hall. Hot water generated by the heat exchanger is distributed to perimeter finned tube radiation (Photo 11) and to hot water heating coils located in two (2) AC units and one (1) HV unit serving the building. Each finned tube zone is equipped with an electric control valve and controlled by the Library's building management system (BMS). Heat provided by the AC/HV units and finned tube radiation is controlled by local space temperature sensors, which are all monitored by the BMS. Temperature setpoints for these spaces can be adjusted at the BMS workstation located in the basement electrical room. A full description of the BMS can be found in section 4.01.4.

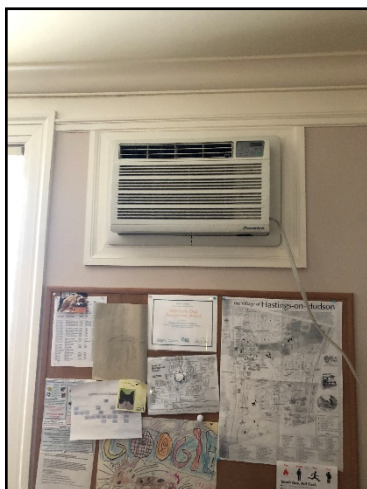
Photo 13. Typical window AC unit

Cooling for the Village Hall is provided by a combination of window AC units and packaged terminal AC units (PTAC's) serving offices in the building (Photo 13), a Trane packaged rooftop unit (RTU) serving the second floor courtroom (Photo 14), and two (2) Mitsubishi split AC units serving the Police Department (Photo 15). The RTU and split AC units are all controlled locally by programmable thermostats located in the spaces they serve. It was noted that the packaged RTU serving the courtroom appears to be in poor condition. There are approximately 11 Friedrich window AC units and 2 PTAC's serving the building. Each window AC unit has an approximate capacity of 1.5 tons (18 MBH) of cooling. A summary of the cooling systems at the Village Hall is shown below in Table 6.

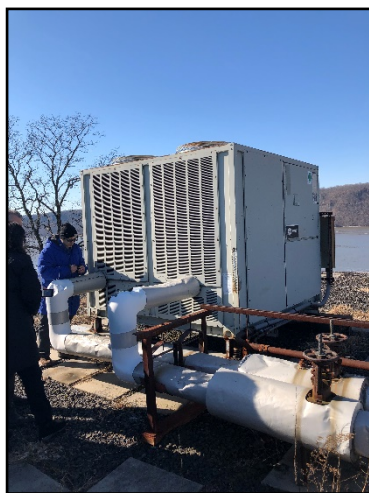
Photo 16. Trane air-cooled chiller

Cooling for the Library is provided by a combination of one (1) 40-ton air-cooled Trane chiller (Photo 16), which serves the main floor, Picture Book Room, and Barnes Room via chilled water coils located in AC and HV units, and one (1) City-Multi split AC unit which serves the Orr Community Room on the lower level (Photo 17). A summary of the chiller plant at the Library is shown below in Table 7.

Chilled water is supplied to spaces via two (2) chilled water pumps located in the penthouse mechanical room. The chiller itself is located on the roof of the building, adjacent to the penthouse. The chiller is automatically controlled by the BMS (Photo 18) and is set to maintain 44°F chilled water supply temperature (CHWS) during occupied hours (determined based on Library hours). The chiller was installed in the 1990's and appears to be in fair condition, while the chilled water pumps appear to be original to the building (1965). The pumps also appear to be in fair condition.

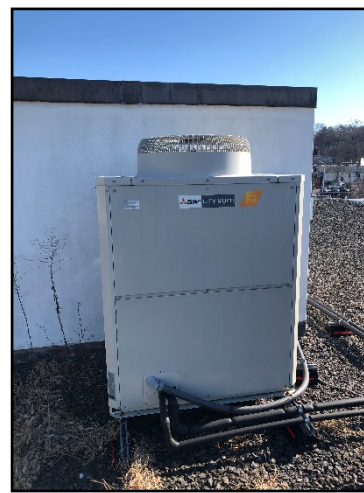
Photo 17. City-Multi condensing unit

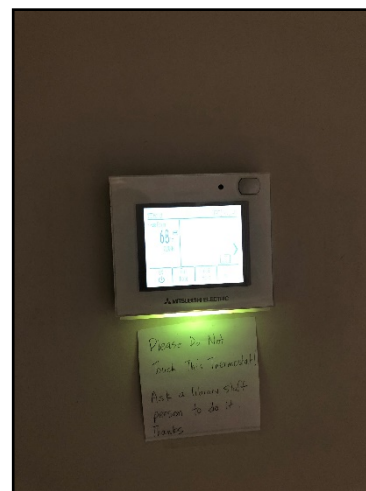
Photo 19. Thermostat for City-Multi heat pump

thermostat, and cannot be controlled by the BMS (Photo 19). It was noted that this unit was recently installed during expansion of the community room.

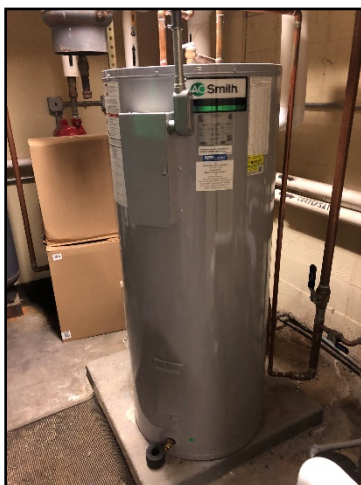
Domestic hot water (DHW) at the Village Hall is generated by a combination electric A.O. Smith water heater and storage tank (Photo 22). The DHW heater has a total capacity of 6 kW and a storage capacity of 80 gallons. The age of the DHW heater could not be verified but it appears to be in good condition.

Photo 22. Electric DHW heater serving Village Hall

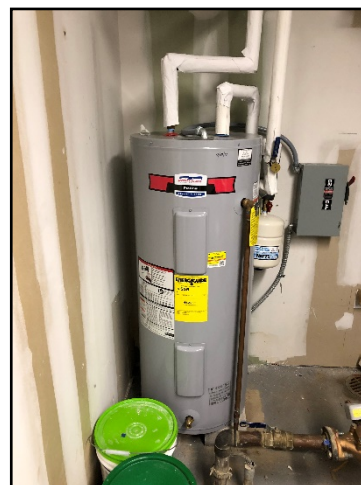
Photo 23. Electric DHW heater serving Library

Domestic hot water at the Library is generated by a combination electric American water heater and storage tank (Photo 23). The DHW heater has a total capacity of 4.5kW and a storage capacity of 40 gallons. The DHW heater was installed in 2017 and appears to be in good condition. A summary of the DHW systems serving the two buildings is shown below in Table 10.

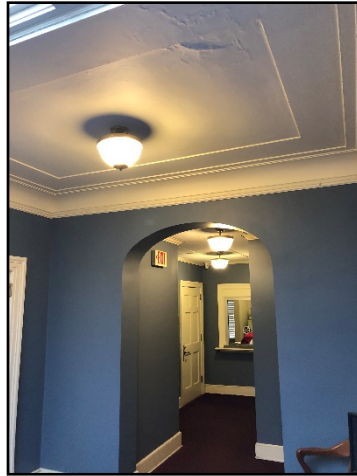
Interior lighting at the Village Hall primarily consists 3-bulb ceiling pendants which contain 13W Fluorescent bulbs, and 2-bulb ceiling pendants containing 28W Fluorescent bulbs. These fixtures are found in all spaces throughout the building (Photos 24 and 25).

Photo 24. Typical Village Hall corridor lighting

This measure investigates the impact on energy consumption of reduced lighting power density utilizing high efficiency LED lighting technology and retrofit products throughout the building. The new LED lighting will result in a reduced lighting power density and potential for high savings. All of the typical 13W and 28W compact fluorescent lighting, as well as the 32W T8 fluorescent lighting in the basement of the building could be replaced with LED retrofit products. The existing lighting power density of the Village Hall is estimated to be 0.52 W/ft<sup>2</sup>. The resulting lighting power density of the entire facility is estimated to be in the range of 0.26 W/ft<sup>2</sup> after a complete retrofit.

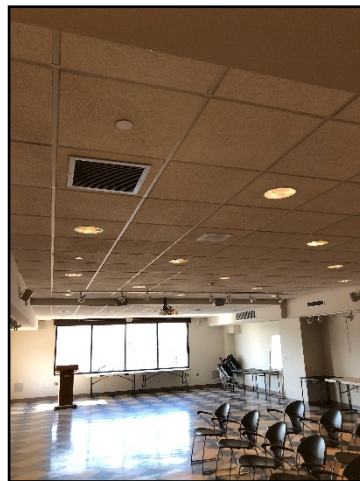
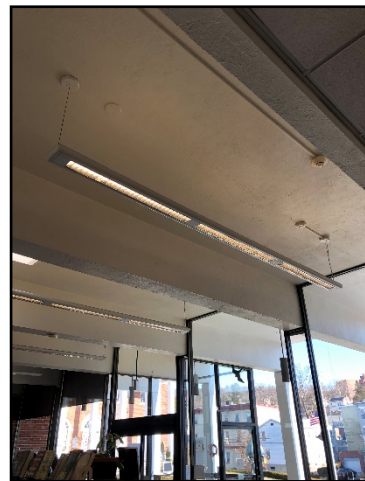
Interior lighting fixtures at the Library primarily consists of 12W and 18W LED lamps, which are found on the main floor, Orr Community Room, Barnes Room, Picture Book Room, and offices (Photos 26 and 27). There are additional wall-mounted lighting fixtures on the lower level of the Library that contain 22W Fluorescent lamps (Photo 28).

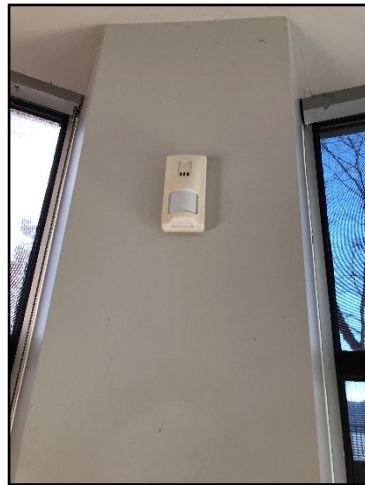
All interior lighting at the Village Hall and Library is controlled manually by toggle switches. Lighting is turned on at the beginning of each day by building staff and typically remains on until the end of the day. It was noted that both buildings have occupancy sensors installed, however building staff indicated that they were intended to be used for security measures and are no longer in use (Photo 29).

Photo 29. Typical occupancy sensor

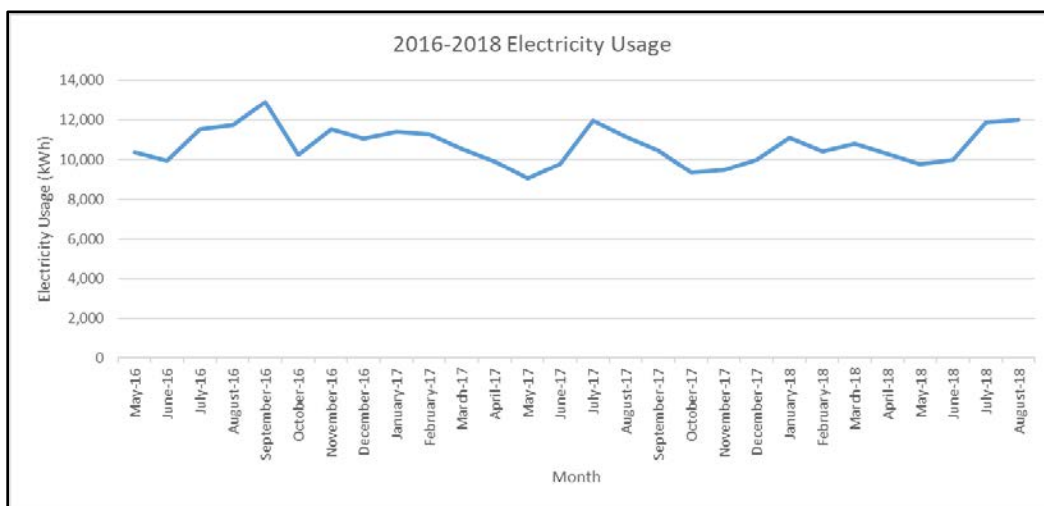
The historical electric usage for the Village Hall is shown in Figure 4. Peak electricity usage typically occurs during the summer months (May – September), likely due to the need to run the window AC units in order to cool the building. The highest monthly usage recorded during this time was 12,880 kWh during September 2016. It was noted that the usage remains relatively constant throughout the year, likely to the limited amount of window AC units at the building.

Figure 4. 2016 – 2018 Village Hall Historical Electricity Use

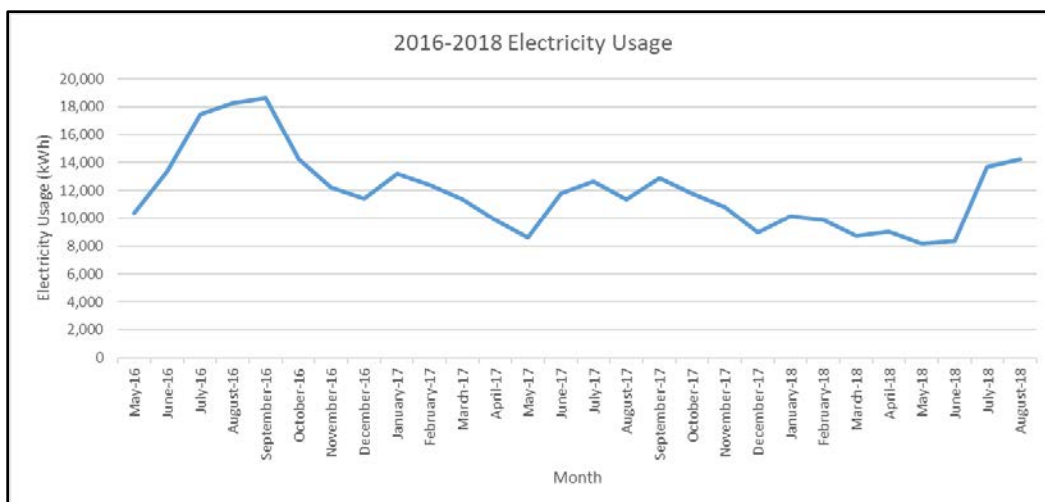
The historical electric usage for the Library is shown in Figure 5. Peak electricity usage typically occurs during the summer months (May – September), likely due to the need to run the air-cooled chiller in order to cool the building. The highest monthly usage recorded during this time was 18,640 kWh during September 2016.

Figure 5. 2016 – 2018 Library Historical Electricity Use

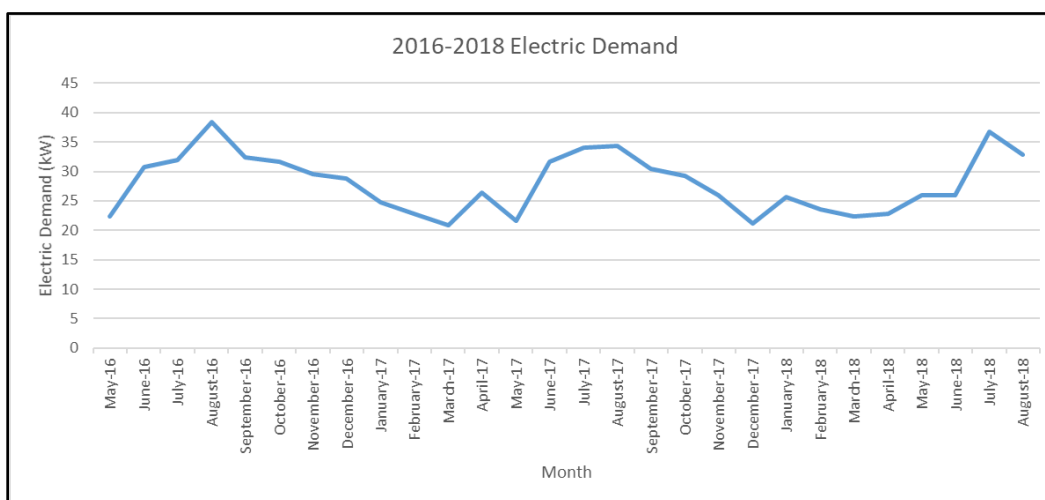
The historical electric demand for the Village Hall is shown in Figure 6. Similar to the historical electricity usage above, the building's peak demand typically occurs between May and September. The highest recorded demand of 38.4 kW occurred in August 2016.

Figure 6. 2016 – 2018 Village Hall Historical Electric Demand

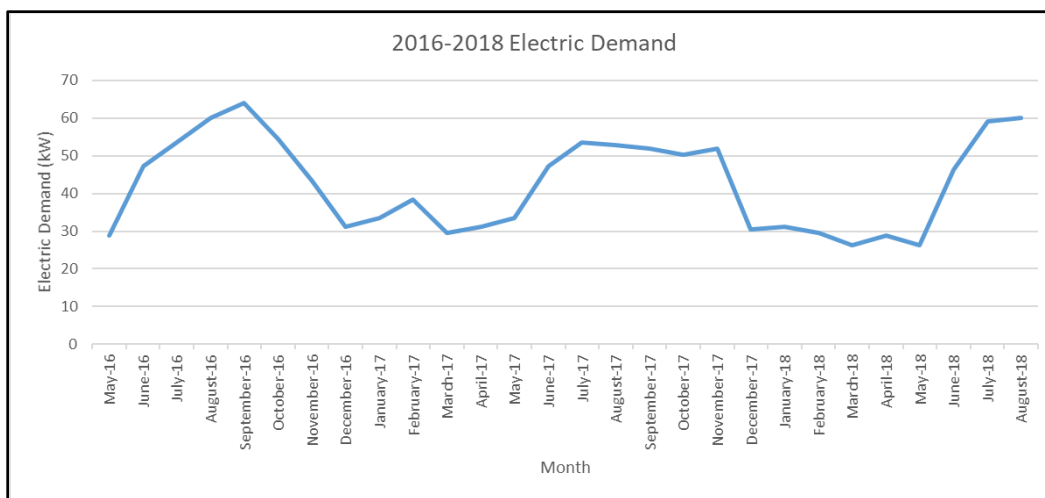
The historical electric demand for the Library is shown in Figure 7. Similar to the historical electricity usage above, the building's peak demand typically occurs between May and September. The highest recorded demand of 64.0 kW occurred in September 2016.

Figure 7. 2016 – 2018 Library Historical Electric Demand

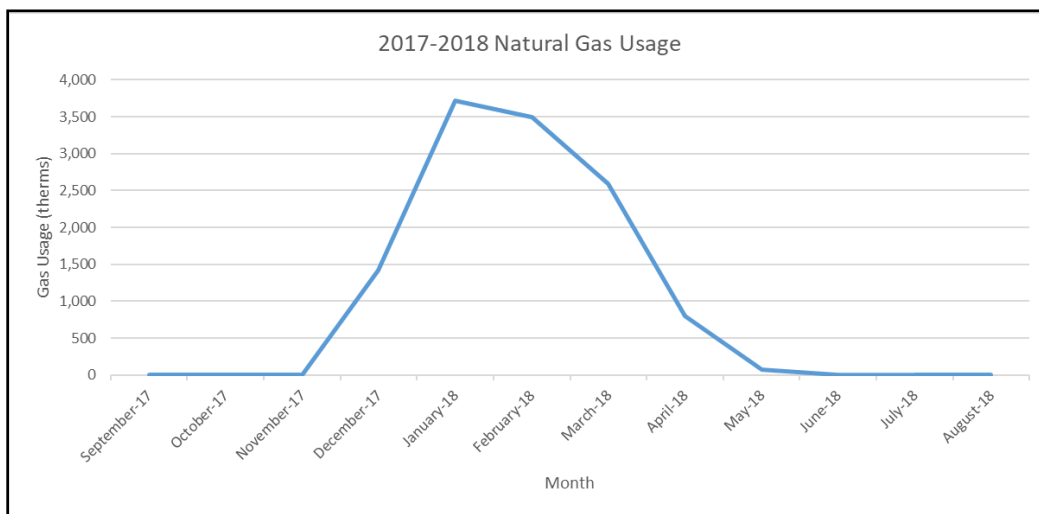
Figure 8 below shows the historical 2017-2018 natural gas usage for the Village Hall and Library. Since these two buildings share a heating plant, and because gas is used for heating only, usage is found to be highest during the winter months. A peak usage of 3,715 therms was recorded in January 2018.

Figure 8. 2017 – 2018 Historical Natural Gas Usage

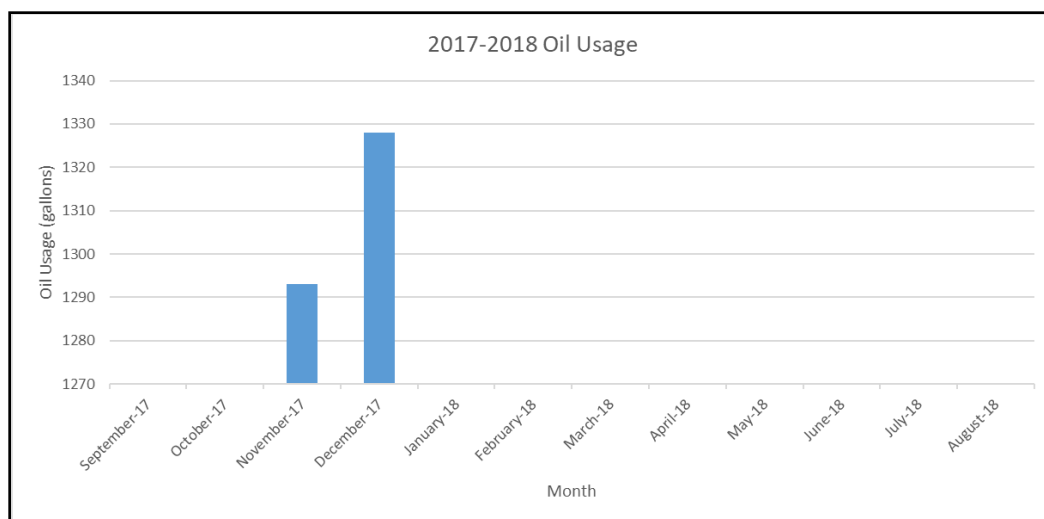
The historical monthly oil usage for the Village Hall and Library is shown in Figure 9. It was noted that these two buildings stopped using oil for heating in 2017, and only two months

of bills from that year were provided. Note that the figure below is a reflection of gallons delivered to the building per month, and not an actual trend of the usage.

Figure 9. 2017 – 2018 Historical Oil Usage

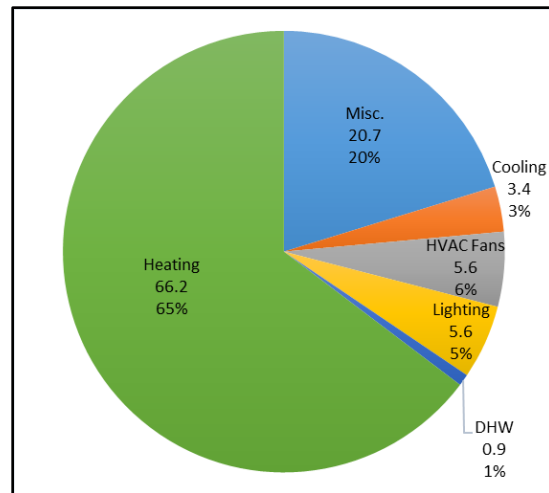
Figure 10 below shows the breakdown of energy intensity (kBtu/ft<sup>2</sup>) by end use type. The results confirm that fuel consumed to run the heating plant accounts for the largest portion of the site energy use and cost.

Figure 10. Energy End Use Breakdown in kBtu/ft.<sup>2</sup>

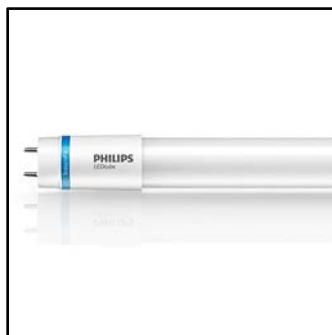
Figure 11. Proposed Philips LED fixture

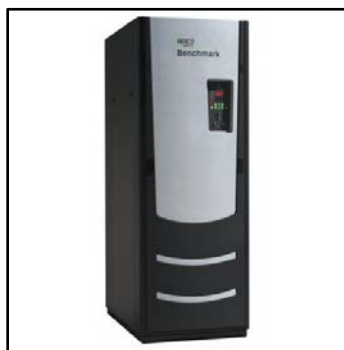
Figure 13. Aerco condensing boiler

This project would eliminate the existing gas fired steam boiler and convert the Village Hall to a hot water system utilizing new gas-fired, high efficiency condensing boilers as the primary source of heating. The low cost of natural gas will reduce operating costs compared to oil. In general, hot water heating systems are more efficient than steam heating system. Installing a hot water boiler plant will allow the building to move away from the obsolete steam heating system along with their associated system losses and higher maintenance issues and costs. This project would necessitate a complete replacement of the heating distribution system. Current best achievable hot water boiler efficiency is in the range of 90% – 91%. Note that the new system would still serve the hot water heating system at the library.

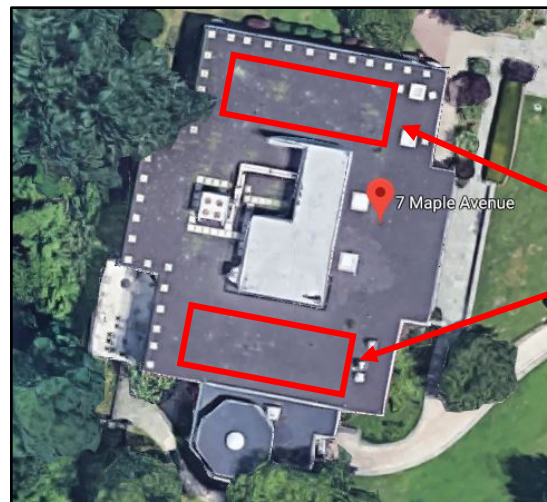
As there is available space on the roof of the library, the installation of solar electric PV panels has been reviewed. It is estimated that about 2,000 ft<sup>2</sup> of roof is available for solar panels. The general orientation of the building is favorable for solar collection, and there are no nearby tall buildings or trees that could potentially cause shading. This makes the library a good candidate for solar PV, and this upgrade would provide significant energy savings toward electricity usage. We estimate the library would have enough roof space for a 30 – 40 kW PV system, which could potentially provide up to 33% of the building's current annual electricity usage.

Figure 17. Proposed PV cell locations

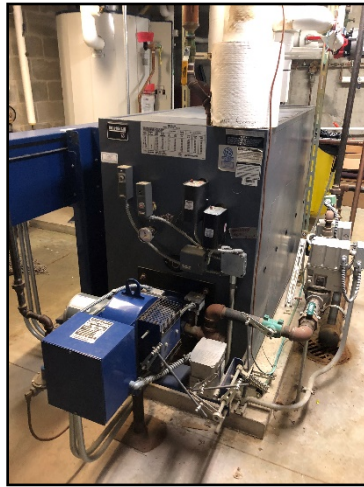
Heating for the Community Center is provided by one (1) gas-fired hot water boiler manufactured by Weil McLain (Photo 33). The boiler has a gross output capacity of 991 MBH, and is equipped with a Power Flame burner that has a maximum capacity of 1,232 MBH. It was noted that the boiler appears to be in good condition. A summary of the heating plant is shown below in Table 13.

Photo 33. HW boiler serving Community Center

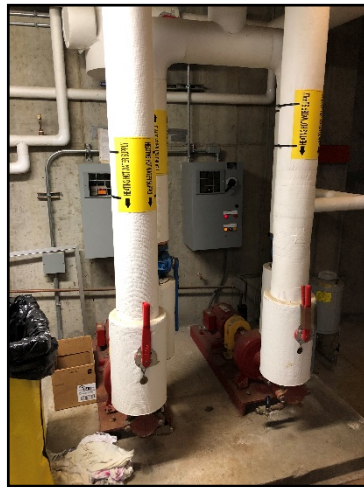
Hot water generated by the boiler is distributed throughout the building via two (2) 3 HP hot water pumps (Photo 35) and serves various perimeter radiation (Photo 36) as well as hot water coils located in the four (4) RTU's and one (1) HV unit serving the building. It was noted that the hot water pumps are equipped with variable frequency drives (VFD's) and have the ability to modulate speed based on heating demand.

Photo 34. Hot water pumps

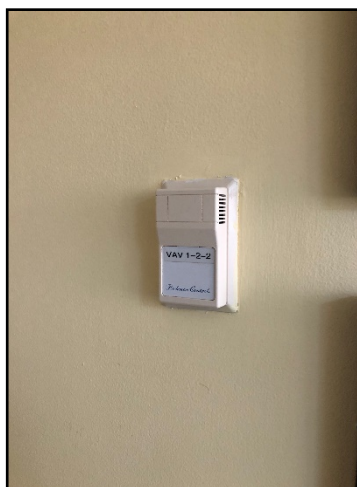
Photo 36. Typical temperature sensor

Heating for each space in the building is controlled remotely by the BMS through wall-mounted temperature sensors (Photo 36). Since the majority of spaces in the building are served by variable air volume (VAV) boxes, each temperature sensor typically monitors one zone and an associated finned tube radiation valve grouped with that specific zone. It was noted that space temperature setpoints can be adjusted via the BMS workstation located in the Recreation Department on the first floor of the building. A description of the BMS can be found in section 5.01.4.

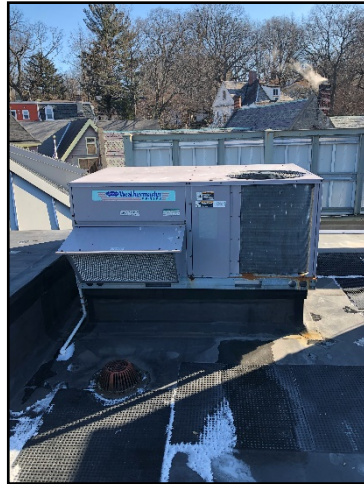
Photo 37. Typical RTU serving Community Center

It was noted that three (3) of the RTU's (RT-1, RT-2, RT-4) serve multiple spaces and contain VAV boxes. All of these systems are controlled by the BMS. Table 14 below shows a summary of the major systems serving the building.

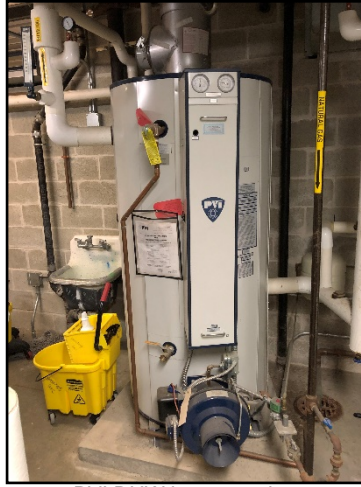
Photo 44. PVI DHW heater and storage tank

Domestic hot water (DHW) is generated by a combination gas-fired PVI DHW heater and storage tank (Photo 44). The DHW heater has a total capacity of 140 MBH and storage capacity of 125 gallons. The domestic hot water loop is controlled by an aquastat and is set to supply 110°F throughout the building. A summary table of the DHW system is shown below in Table 15.

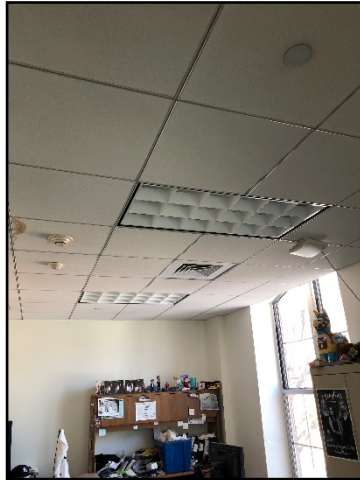
Interior lighting fixtures primarily consist of 32W T8 LED and Fluorescent lamps, which are in all spaces throughout the building (Photos 45 and 46). The lobby and community room have additional ceiling pendants and wall-mounted fixtures that all contain fluorescent lamps (Photos 47 – 49). It was noted that the Community Center is in the process of converting all fixtures to LED lamps.

Photo 45. Typical 32W T8 lighting fixtures in offices

This measure investigates the impact on energy consumption of reduced lighting power density utilizing high efficiency LED lighting technology and retrofit products throughout the building. The new LED lighting will result in a reduced lighting power density and potential for high savings. All of the typical 32W T8 fluorescent lighting throughout the Community Center and the existing wall-mounted fluorescent fixtures in the multi-purpose room could be replaced with LED retrofit products. The existing lighting power density of the building is estimated to be 0.56 W/ft<sup>2</sup>. The resulting lighting power density of the entire facility is estimated to be in the range of 0.42 W/ft.<sup>2</sup> after a complete retrofit.

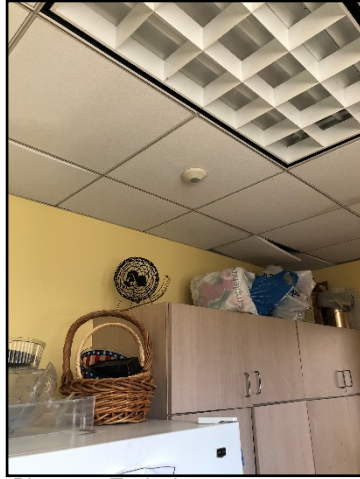
Photo 50. Typical occupancy sensor

Interior lighting is primarily controlled by ceiling-mounted occupancy sensors in each space (Photo 50). Lighting in the community room is controlled manually.

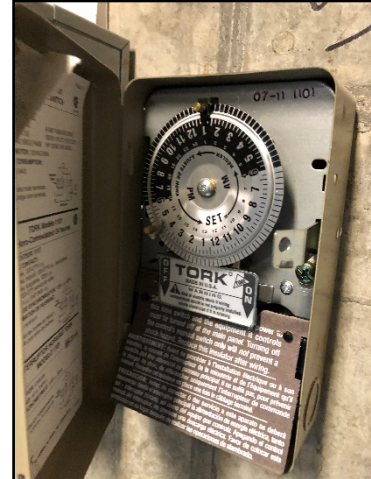
Photo 51. Timer for exterior lighting

Exterior lighting is controlled by a timer located in the basement electrical room (Photo 51).

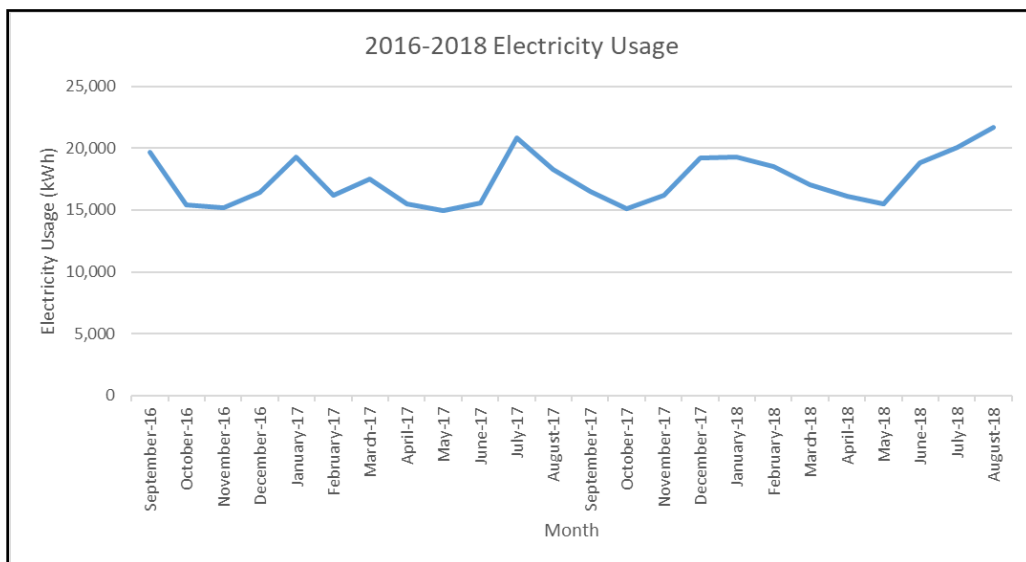
The historical electric usage for the Community Center is shown in Figure 22. Peak electricity usage typically occurs during the summer months (May – September), likely due to the need to run the window AC units in order to cool the building. The highest monthly usage recorded during this time was 21,680 kWh during August 2018.

Figure 22. 2016 – 2018 Historical Electricity Use

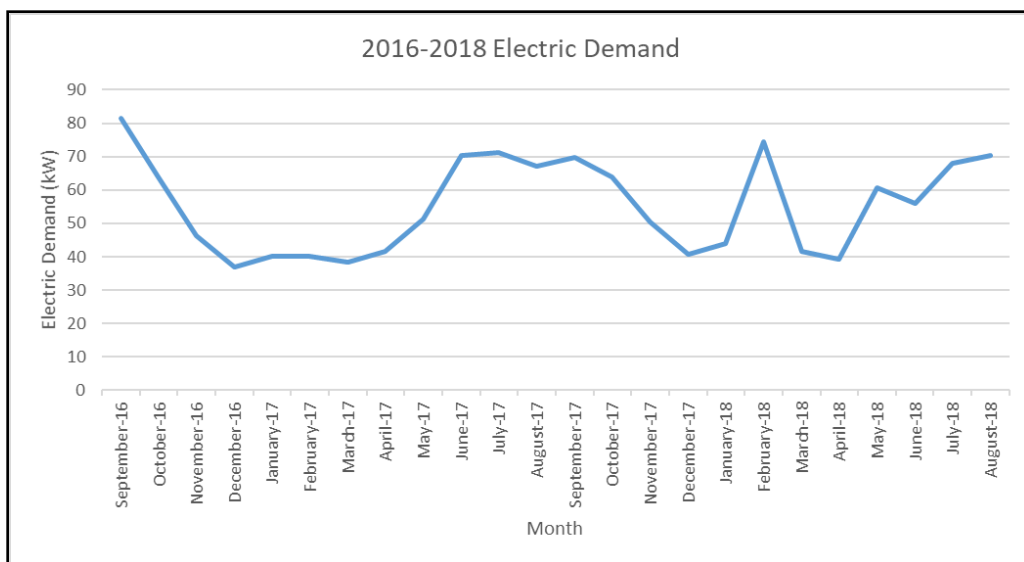
The historical electric demand is shown in Figure 23. Similar to the historical electricity usage above, the building's peak demand typically occurs between May and September. The highest recorded demand of 81.6 kW occurred in September 2016.

Figure 23. 2016 – 2018 Historical Electric Demand

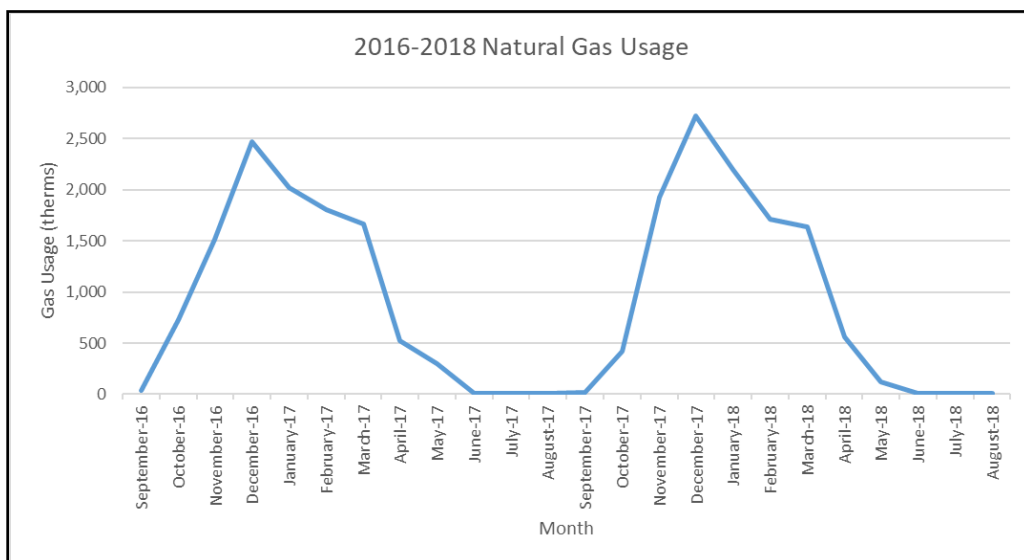
Figure 24 below shows the historical 2016-2018 natural gas usage for the Community Center. Since gas in this building is used for heating only, usage is found to be highest during the winter months. A peak usage of 2,726 therms was recorded in December 2017.

Figure 24. 2016 – 2018 Historical Natural Gas Usage

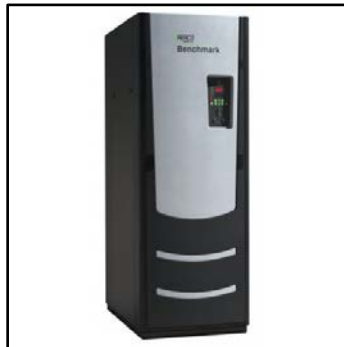
Figure 26. Aeroco condensing boiler

This project would eliminate the existing standard efficiency gas-fired boiler at the community center and install a new high efficiency, condensing boiler for heating. We estimate that the boiler efficiency of the existing heating plant is approximately 81%. Current best achievable hot water boiler efficiency is in the range of 90% – 91% when used to serve an existing building.

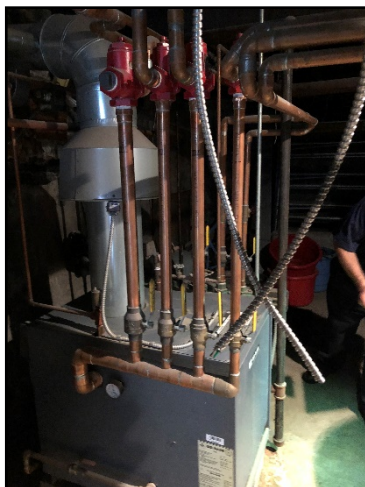
Heating for the building is provided by one (1) gas-fired hot water boiler manufactured by Weil McLain (Photo 54). The boiler has a gross capacity of 296 MBH. Hot water generated by the boiler is distributed throughout the building via four (4) inline hot water recirculation pumps that separate the building into four (4) separate zones which include the Chief's office, truck room (main garage), bar room, and the second floor lounge space. Each zone contains perimeter finned tube radiation for heating (Photo 55). It was noted that the large majority of hot water piping is uninsulated. A summary of the heating plant is shown below in Table 18.

Photo 54. HW boiler serving Hook and Ladder Co.

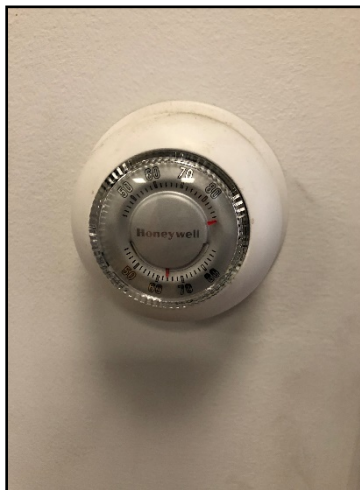
Each heating zone is controlled by a local wall-mounted thermostat, which controls the finned tube radiation in that particular zone (Photo 56). It was noted that the thermostat controlling the finned tube radiation in the bar room appears to have recently been replaced. Building staff indicated that thermostats are typically kept at a constant temperature setpoint (approximately 70°F) during the heating season.

Photo 56. Typical heating thermostat

This measure assesses the energy reduction and cost savings associated with implementing a night setback heating setpoint for the boiler. All of the existing dial Honeywell thermostats could be replaced with programmable thermostats that have the ability to adjust heating setpoints based on a predetermined occupied and unoccupied schedule. Lowering the heating setpoint will reduce boiler run time and reduce the overall EUI of the building.

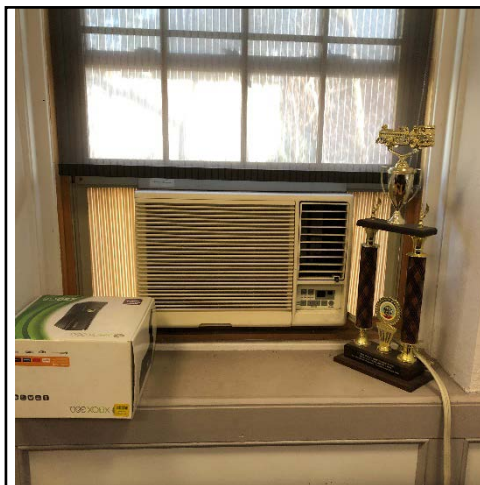
Photo 57. Typical window AC unit

Cooling is provided by a combination of window AC units and Mitsubishi split AC units (Photos 57 and 58). There are two (2) window AC units, which serve the first floor workout room and second floor lounge space. Each window AC unit has an approximate capacity of 1 – 1.5 tons (12-18 MBH) of cooling. There are also three (3) Mitsubishi split AC units, which serve the bar room and Chief's office respectively. The two (2) units serving the bar room have a capacity of 2.5 tons (24-30 MBH) each, and the unit serving the Chief's office has a total capacity of 3 tons (36 MBH). A summary of the cooling systems serving the building is shown below in Table 19.

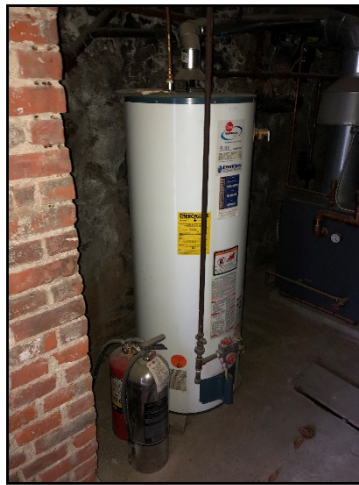
Photo 59. Rheem DHW heater

Domestic hot water (DHW) is generated by a combination gas-fired Rheem DHW heater and storage tank, which is located in the basement (Photo 16). The DHW heater has a total capacity of 40 MBH and storage capacity of 50 gallons. A summary of the DHW system is shown below in Table 20.

Table 21. Hook and Ladder DHW System Summary						
Manufacturer	Fuel Source	Heating Capacity (MBH)	Storage Capacity (Gal)	HWS Temperature (°F)	Quantity	Year Installed
Rheem	Natural Gas	40	50	-	1	2003

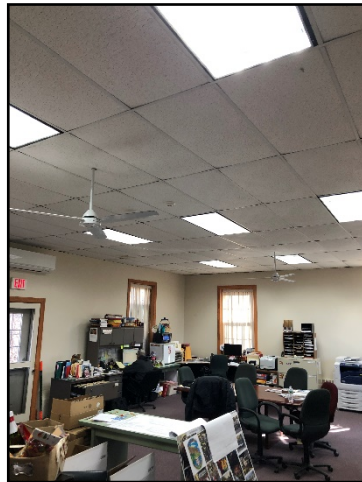
Interior lighting primarily consists of 32W T8 fluorescent and round 13W LED light fixtures found in the main garage, chief's office, bar room, and kitchen (Photos 60 and 61). There are additional light fixtures that contain Satco T8 U-tube shaped fluorescent lamps found in the workout room and second floor lounge (Photo 62).

Photo 60. Typical T8 fluorescent lighting

This measure investigates the impact on energy consumption of reduced lighting power density utilizing high efficiency LED lighting technology and retrofit products throughout the building. The new LED lighting will result in a reduced lighting power density and potential for high savings. All of the typical 32W T8 fluorescent lighting in the building could be replaced with LED retrofit products. The existing lighting power density of the building is estimated to be 0.43 W/ft<sup>2</sup>. The resulting lighting power density of the entire facility is estimated to be in the range of 0.31 W/ft.<sup>2</sup> after a complete retrofit.

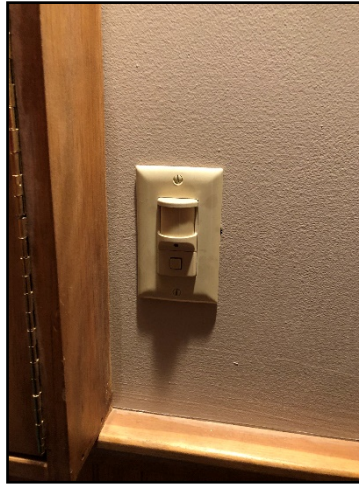
Photo 63. Occupancy sensor in truck room

The majority of lighting in the building is controlled manually by toggle switches. However, there is a row of lights in the truck room that is controlled by a wall-mounted occupancy sensor (Photo 63).

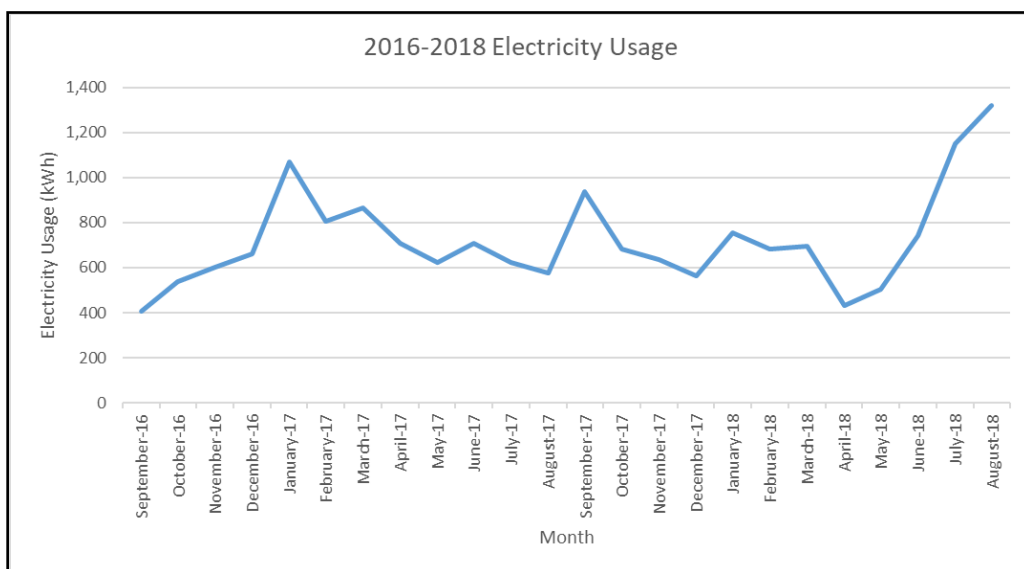
The historical electric usage for Hook and Ladder Fire Company is shown in Figure 31. Peak electricity usage typically occurs during the summer months (May – September), likely due to the need to run the window AC units in order to cool the building. The highest monthly usage recorded during this time was 1,320 kWh during August 2018.

Figure 31. 2016 – 2018 Historical Electricity Use

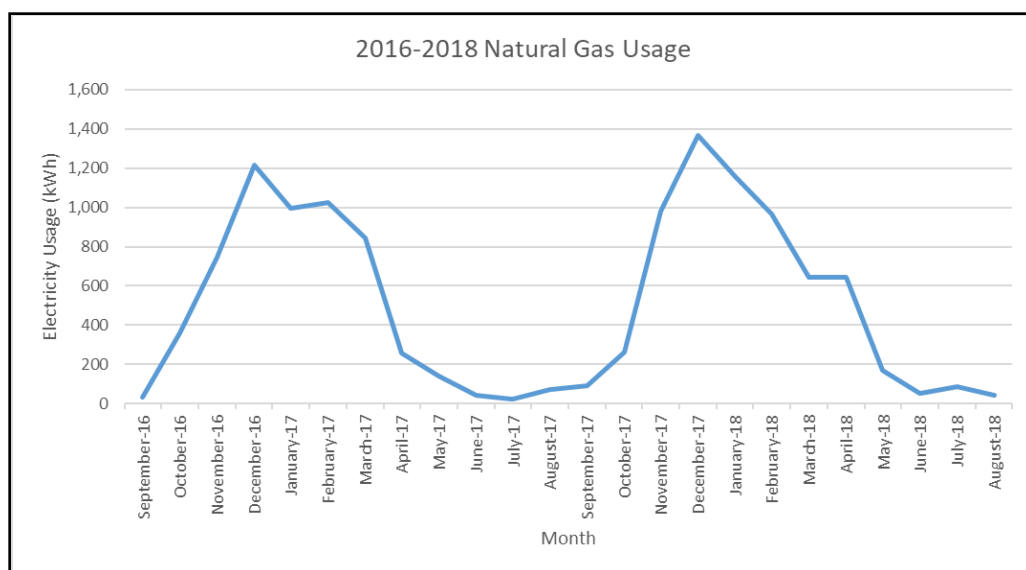
Figure 32 below shows the historical 2016-2018 natural gas usage for the building. Since gas in this building is used for heating only, usage is found to be highest during the winter months. A peak usage of 1,366 therms was recorded in December 2017.

Figure 32. 2016-2018 Historical Natural Gas Usage

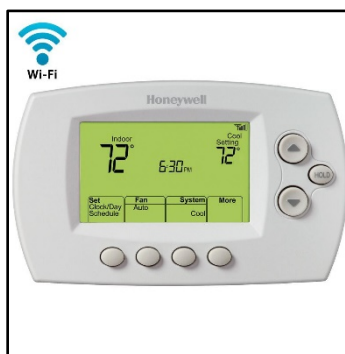
Figure 34. Typical Honeywell programmable thermostat

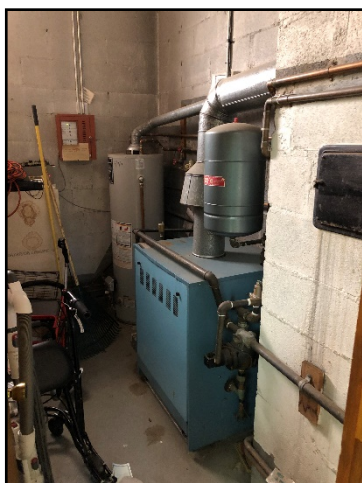
Photo 66. HW boiler serving Ambulance Garage

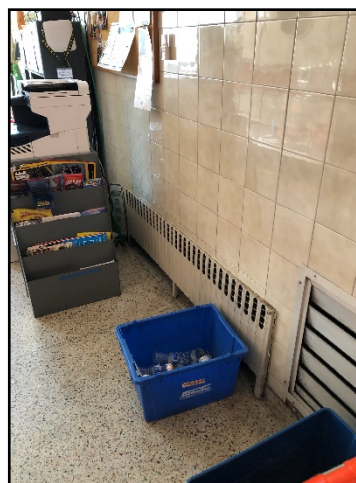
Photo 67. Typical hot water radiator

Heating for the building is provided by one (1) gas-fired hot water boiler manufactured by Burnham (Photo 16). The size of the boiler plant was unable to be verified, as the boiler did not have any nameplate data and OLA was unable to open the front panel of the boiler. Hot water generated by the heating plant is distributed to various perimeter radiators located in the main garage (Photo 67). There appears to be no form of heating for the kitchen and lounge area. A summary of the heating plant is shown below in Table 24.

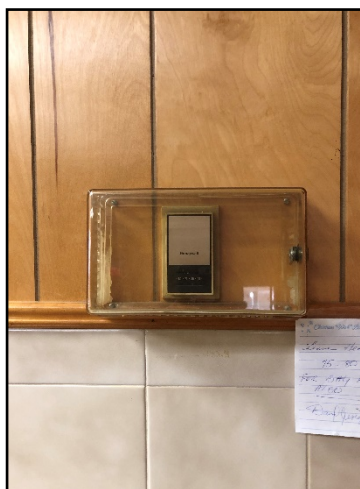
Photo 68. Thermostat serving Ambulance Garage

Heating for the building is controlled by a local wall-mounted thermostat, which controls all of the perimeter radiators in the main garage (Photo 68). It was noted that the thermostat is enclosed in a plastic casing, and appears to be left at a constant temperature between 75 – 80°F.

This measure assesses the energy reduction and cost savings associated with implementing a night setback heating setpoint for the boiler. The existing Honeywell thermostat could be replaced with a programmable thermostat that has the ability to adjust heating setpoint based on a predetermined occupied and unoccupied schedule. Lowering the heating setpoint will reduce boiler run time and reduce the overall EUI of the building.

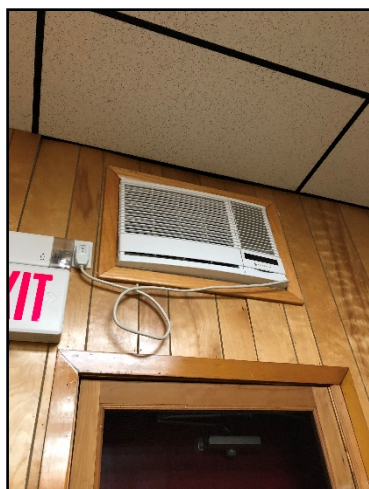
Photo 69. Typical window AC unit serving lounge area

Cooling for the building is provided by three (3) Friedrich window AC units, which serve the main garage and lounge area respectively (Photos 69 and 70). Each window AC unit has an approximate capacity of 1 – 1.5 tons (12-18 MBH) of cooling, and is remotely controlled. A summary of the window AC units serving the building is shown below in Table 25.

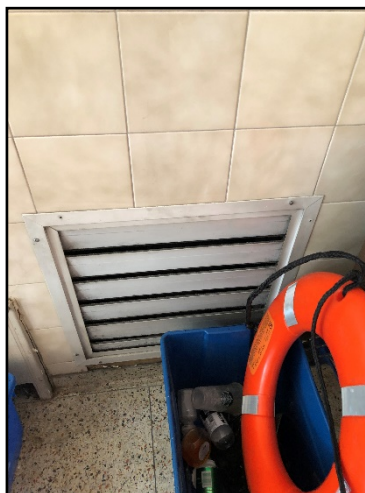
Photo 71. Vent located in main garage

There is no mechanical ventilation system serving the Ambulance Garage. Ventilation is primarily provided by opening windows and the garage doors. It was noted that there is a vent located in the main garage that could provide ventilation for the space, but its purpose could not be confirmed (Photo 71).

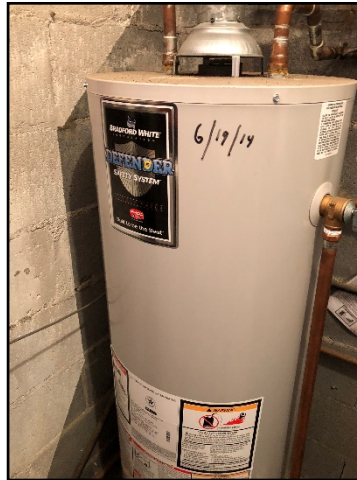
Photo 72. Bradford White DHW heater

Domestic hot water (DHW) is generated by a combination gas-fired Bradford White DHW heater and storage tank, which is located in the boiler room (Photo 72). The DHW heater has a total capacity of 40,000 Btu/hr and storage capacity of 40 gallons. A summary of the DHW system is shown below in Table 26.

Table 26. Ambulance Garage DHW System Summary					
Manufacturer	Fuel Source	Heating Capacity (MBH)	Storage Capacity (Gal)	Quantity	Year Installed
Bradford White	Natural Gas	40	40	1	2014

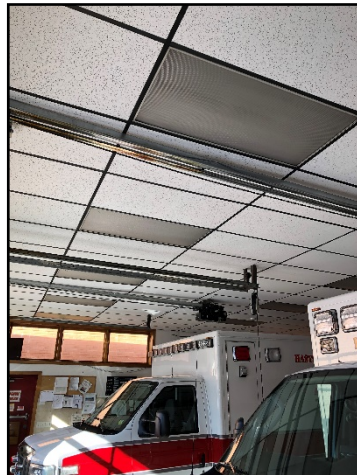
Photo 73. Typical T8 fluorescent lighting in main garage

Interior lighting primarily consists of 2 and 3-bulb T8 fluorescent light fixtures containing Sylvania 32W T8 fluorescent lamps. These fixtures are found throughout the main garage and lounge area (Photos 73 and 74).

This measure investigates the impact on energy consumption of reduced lighting power density utilizing high efficiency LED lighting technology and retrofit products throughout the building. The new LED lighting will result in a reduced lighting power density and potential for high savings. All of the typical 34W T8 fluorescent lighting in the building could be replaced with LED retrofit products. The existing lighting power density of the building is estimated to be 0.72 W/ft<sup>2</sup>. The resulting lighting power density of the entire facility is estimated to be in the range of 0.49 W/ft.<sup>2</sup> after a complete retrofit.

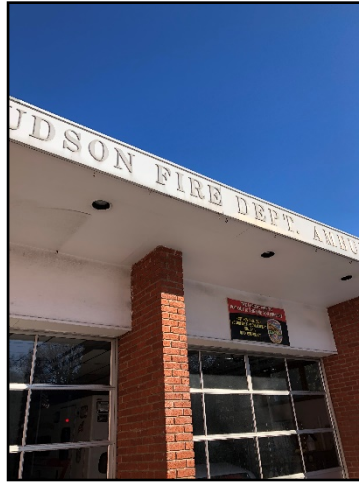
Photo 75. Typical exterior lighting

Exterior lighting is minimal and typically features round ceiling mounted fixtures, which appear to contain fluorescent bulbs (Photo 75).

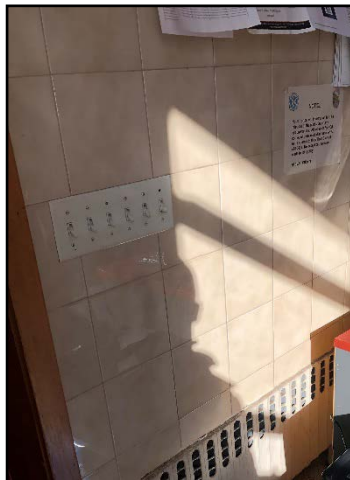
Photo 76. Typical manual light switches

All interior lighting is controlled manually by toggle switches (Photo 76). Exterior lighting appears to be controlled by timers, but this could not be verified (Photo 77).

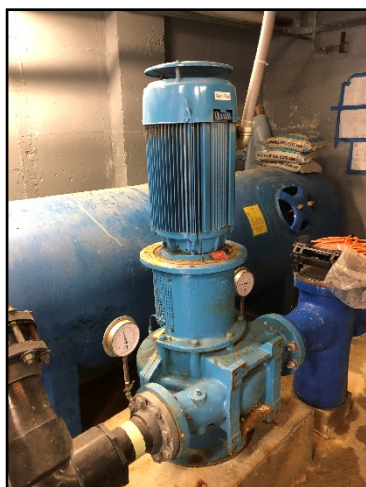
Photo 80. Main pool feature pump

The Chemka Pool complex features three (3) different pools: the main pool, training pool, and wading pool. Each pool contains its own dedicated feature pump and chemical monitoring system (Photos 80 and 81). The main and training pools also have their own dedicated filtration tanks, which collect and filter the pool water before it is pumped to its respective pool.

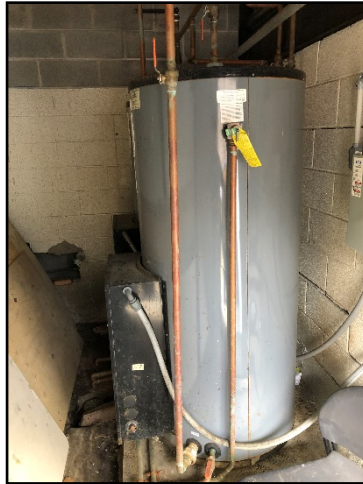
Photo 82. Rheem electric DHW heater

Domestic hot water (DHW) is generated by two (2) combination electric Rheem DHW heaters and storage tanks located in the building (Photo 82). Each DHW heater has a total input capacity of 9 kW and storage capacity of 120 gallons. A summary of the DHW system is shown below in Table 30.

Table 30. Chemka Pool Building DHW System Summary					
Manufacturer	Fuel Source	Heating Capacity	Storage Capacity (Gal)	Quantity	Year Installed
Rheem	Electric	9 kW (each) 30.7 MBH (each)	120 (each)	2	2004

Replacing the existing electric resistance domestic hot water heaters with a commercial grade electric heat pump system should be considered in the future. It is possible to utilize the existing storage tanks. Providing the building with a new high efficient electric heat pump water heater would reduce the source EUI of the building.

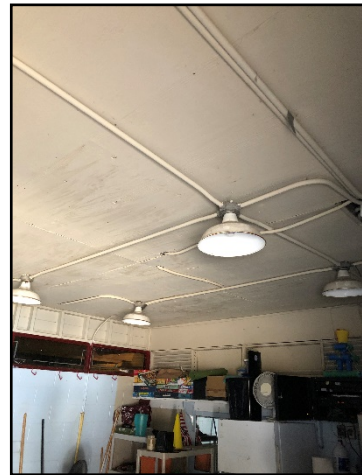
Photo 84. Typical staff office lighting

Interior lighting for the locker rooms and staff office primarily consists of round ceiling mounted fixtures, which contain a mixture of LED and fluorescent bulbs (Photos 83 and 84).

Although much of the space has already been converted to LED lighting, this measure investigates the impact of a complete LED retrofit and energy consumption of reduced lighting power density. The new LED lighting will result in a reduced lighting power density and potential for high savings. All of the typical 23W fluorescent and 32W T8 fluorescent lighting in the building could be replaced with LED retrofit products. The existing lighting power density of the building is estimated to be 0.33 W/ft<sup>2</sup>. The resulting lighting power density of the entire facility is estimated to be in the range of 0.19 W/ft.<sup>2</sup> after a complete retrofit.

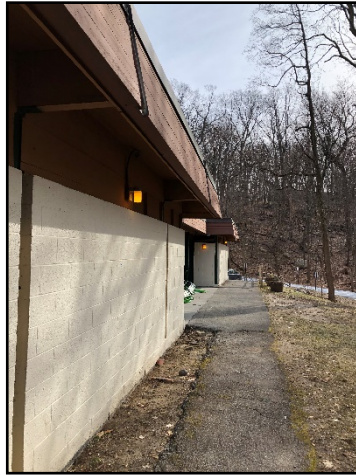
Photo 85. Typical exterior lighting

Exterior lighting primarily consists of wall and ceiling mounted fixtures containing fluorescent lamps (Photo 85). There are two (2) exterior light towers that provide light for the entire pool complex. Each tower contains approximately sixteen (16) bulbs (Photo 86). The wattage of these bulbs could not be verified during the site visit.
