**VILLAGE OF HASTINGS-ON-HUDSON  
MUNICIPAL GREENHOUSE GAS (GHG)  
ANALYSIS AND ACTION PLAN  
ENERGY AUDIT REPORT**

**DRAFT REPORT FOR REVIEW AND COMMENT**

**MARCH 15, 2019**

**OLA CONSULTING ENGINEERS, PC**  
Hawthorne, NY

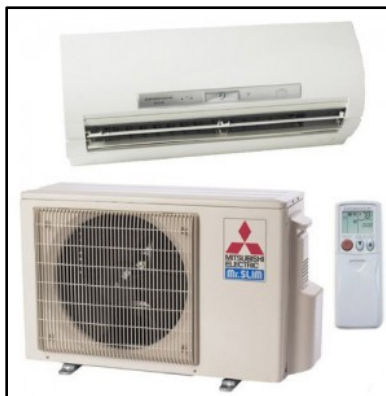
Figure 44. Single-zone Mitsubishi air-source heat pump

This measure assesses the energy reduction associated with installing a single-zone air source heat pump to heat and cool the pool equipment room. Air source heat pumps typically offer high heating and cooling efficiencies, which could result in an overall EUI reduction and cost savings. Indoor units would be installed where appropriate, providing heating and cooling to the spaces they serve.

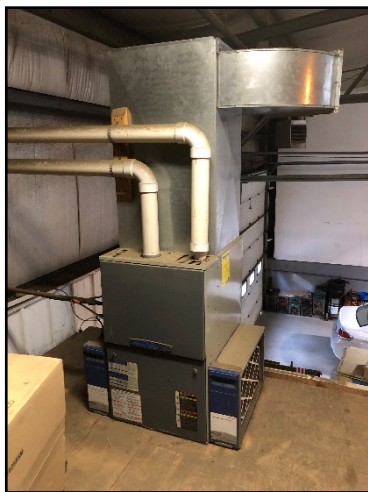
Photo 89. Gas-fired furnace serving repair shop

Heating for the garage is provided by a combination of an American Standard condensing gas-fired furnace serving the repair shop (Photo 89), and Reznor gas-fired unit heaters serving the remainder of the garage (Photo 90). A summary table of the heating systems at the DPW garage is located in Table 34 below.

The gas-fired furnace is located on an elevated platform and serves the open areas of the repair shop only. The offices, restrooms, and lounge area are all considered enclosed spaces and are not adequately heated by the furnace. Heating for these spaces is provided only by plug-in heaters and radiators (Photo 91). There is an additional office that is served by electric baseboard and controlled by a wall-mounted Lux thermostat (Photo 92). It was noted that only two (2) of the unit heaters serving the garage have been replaced and are currently functioning (Photo 93). The remaining unit heaters have been dysfunctional for several years according to staff and are abandoned in place.

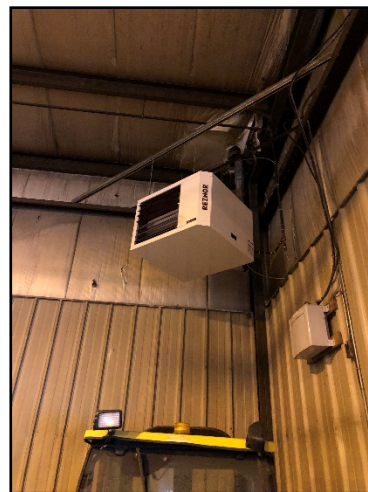
Photo 90. Typical gas-fired unit heater serving garage

Table 34. DPW Garage Heating Plant Summary						
Manufacturer	Type	Capacity (MBH)	Fuel Source	Quantity	Year Installed	Typical Operating Time
American Standard	Furnace	-	Natural Gas	1		7:00am – 3:30pm
Reznor	Unit Heater	75* (each)	Natural Gas	2		7:00am – 3:30pm

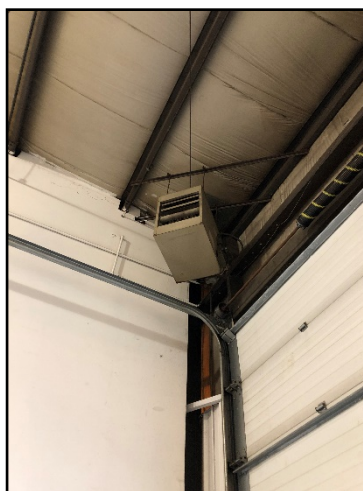
Photo 93. Typical gas-fired unit heater abandoned in place

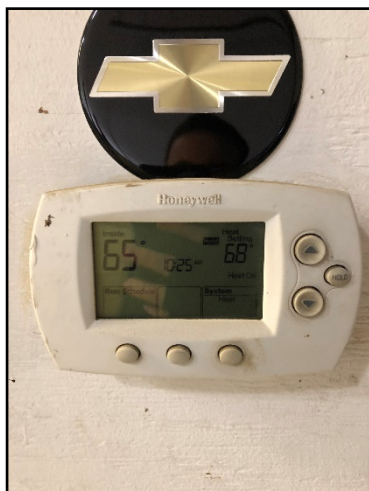
Photo 94. Thermostat controlling gas-fired furnace

Heating for the repair shop is controlled by a wall-mounted programmable Honeywell thermostat located outside one of the offices (Photo 94). It was noted that staff typically set the thermostat for approximately 68°F during occupied hours, and will automatically reduce the temperature setpoint to approximately 62°F during unoccupied hours. Heating for the garage is also controlled by similar wall-mounted Honeywell thermostats (Photo 95). Each thermostat typically controls one of the Reznor unit heaters.

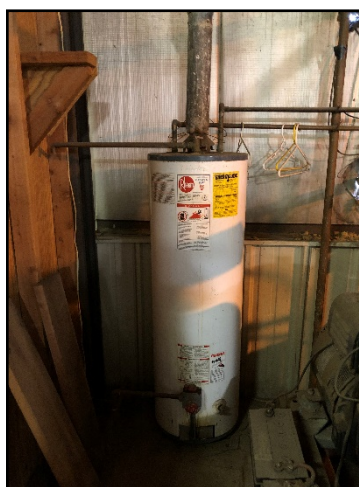
Photo 82. Rheem DHW heater

Domestic hot water (DHW) is generated by one (1) combination gas-fired Rheem DHW heater and storage tank located in the repair shop (Photo 96). The DHW heater has a total input capacity of 38 MBH and storage capacity of 40 gallons. A summary of the DHW system is shown below in Table 36.

Table 36. DPW Garage DHW System Summary					
Manufacturer	Fuel Source	Heating Capacity (MBH)	Storage Capacity (Gal)	Quantity	Year Installed
Rheem	Natural Gas	30	40	1	2003

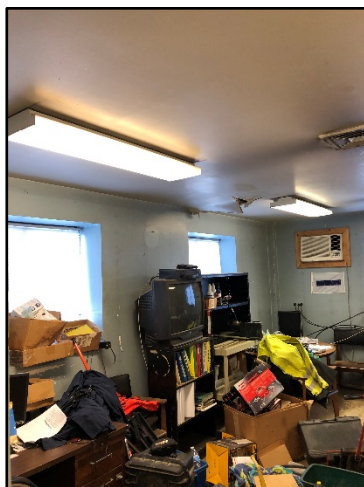
Photo 97. Typical T8 fluorescent light fixtures

Interior lighting primarily consists of T8 fluorescent light fixtures in offices, restrooms, and the lounge area, ceiling hung metal halide fixtures in the repair shop, and ceiling hung high pressure sodium (HPS) fixtures in the remainder of the garage (Photos 97 – 99).

This measure investigates the impact on energy consumption of reduced lighting power density utilizing high efficiency LED lighting technology and retrofit products throughout the building. The new LED lighting will result in a reduced lighting power density and potential for high savings. All of the typical 32W T8 fluorescent lighting and HPS / metal halide flood lighting in the building could be replaced with LED retrofit products. The existing lighting power density of the building is estimated to be 0.33 W/ft<sup>2</sup>. The resulting lighting power density of the entire facility is estimated to be in the range of 0.16 W/ft.<sup>2</sup> after a complete retrofit.
