Structure Preservation Evaluation Former Anaconda Wire and Cable Plant Hastings-on-Hudson, NY October 17, 2006

HASTINGS-ON-HUDSON NEW YORK STRUCTURE PRESERVATION EVALUATION

Summary of Findings

## Structure Preservation Evaluation

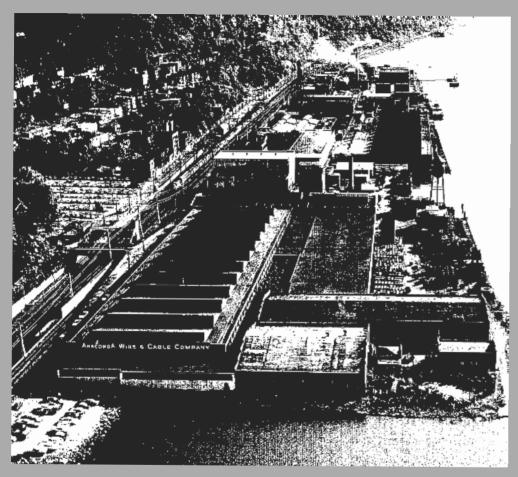
1955

#### Building 51

- -Eastern section of roof (wood) constructed earlier than western (concrete)
- -Interior masonry wall at western end
- -Once many windows. Upper clerestory had rack and pinion mechanism.
- -Typical of early 20th Century mill buildings

#### Building 52

- -Larger structure
- -Sawtooth skylight structure
- -Once many windows on openings one above the other
- -Overhead gantry crane is interesting historical artifact.
- -Building retains integrity of setting, design, materials and workmanship: good example
- of early 20th century industrial building

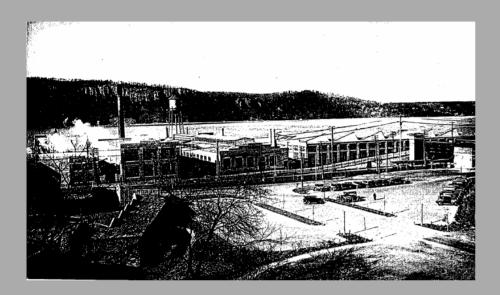
#### Water Tower

- -Built prior to 1924
- -Typical feature of industrial sites
- -As vertical focal point, intrinsic value as one of few remaining vestiges of village industrial birth and boom years

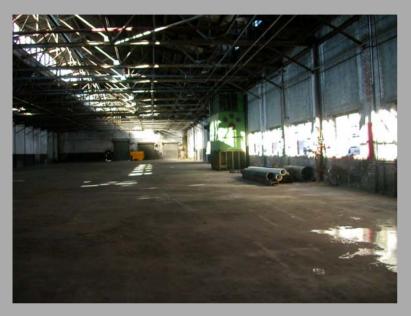
## Building 51 Structure

- Long span steel trusses:
   at east end, wood rafters, planking;
   at west end, concrete plank/
   cast in place roofing
- -East end of building:

Deterioration of wood rafters/ planking

- -Cracks within piers (esp. first two at NW corner), evidence of steel delamination and force of steel pushing brick pier from wall.
- Evidence of wicking action of moisture in interior walls

- -East end of building: Totally replace wood rafters/ planking
- -Cracks within piers : remove brick, evaluate steel
- (set baseline with intact piers). Clean/rustproof problem areas.
- -Replace brick or use repair mortar
- -Repoint entire building
- -Ballpark repair cost: \$1,500,000
- -To stabilize only: \$700,000

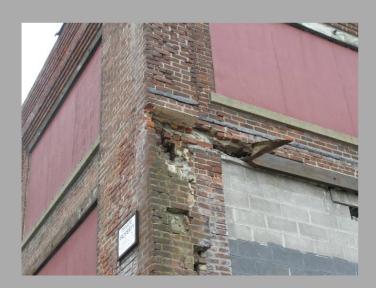
## Building 52 Structure

- Long span saw tooth truss structure, concrete plank or poured in place roof.
- Brick masonry bearing walls with buried steel columns
- -Adjacent building demolished (damage)
- -In general, good condition. Some cracks within piers evidence of steel delamination and force of steel pushing brick pier from wall.
- -Interior concrete block wall (not original) has diagonal crack about centerline
- -Evidence of wicking action of moisture in interior walls

- -Wall, pier repairs similar to Building 51
- -West side of building:

Need to repair damage from adjacent building demolitions

- -Cordon off, repair or remove parapets
- -Clean rust, coat deteriorated steel bases or add steel plates to reinforce to original capacity

-Ballpark repair cost: \$1,000,000

*-To stabilize only: \$500,000*

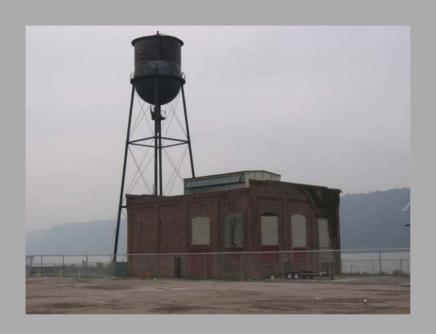
## Water Tower

-Need more detailed survey of connections (possibly with lift truck) and examination of base conditions
