# REPORT ON PRE- DESIGN INVESTIGATION DATA SUMMARY REPORT FORMER ANACONDA WIRE & CABLE PLANT SITE HASTINGS-ON-HUDSON, NEW YORK

BY Haley & Aldrich of New York Rochester, New York

**NYSDEC SITE #3-60-022**

File No. 28612 10 August 2015

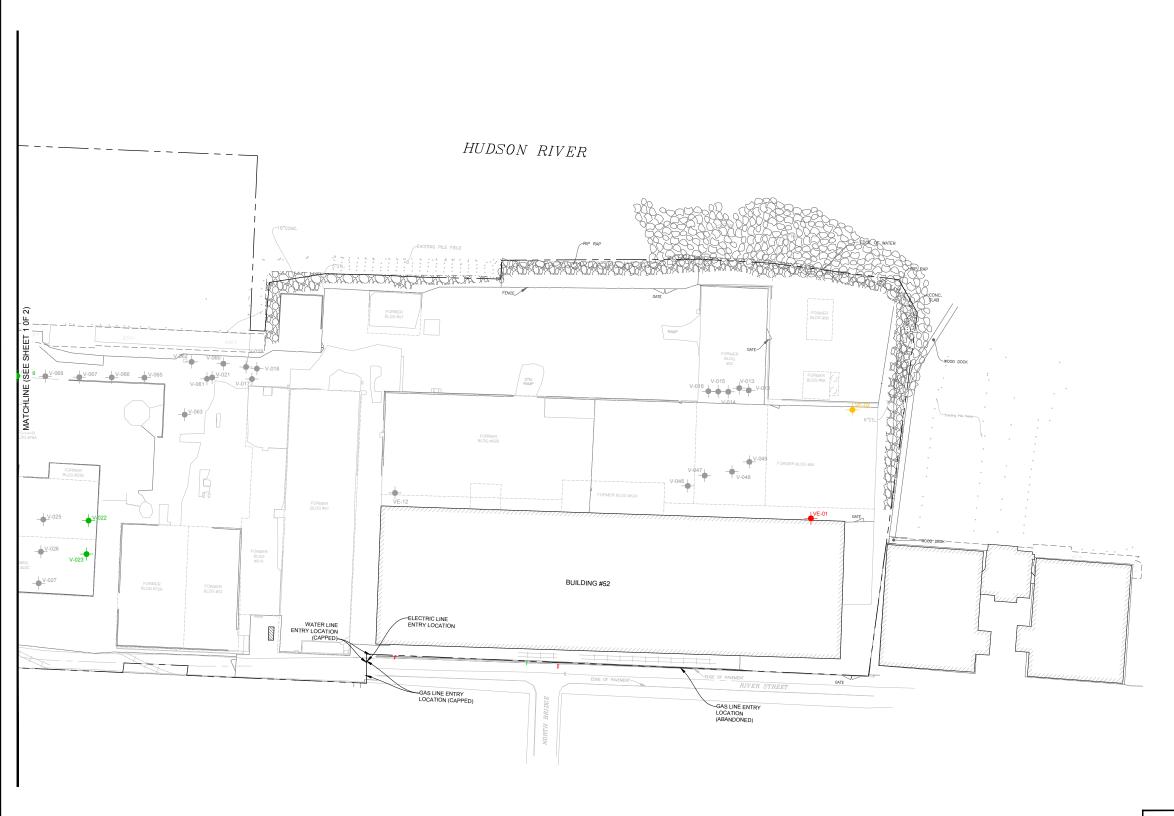
VOID INVESTIGATION BORING (0-1" DEPTH) VOID INVESTIGATION BORING (2-6" DEPTH) VOID INVESTIGATION BORING (7-12" DEPTH) VOID INVESTIGATION BORING (13 DEPTH) — - - — PROPERTY LINE RAIL ROAD EXISTING STRUCTURES FORMER STRUCTURES FENCE
