# ONE RIVER STREET

## HASTINGS-ON-HUDSON NEW YORK STRUCTURE PRESERVATION EVALUATION

## Structure Preservation Evaluation

FINAL REPORT  
May 2006

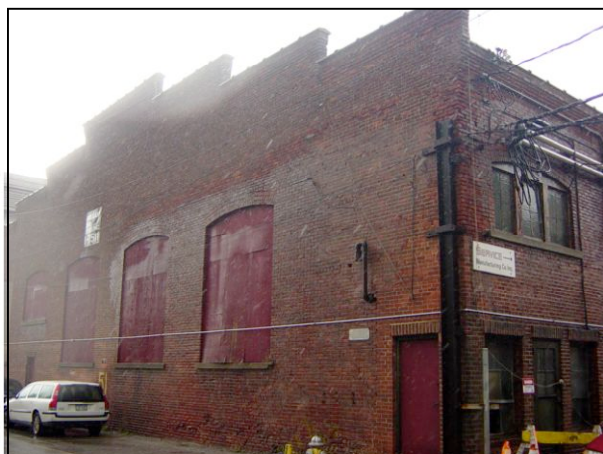
*Building 51 eastern gable end and fenestration.*

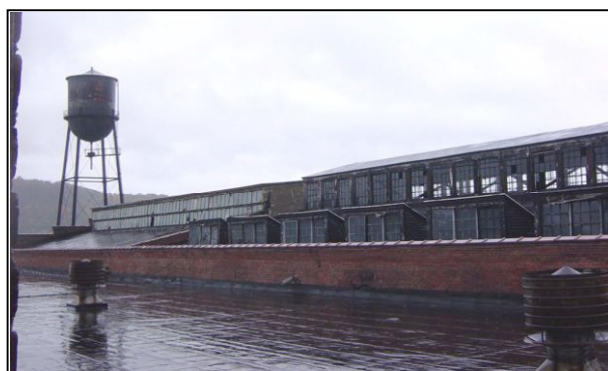
*Building 51 monitor detail of the eastern and western sections. The earlier, western section is the right side of the photograph. The roof of Building 51A is in the foreground. The Water Tower is visible in the background.*

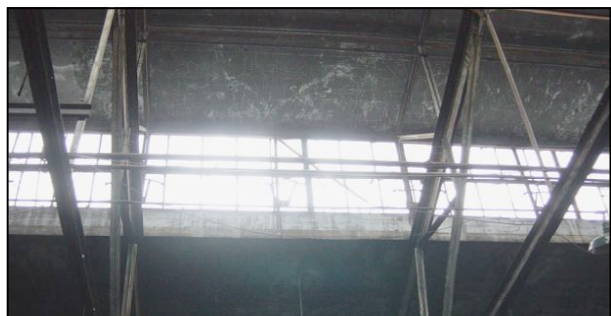
*Building 51 clerestory windows and opening mechanism.*

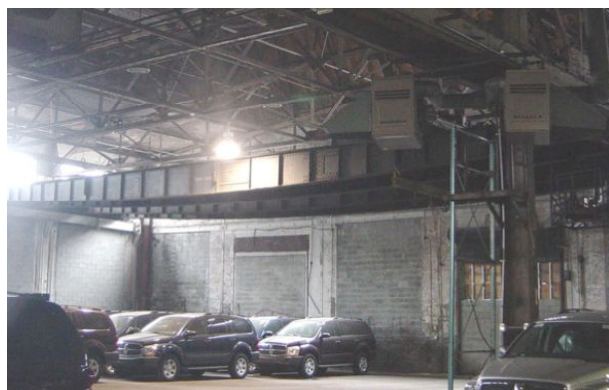
*Building 52. Historic crane is an industrial artifact.*

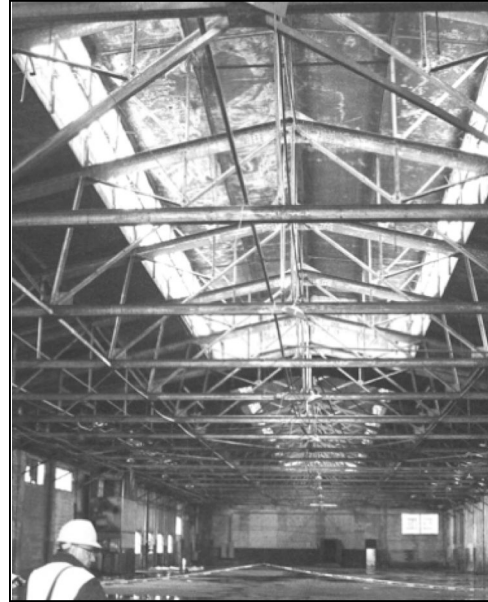
*Long span trusses and light monitor*

The wood section was cordoned off due to numerous structural failures of the wood joists/rafters and wood decking. The steel trusses all appeared to be in good condition with no signs of deterioration, despite the extensive leaks. (At the time of the visit, heavy rains were occurring and the roof was leaking severely in numerous locations.) The wood joists (3" x 10" at 24" o/c) at the top of the monitor roof appeared to be in good condition. At the lower sections of roof (3" or 4" x 8" @ 48" o/c), below the monitor, there were several areas of total collapse of deteriorated wood and numerous areas of severe to moderate water damage. It is our recommendation that this remain cordoned off and that eventually, total replacement of the joists at this elevation be undertaken. At the interior, there are several columns/piers that exhibit cracks vertically along them. This is typically a sign of rusting and delamination of the steel column buried with in the brick.

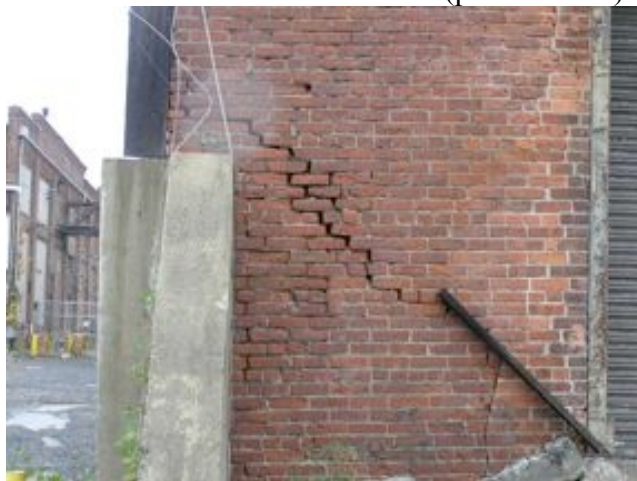
The exterior walls of this building are brick masonry with infill of cmu at former window openings. At the west elevation, there are settlement cracks at the north end (photo below).

This could be the result of a foundation settlement or pile failure and should be investigated further. The parapet is also

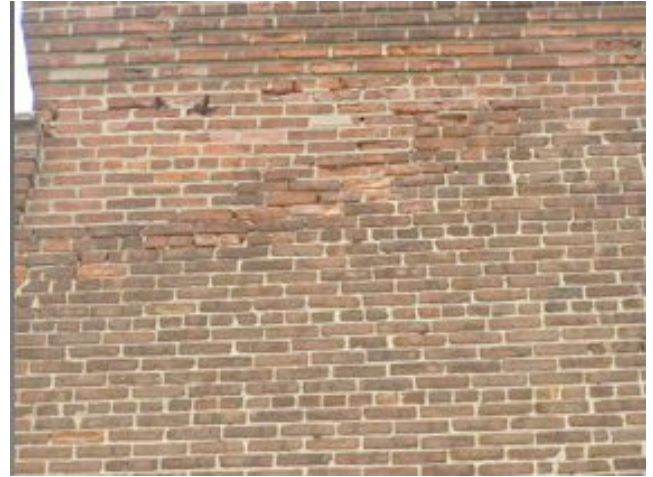
deteriorated in places, probably due to long term water damage (photo below).

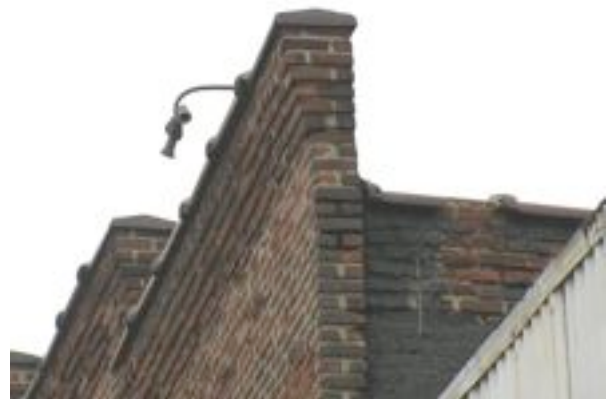
It is also leaning out (photo below) as a result of either lateral forces (wind) or water and freezing action. At the base of the building, the face of the brick has spalled off in spots due to water wicking and freeze thaw (previously explained above).

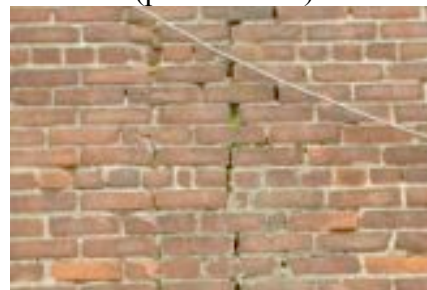
At the north elevation, the cracks previously described at the interior at the steel columns, also reflect themselves at the exterior in numerous locations (photo below).

This should be probed to determine the condition of the steel column and to verify that the structure is sound. From what we see, it appears that this is an early stage of cracking and the delamination is probably minor. The bottom of the wall consistently shows sign of mortar deterioration as well (photo below).

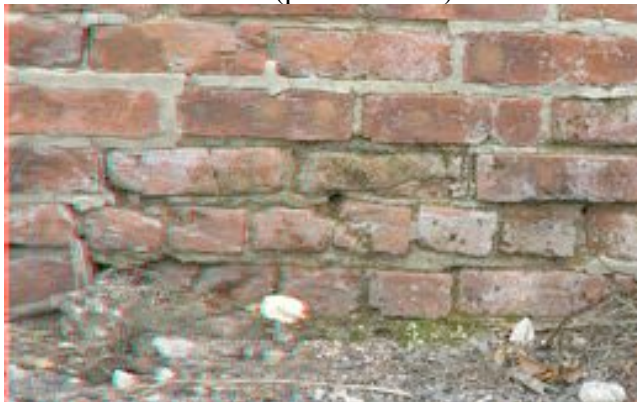
This is probably due to moisture wicking and appears to have been patched previously. In fact, much of the patching mortar appears to be of a poor and inconsistent quality.

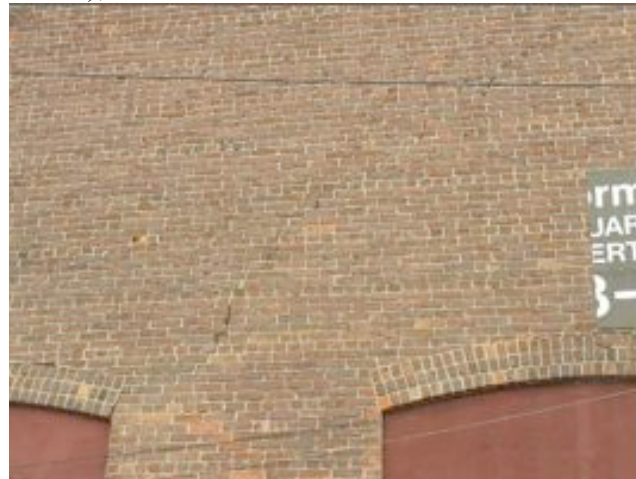
as well as cracks at the second window (photo below),

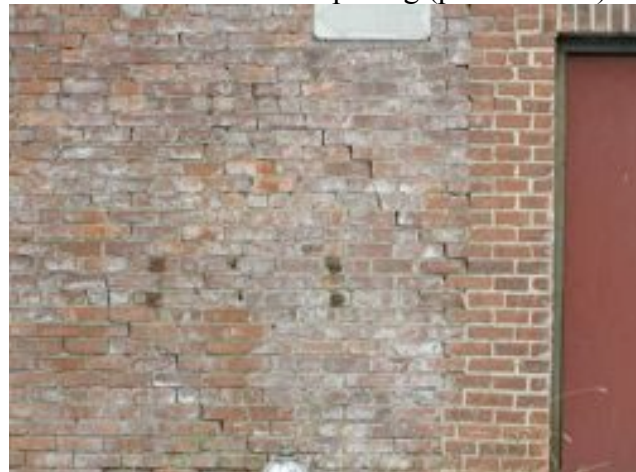
and near the north door opening (photo below).

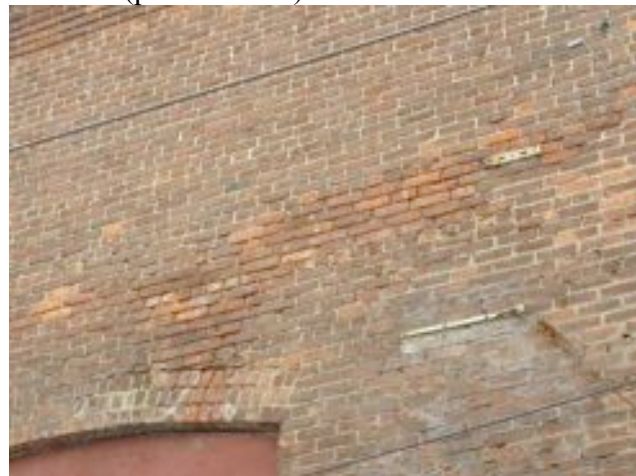
The mortar is also deteriorated particularly above the door (photo below).

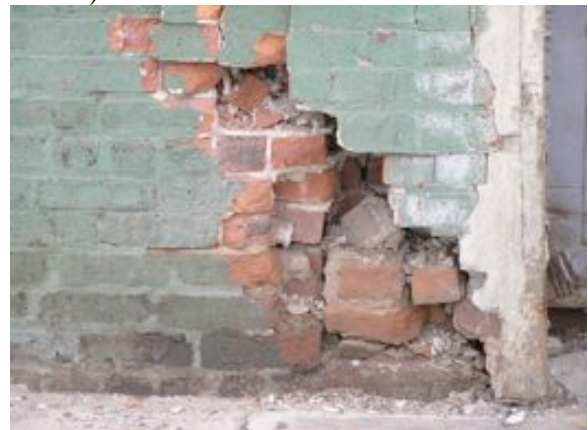
There is also severe deterioration at the base of a pier that appears to be due to impact (photo below).

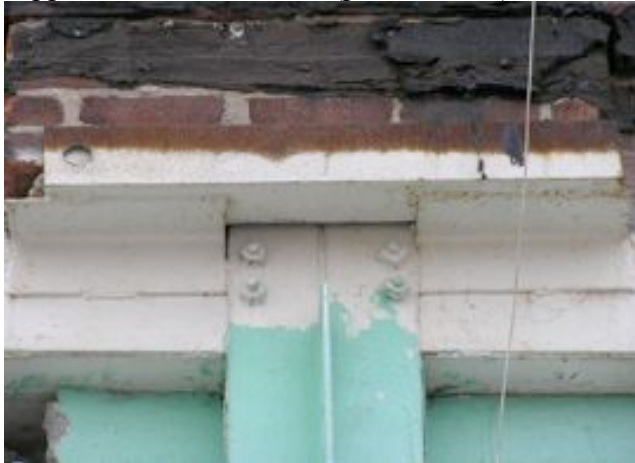
At eight columns/piers, the brick covering over the piers has been removed and the steel is exposed. It appears that this may have occurred during demolition. These columns are now exposed to the elements and will deteriorate rapidly if left unprotected. At the piers, the brick above the tops of the columns appears to be supported on steel lintels (photo below).

This may have been due to the fact that the adjoining roof ended at this elevation and the brick continued above this point—evidenced by the roof tar that remains at this location. These lintels may have been added when the adjoining building was erected separately and the brick wall removed. The only other possibility is that this was originally one contiguous building as the brick is only above the roof.

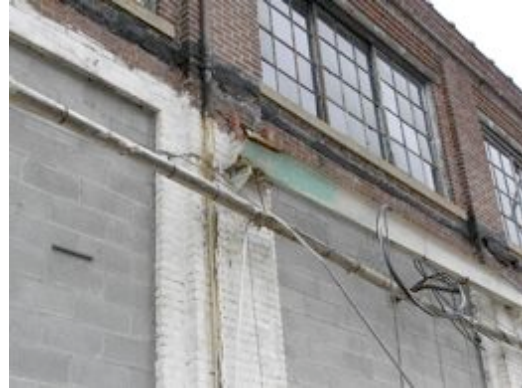
or to remaining steel crane structure due to the recent demolition (photo below).

This leaves several precarious situations of steel hanging off the building or loose bricks allowing water to penetrate and freeze. This could become a safety hazard and should be addressed. At one location, there is a section of brick that must have been removed during the demolition that has resulted in the pier above it being unsupported (photo below).

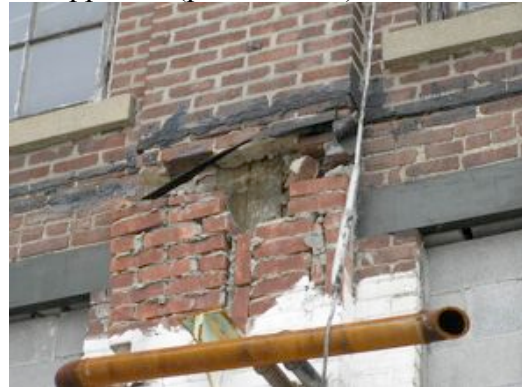
This too is a dangerous condition. Lastly, the northernmost pier is damaged, probably due to demolition, including missing brick and a large crack (photo below).

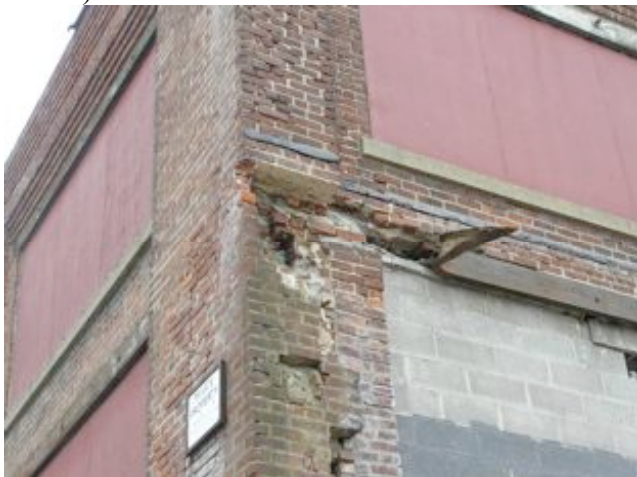
This must be addressed as there are instabilities in the brick above and the winter will bring more damage through freeze-thaw. Extensive pointing is also required throughout this façade (photo below).

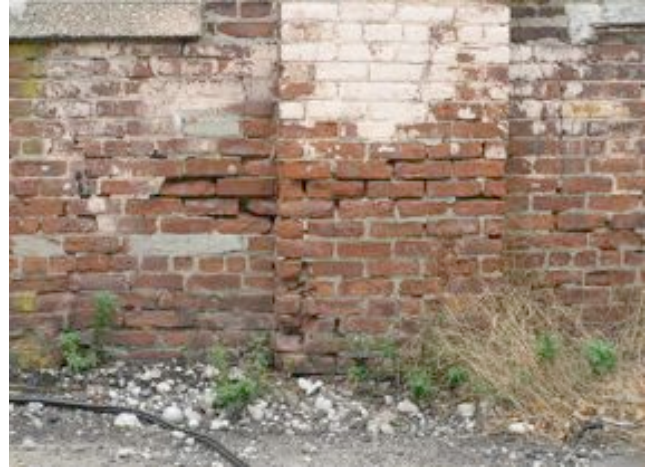
The south façade is also partially inaccessible due to fencing. However, we were able to access this area at a different time to ascertain enough information on its condition. The base of this elevation is consistently in poor condition due to wicking damage. If left alone, this wall will continue to deteriorate and severe distress will occur (photo below).

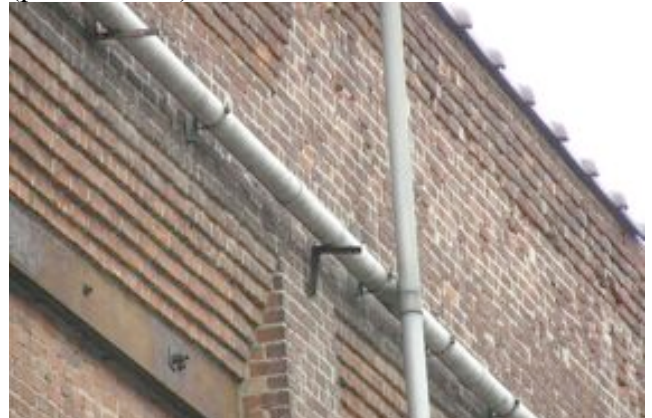
A section of the parapet towards the east end may require replacement, as it is exhibiting signs of rotation, brick delamination, prior attempts at repair, and severe joint recessing, though the photo does not fully reflect what is occurring (photo below).

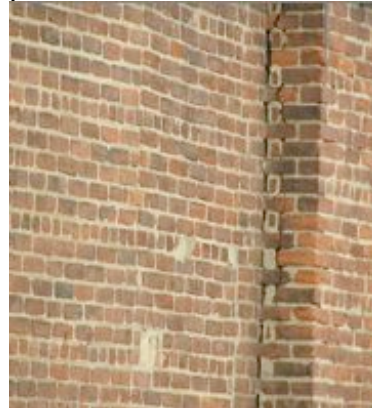
Lastly, a pier is delaminating from the column and requires removal and/or stabilization due to potential for freeze/ thaw failure (photo below).

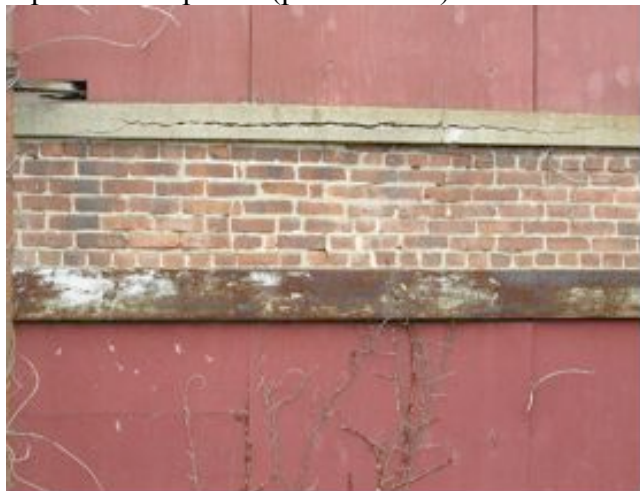
The latter is very common on this elevation. The sills below the window that are concrete are cracked at several locations and should be replaced or repaired (photo below).

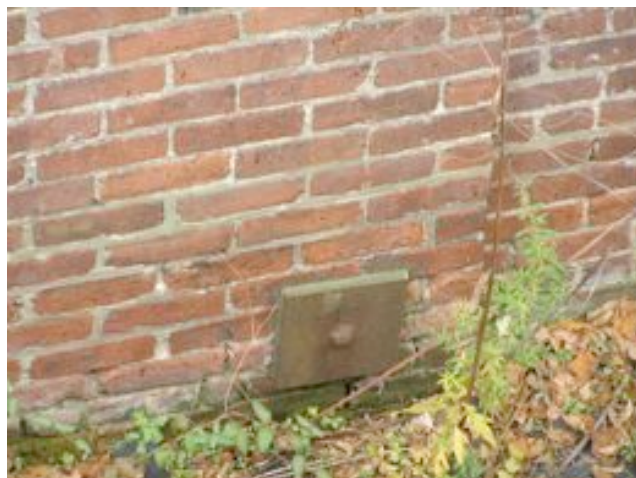
At many of the piers, there is a steel tie plate of unknown use that is exposed on the exterior (photo below).

Though these plates appear to be in good condition, they should be better protected with a rust inhibitive primer. At the north end, the parapet is in poor condition due to loss of mortar and brick face (photo below).

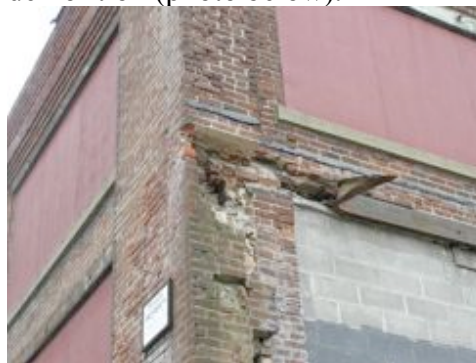
Lastly, the northernmost pier is in very poor condition, primarily due to the adjacent demolition (photo below).
