RE: Draft Water Tower Preservation Plan, Harbor at Hastings Site

**PRE-DRAFT
WATER TOWER PRESERVATION PLAN**

**Harbor at Hastings Site
1 River Street
Hastings-on-Hudson, New York**

February 2019

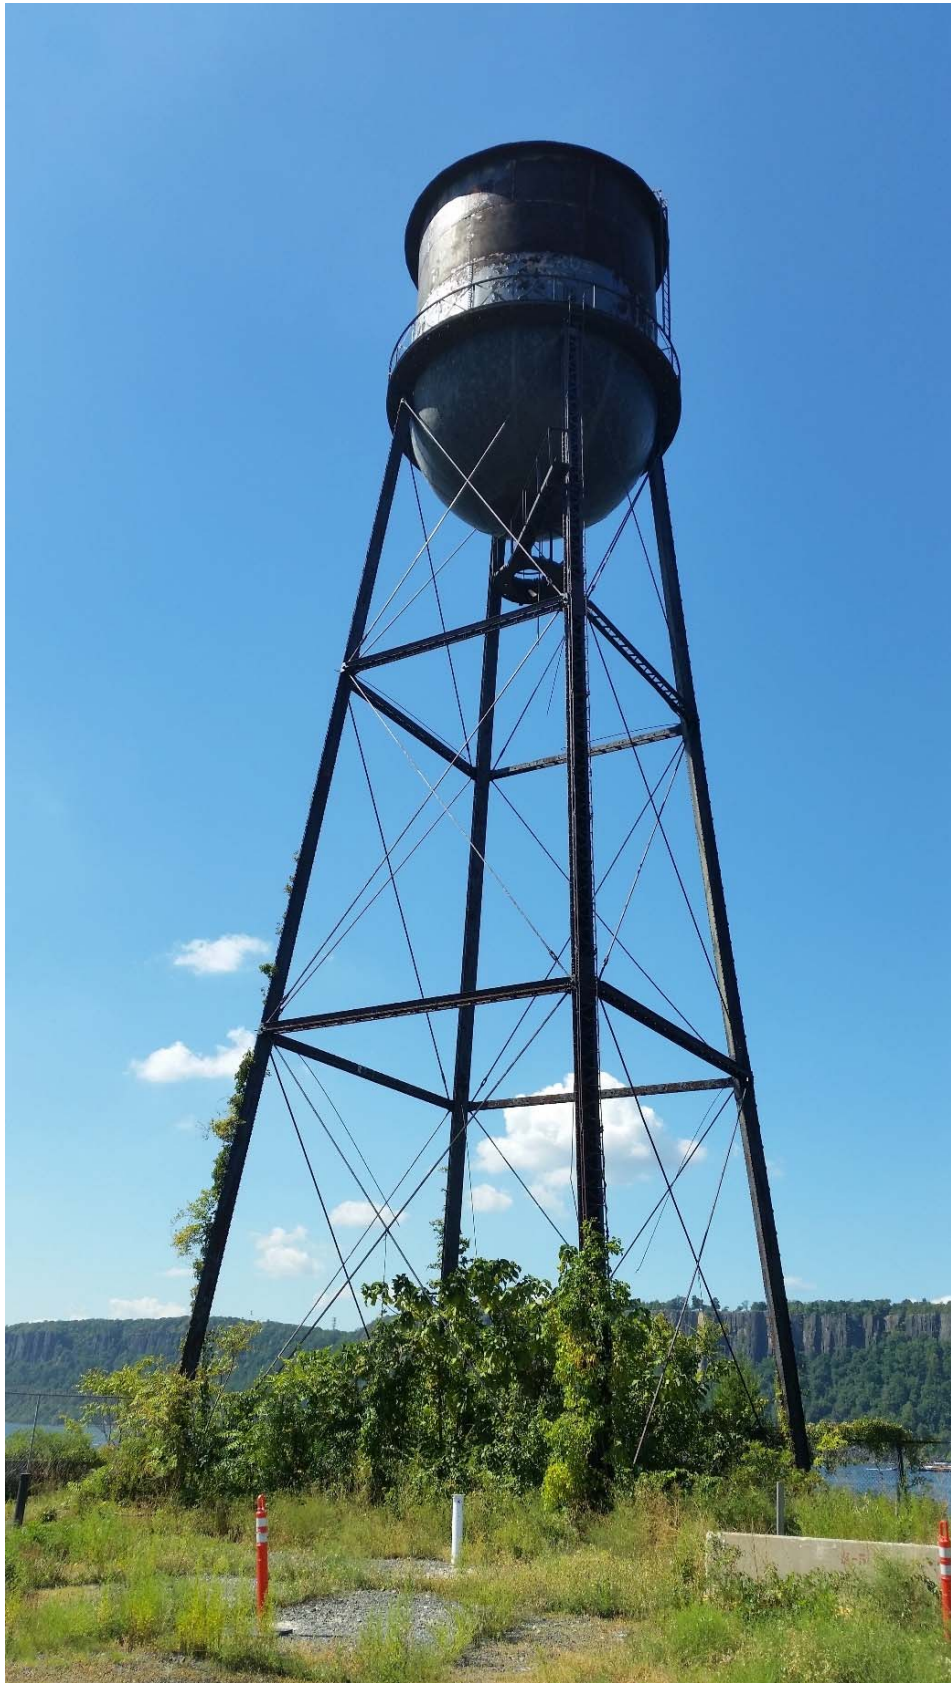
Figure 1

The Water Tower (Figure 1) was constructed circa 1916 for the National Conduit & Cable Company's operations at 1 River Street in Hastings-on-Hudson, New York. In 1919, Anaconda Copper and Mining Company, a predecessor to Anaconda Wire and Cable Company (AWC), purchased part of the property and eventually merged into AWC.

Water Tower Photograph

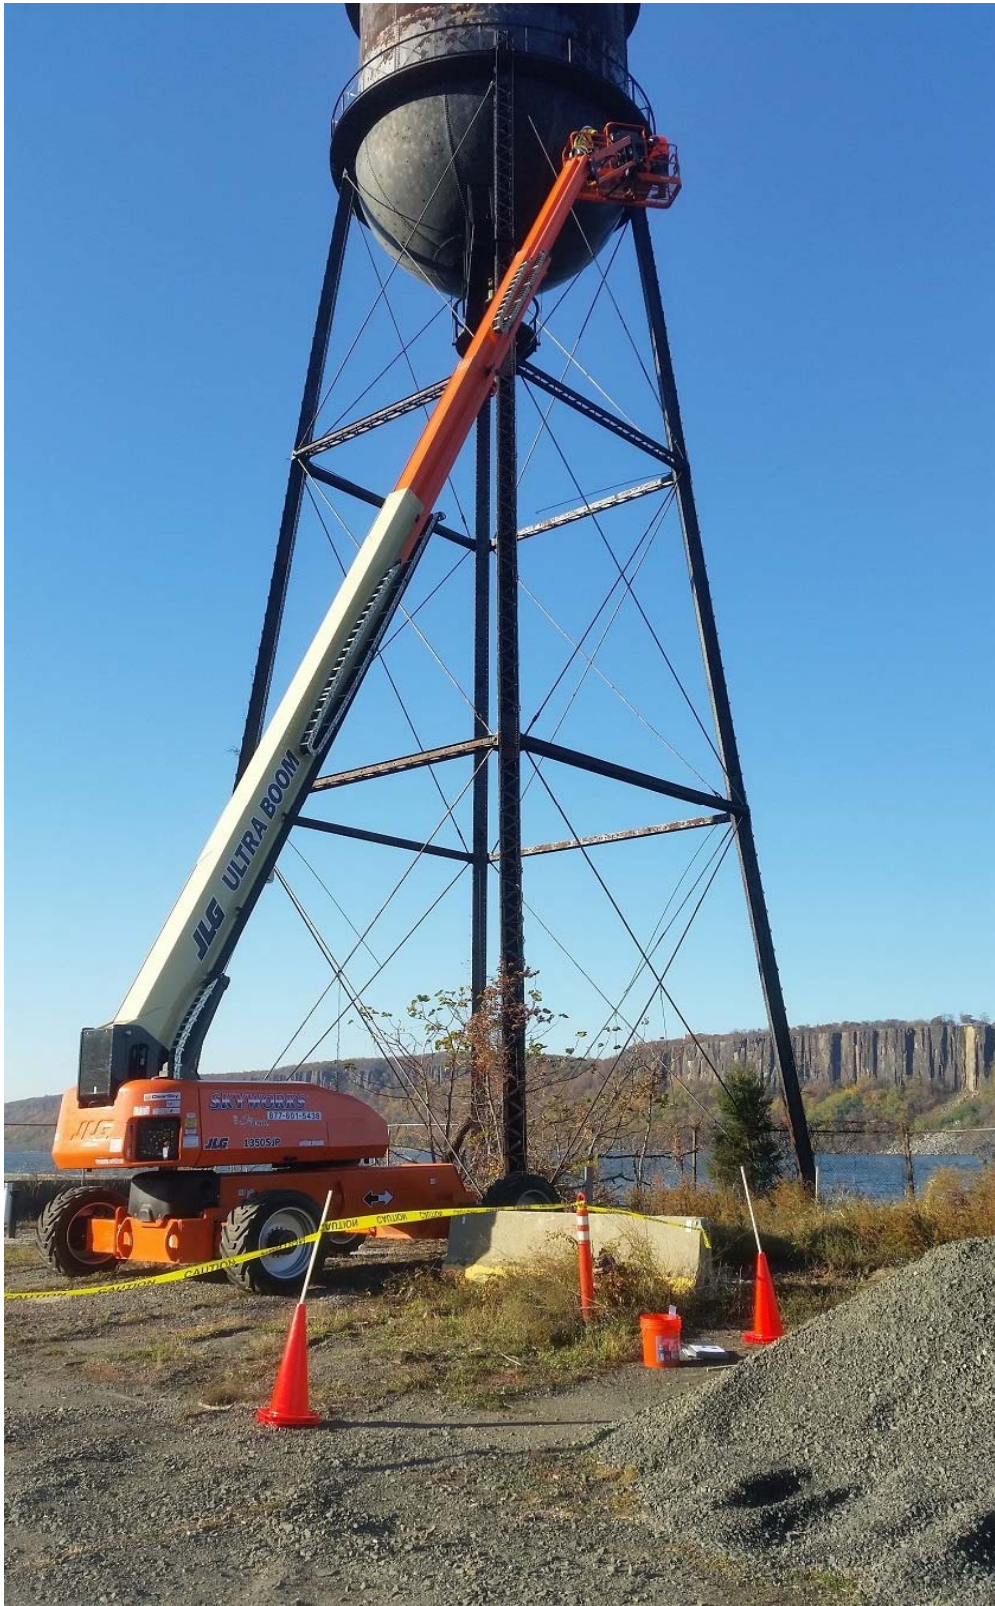
A visual inspection of the structural members and their connections was performed using a 135-foot personnel lift (Photo No. 2). Where access was possible, a hands-on inspection was performed including recording the thickness of structural members and the water tank using an ultrasonic measuring device and a basic caliper, to determine possible section loss due to corrosion.

Photo No. 2: View of the Water Tower and personnel lift looking west.

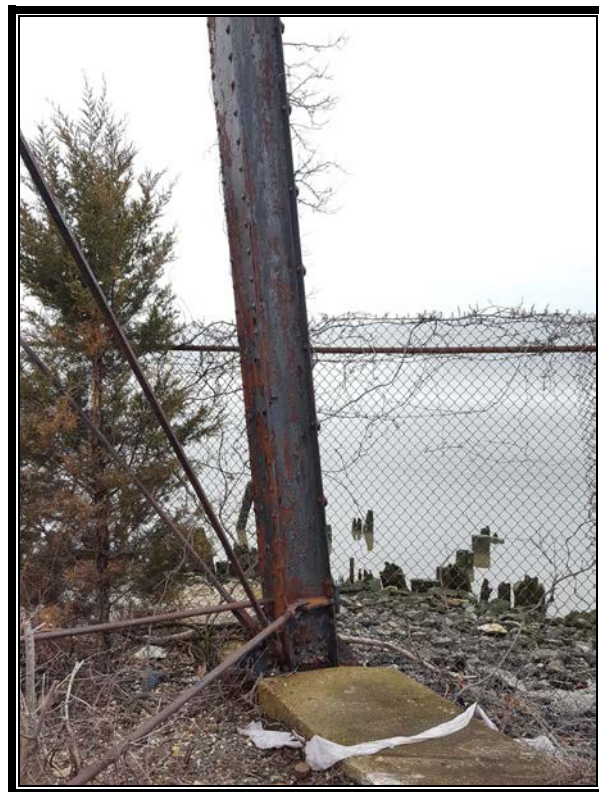
Photo #2: Northwest Structural Post

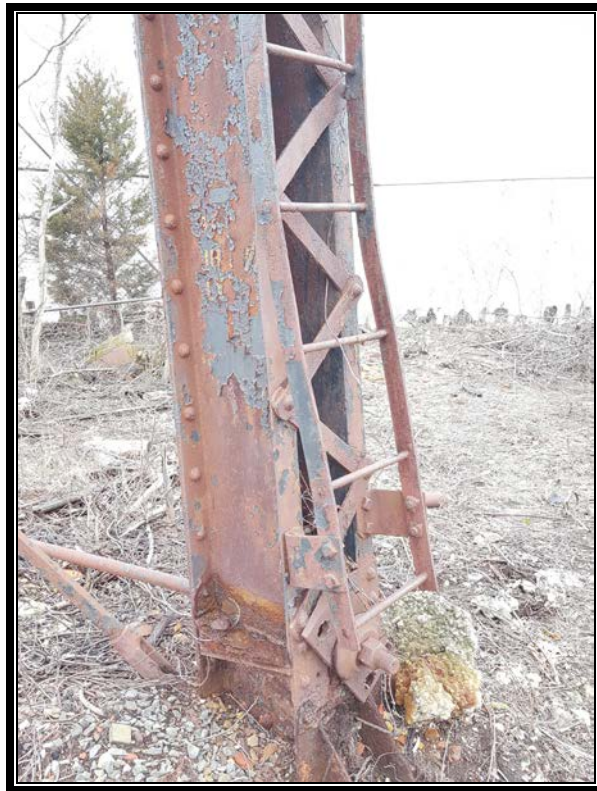
Photo #3: Northeast Structural Post

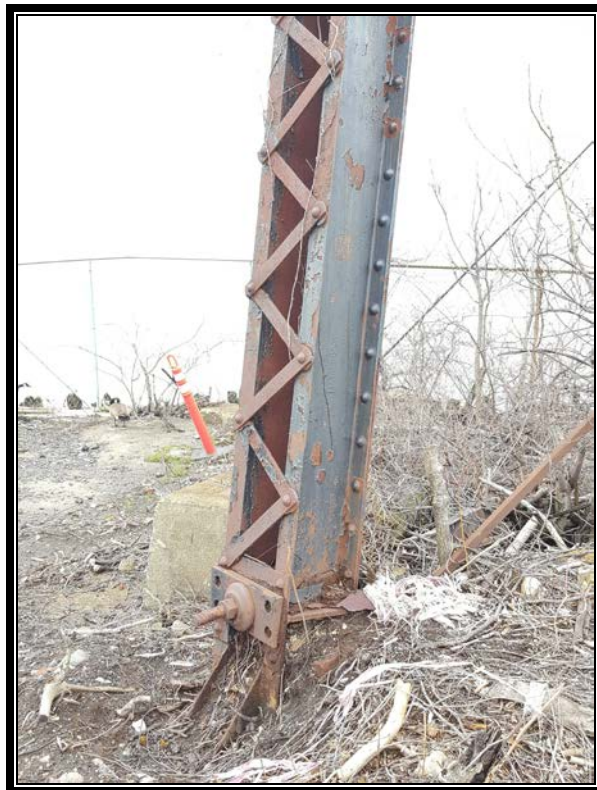
Photo #4: Southeast Structural Post
