APPLICATION FOR BUILDING PERMIT

Building 52, located at 1 River Street, Hastings on Hudson, NY, is to be demolished while the concrete slab will remain intact. See attached narrative for details.

DECOMMISSIONING AND DEMOLITION OF BUILDING 52 NYSDEC SITE #3-60-022 1 RIVER STREET HASTINGS-ON-HUDSON, **NEW YORK**

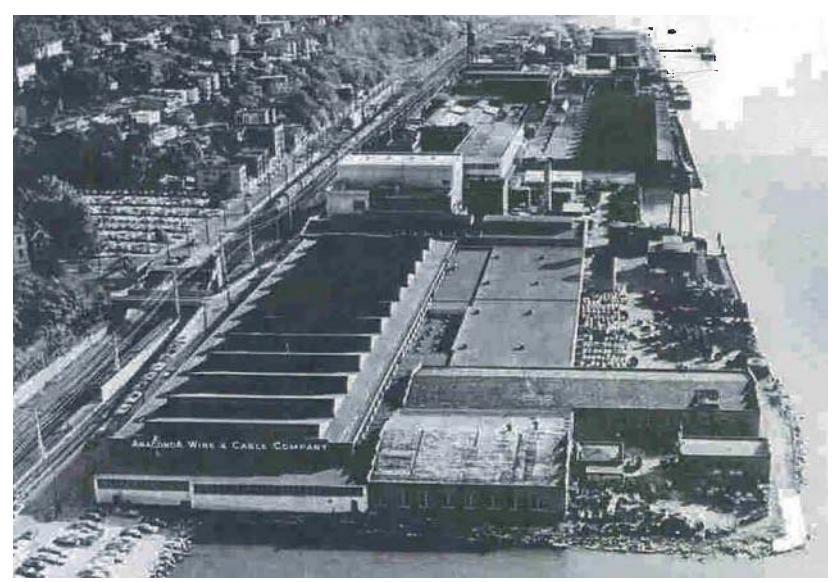
Historic site photo showing its many buildings (Building 52 is at lower left)

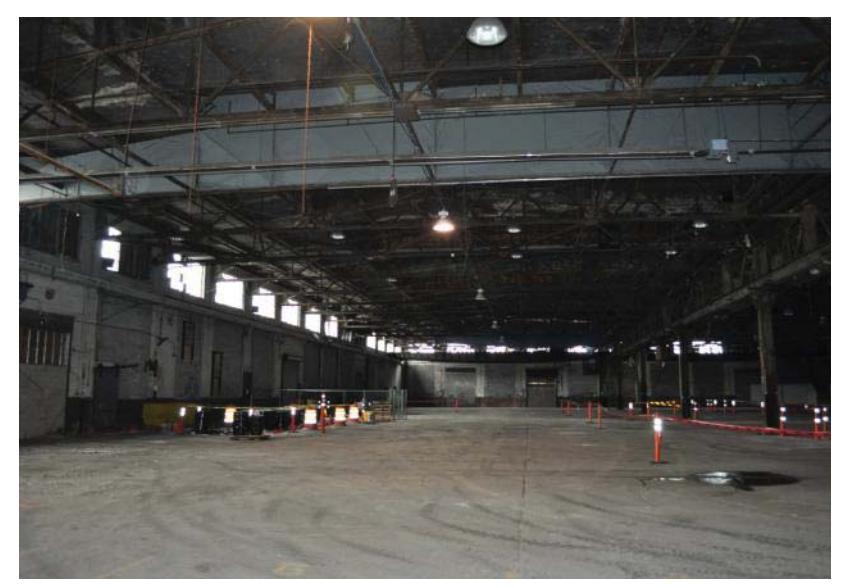
The floor is exposed concrete and based on visual observations appears to be in fair to good condition [**photo 1**]. There are various trenches that may have housed pipes or rails, which have been filled in with concrete, most likely at a later date than when the slab was poured. [**photo 2**]. The surface is somewhat uneven across the entire floor. There is an existing pile layout drawing, which led us to assume that the majority of the floor consists of a spanning slab.

Photo 1: Overall interior

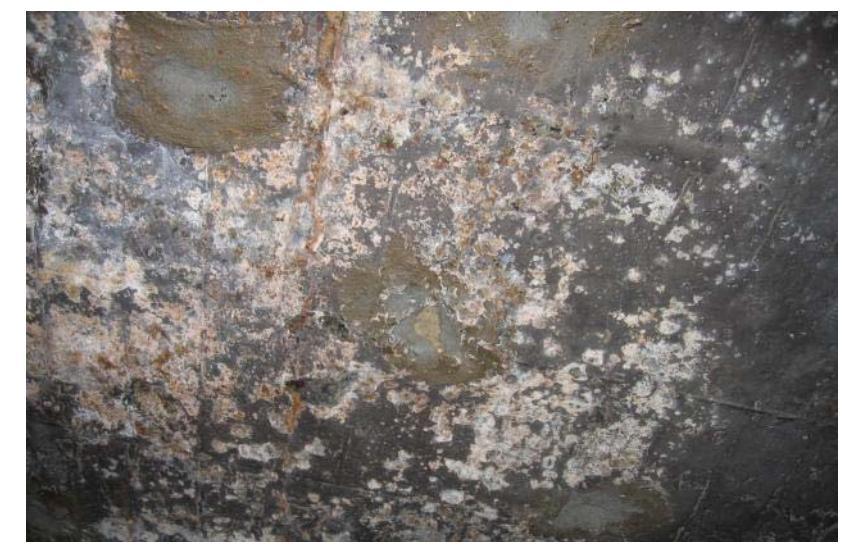
During one site visit RSA was able to observe the underside of the roof slab from a scissor lift in various locations throughout the building. RSA personnel were not allowed to touch this surface due to the potential of environmental impact. RSA was only to observe it visually and direct the environmental contractor, Envirocon, to perform soundings on the slab. From the ground, looking up at the underside of the roof, the slab appeared mottled, as if there was possibly a large amount of moisture infiltration in many areas. Once up in the lift however, it was clear that what had looked like mold or other indicators of moisture infiltration was actually due to peeling and flaking of some sort of coating that had been applied to the underside of the slab [photo 6]. It is not clear what the coating was intended for but it is likely that moisture has caused it to flake off.

Photo 6: Underside of roof slab - surface

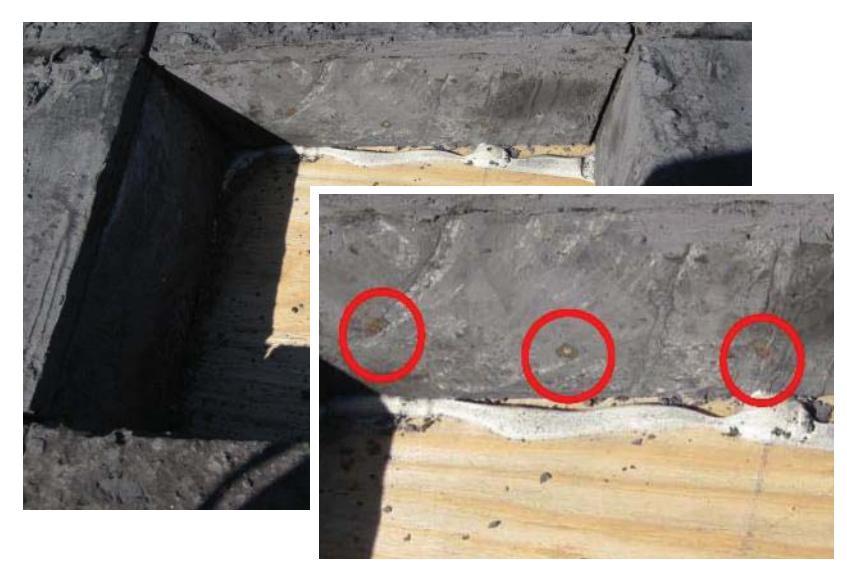
Photo 12: Roof probe #6 - cross ection with reinforcing

Seven roof probes were observed by RSA to further confirm the make-up, reinforcing and condition of the roof slab. From the probes, the thickness of the slab was measured at approximately 4 inches (+/- 1/2 inch) with a layer of W2 (0.159-inch diameter) wire mesh located 3/4 inch (+/- 1/4 inch) from the bottom side of the slab [photo 12]. The wire mesh spanning parallel to the slab (east-west) was spaced at 3 inches on-center. This spacing was consistent at all seven probes. The mesh perpendicular to the slab span (north-south) was minimal and a definitive spacing could not be determined as there was typically only one piece of wire per probe. This would indicate a spacing, for what is commonly called the temperature reinforcing, of 12 inches or larger. A sketch of the typical roof probe findings can be found on **RP-1** in **Appendix C**.

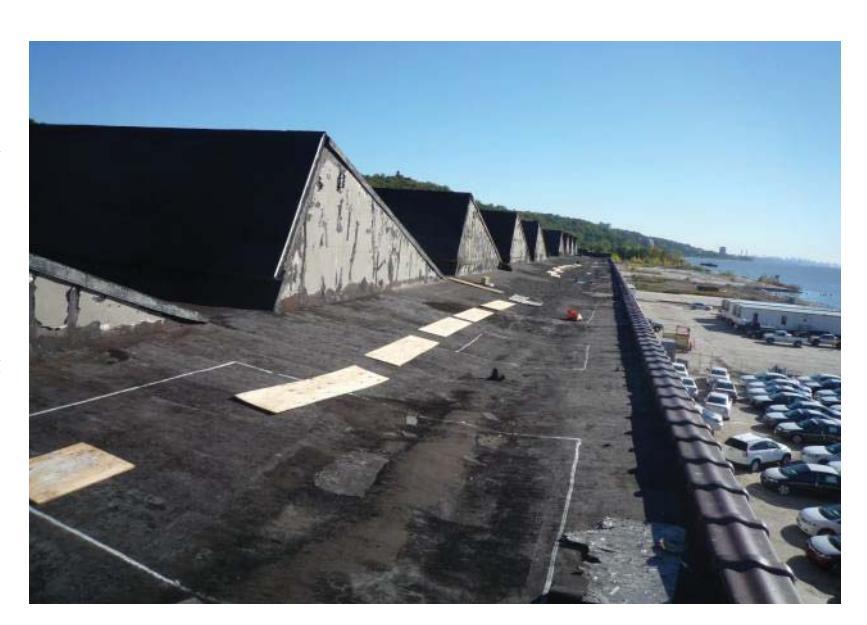
The roof, a "saw-tooth" type commonly used on industrial buildings of the era, is an extension of the highly rational layout of the building's floor plan. Northfacing glazed areas in the skylight "monitors" of the saw-tooth design allowed diffused, non-direct natural light to the interior. The height of the glazing area was divided between two lites; remnants of internal mechanical devices at the frames suggest the glazing was operable. Originally, the roof configuration had a dozen monitors spaced evenly across the length of the building. Each monitor occupies three structural bays of the building's length; the low side of every monitor coinciding with one of the twelve columns along the building's central column line. A typical monitor spans much of the building's width, with its triangular end set back about 24 feet from the east and west façade walls [photo 14].

Photo 14: Overall of roof looking south

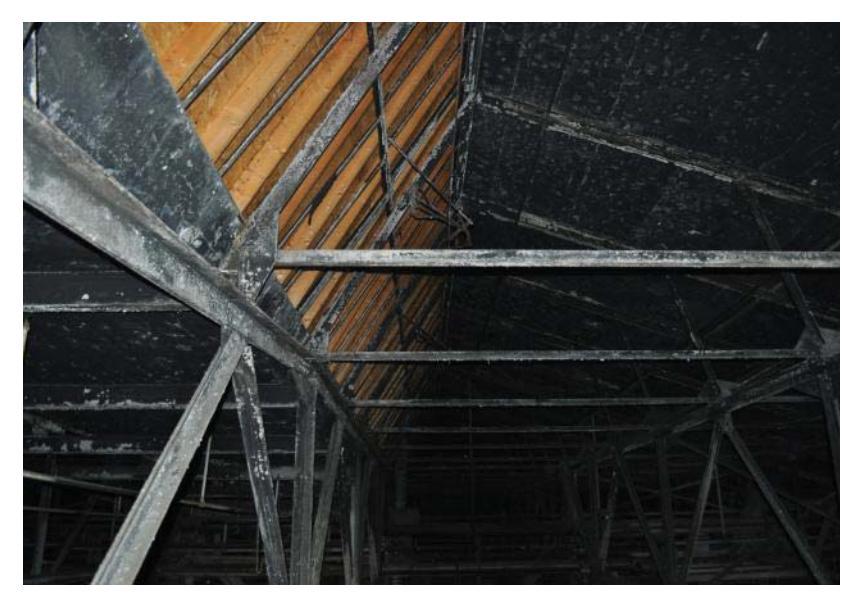
The steeply sloped, formerly glazed portion of the skylight monitors presently have wood structure infill, oriented strand board (OSB) covering, building paper and asphalt roofing shingles. Shingles are approaching the end of their service life and are missing at limited areas. During a single up close observation, conducted by lift from the interior, the existing remaining metal skylight frames were examined. All glazing has been removed; broken remnants of glass are visible along the edges of the frames. Based on the observed skylight frame, we assume all steel frames to be deteriorated beyond repair [**photo 16**].

framing members, spaced approximately 22 inches on Photo 16: Interior view of skylight frame center. Expanded metal lath, fastened with metal wire

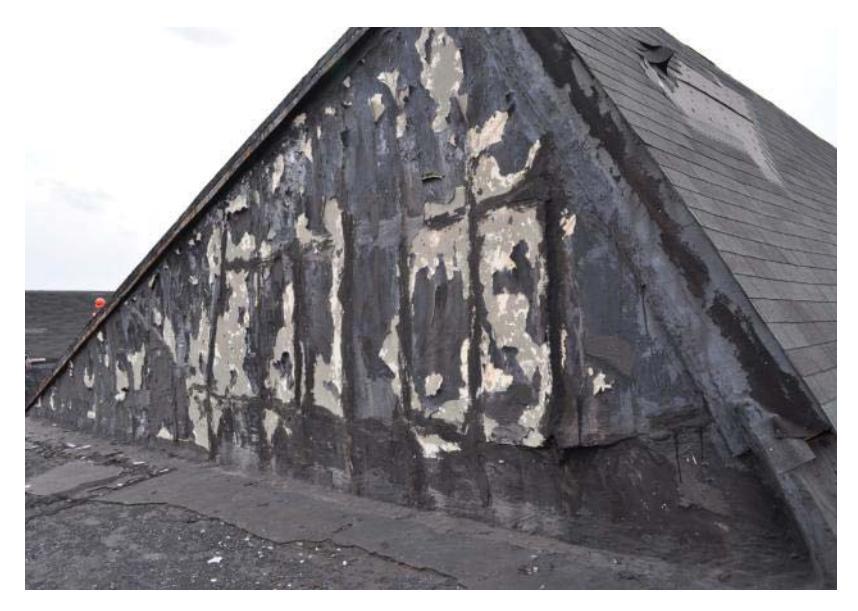
Failures at these walls include loss of coatings, cracking, and deformation of the wall surface due to deterioration of the metal framing. Bulging typically occurs more toward the south end of the building, at both the east and west end walls. The deformation, increasing proportionally to the height of the triangular wall, is greatest at the bottom [**photo 17**]. A potentially dangerous condition exists where large pieces of cement plaster, having de-bonded from the metal lath, could fall into the building.

Photo 17: Cement plaster side wall at roof monitor

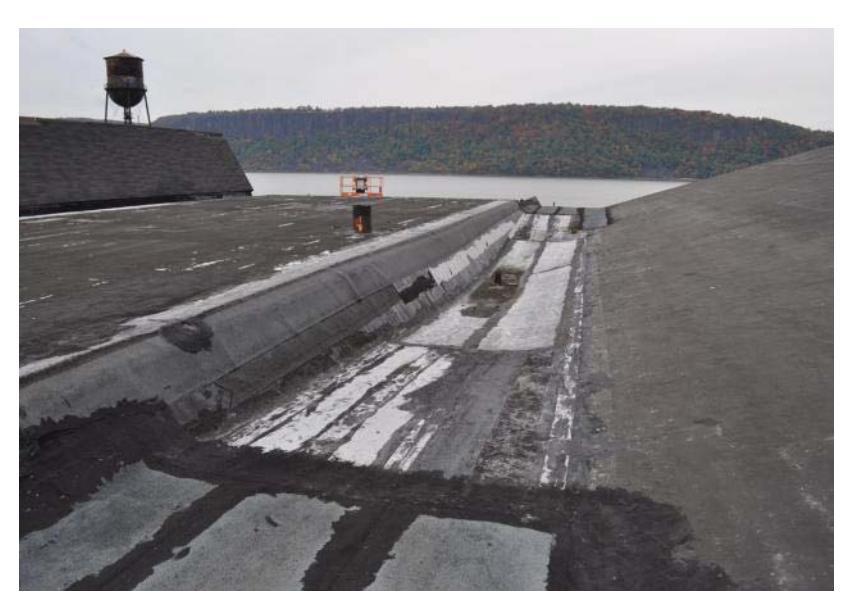
The roof monitor between column lines 22-25, including the concrete deck, much of the curb, and associated supporting steel, no longer exists. The monitor has been replaced by low slope roof on metal deck [**photo 18**]. The roof membrane over the metal deck differs from most of the building. At this area, the deteriorated membrane appears to be some sort of a glass fiber reinforced top sheet covered with a bitumen flood coat.

Photo 18: Low slope roof at former roof monitor

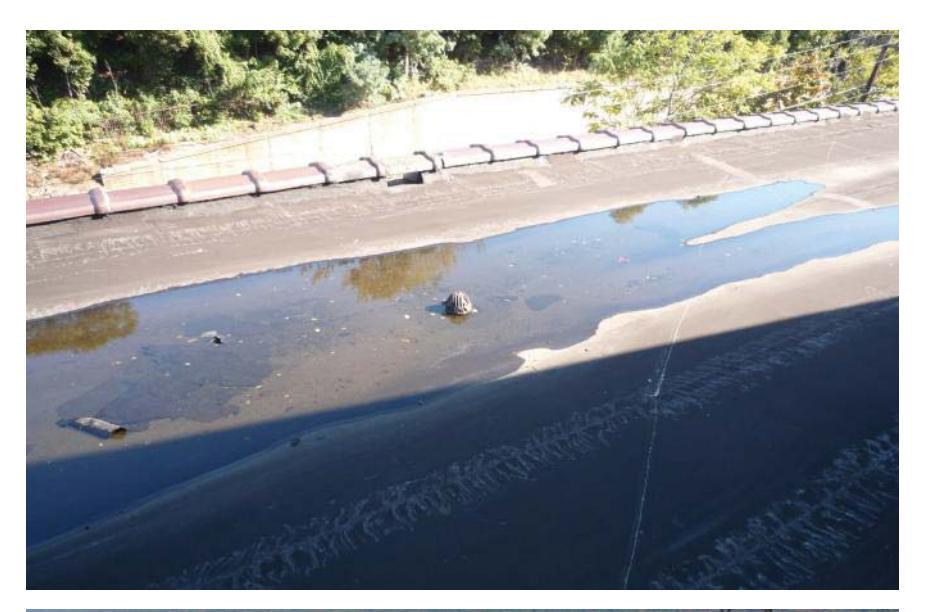
The parapet walls vary in height. At east and west façades, where the coping is just inches above the deck, the membrane terminates beneath the terra cotta coping [**photo 19**]. At north and south facades, where the parapet height varies between two to three feet above the roof deck, the roof membrane terminates at copper counter-flashing some eight inches above the roof deck. Most of the counter-flashing has been covered with successive layers of roofing mastic.

Photo 19 (top): Coping at east façade wall. Note overflow opening and presence of standing water.

Parapet Walls: Roof parapets require extensive masonry work to stabilize them. First, remove all existing terra cotta coping sections and inspect the exposed top courses of masonry. Reconstruct the top courses (assume top two courses of brick) as required to ensure their stability. Install a new plywood substrate to cap the repaired masonry. Provide new self-adhered sheet waterproof membrane and new TPO clad sheet metal coping over the plywood substrate, and tie each to the TPO roof membrane.

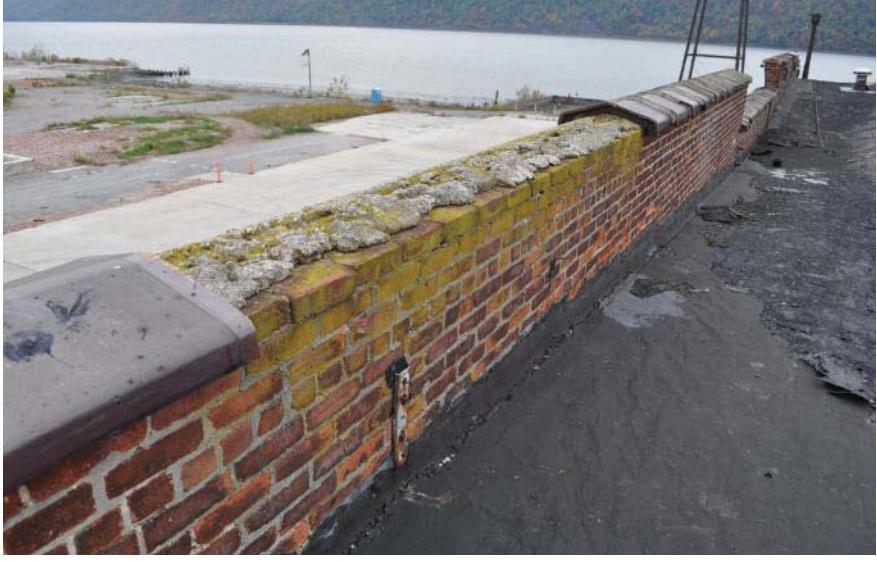
Photo 20 (middle): Coping at south façade wall. Note missing coping.

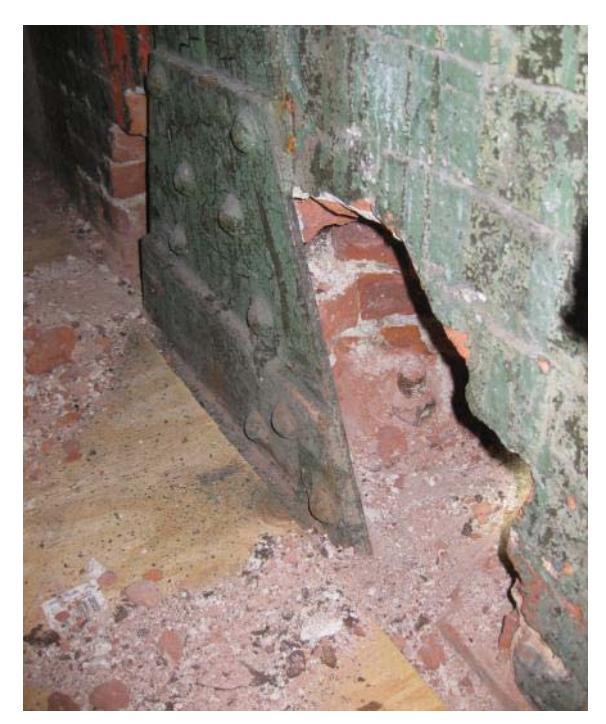
The four column base probes uncovered built-up steel columns atop base plates which were anchored into concrete piers (see **sketch WP-1B** through **WP-3** in **Appendix C**). The columns consisted primarily of angles and plates that were riveted together which is consistent with construction practices at the time the building was erected. Some of the columns have trapezoidal plates parallel to their flanges, however, these were not found at all locations [**photo 22**]. It is unclear what these additional plates were for, but they may have been used to transfer additional forces into the foundations.

Photo 22: Wall probe #3 - column base

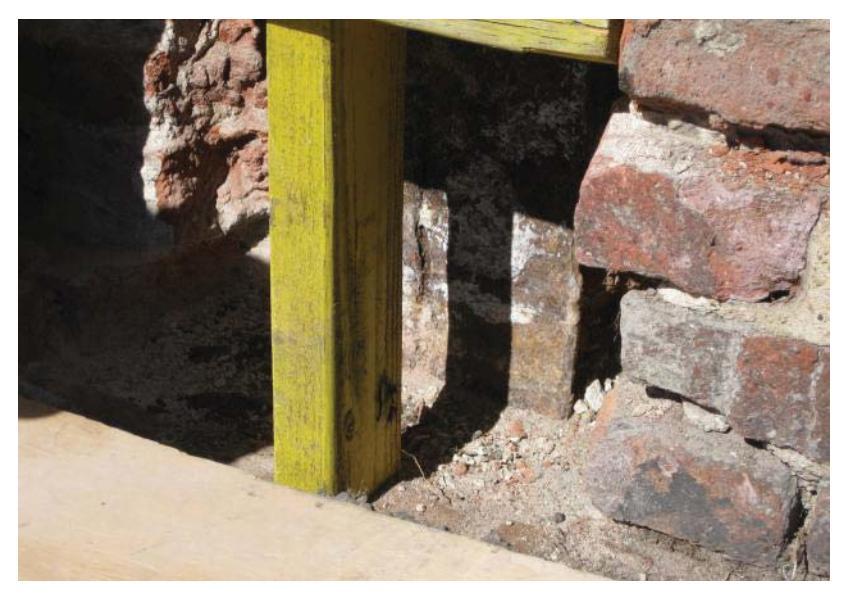
The column bases observed generally showed little signs of corrosion. Any corrosion found was typically on the lower 12-18 inches of the column and did not appear to be aggressive. The column probe that had the largest amount of corrosion was wall probe 1A [**photo 23**]. The increased amount of corrosion was not found to be a surprise as this column was located behind a pilaster that had shown signs of deterioration (both cracking and separation from the wall) which would allow for increased amounts of water to reach the column. All of this being said, the corrosion of the column was not significant enough to cause concern for the stability of the building.

Photo 23: Wall probe #1A - column base

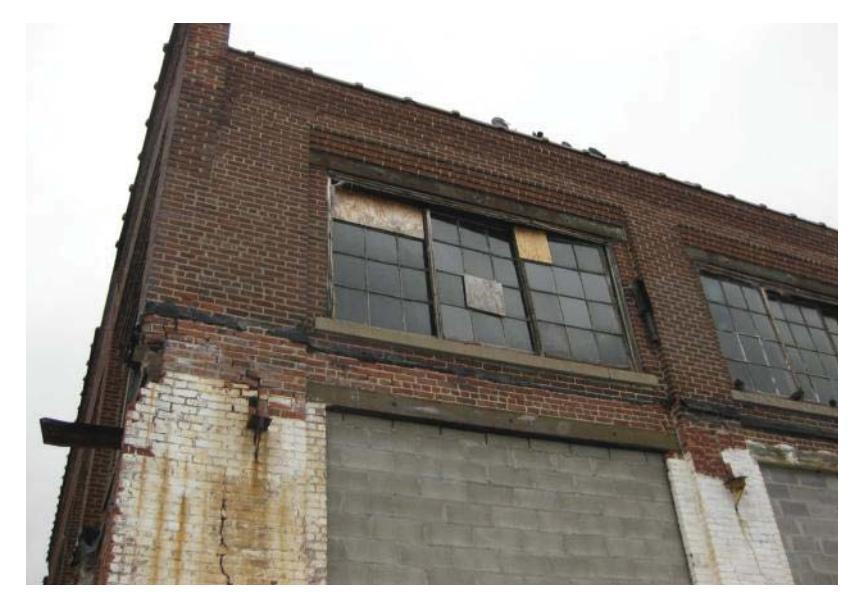
The west wall provided the most diverse range of conditions on the entire building and was mostly due to previous building extensions that have since been removed. The building previously had one shed-style addition that extended from grid 1 to grid 13. The remnants of this addition are still visible as T-shaped pieces of steel protruding from the masonry pilasters as well as painted masonry and a flashing reglet [**photo** 24]. In order to help seal the building and prevent deterioration of the exterior walls in this area, it is recommended that the steel T's be removed. At all sides, the steel lintels over windows should be scraped and painted and the reglet be removed.

Photo 24: T-shapes at west wall

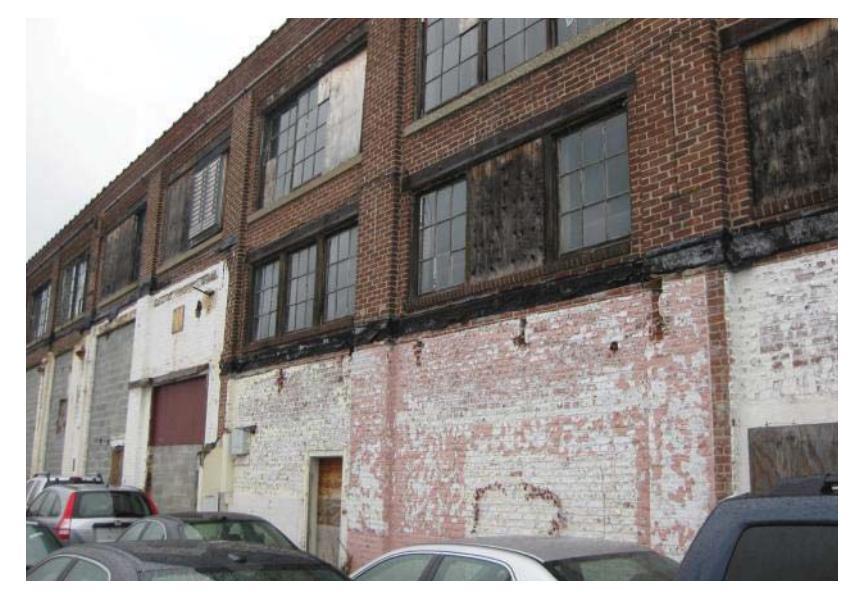
Between grids 15 and 22 there is evidence of another extension which has since been mostly removed. It appears that this was once a bathroom for the building. Below the lowest windows, there were numerous abandoned beam pockets and paint and ceramic tiles on the masonry wall [**photo 25**]. There was also a large stretch of various tile materials adhered to the exterior slab on grade. As indicated on drawing S-100, the removal of all finishes (i.e., paint and tiles) is recommended from this area and any beam pockets should be filled with new masonry.

Photo 25: West wall beam pockets and paint

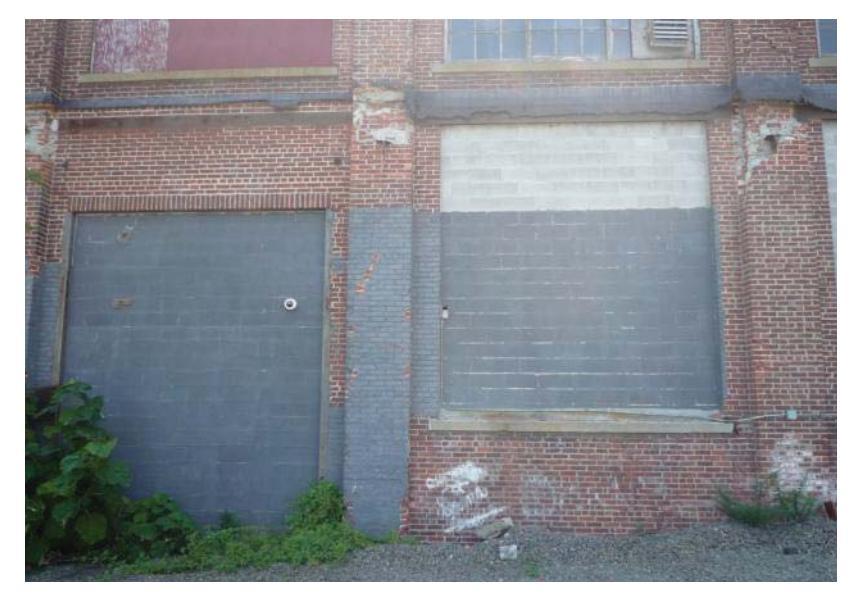
Similar to the shed that had existed on the west wall, the north wall also once had a building extension. The only remaining pieces of this addition are T-shaped pieces of steel extending from the masonry pilasters along the wall and a flashing reglet just below the upper windows [**photo 29**]. Both the steel T's and flashing reglet shall be removed and the masonry repaired to help prevent additional moisture from entering the building. The remaining work on the north wall is primarily repointing of the existing masonry and the scraping/ painting of the exposed steel lintels. It is thought that, like the east wall, the north wall saw little sunlight and thus did not have the

Photo 29: T-shapes at north wall

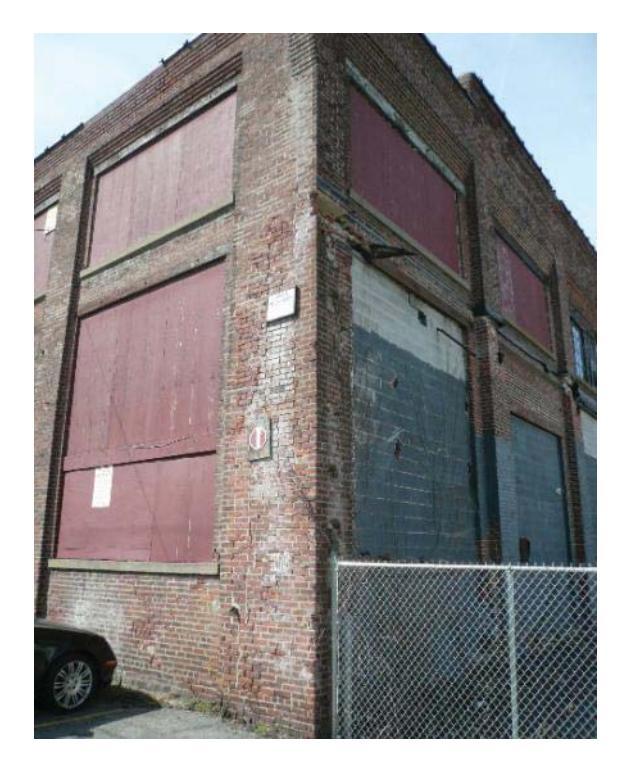
Photo 30: Southeast pilaster

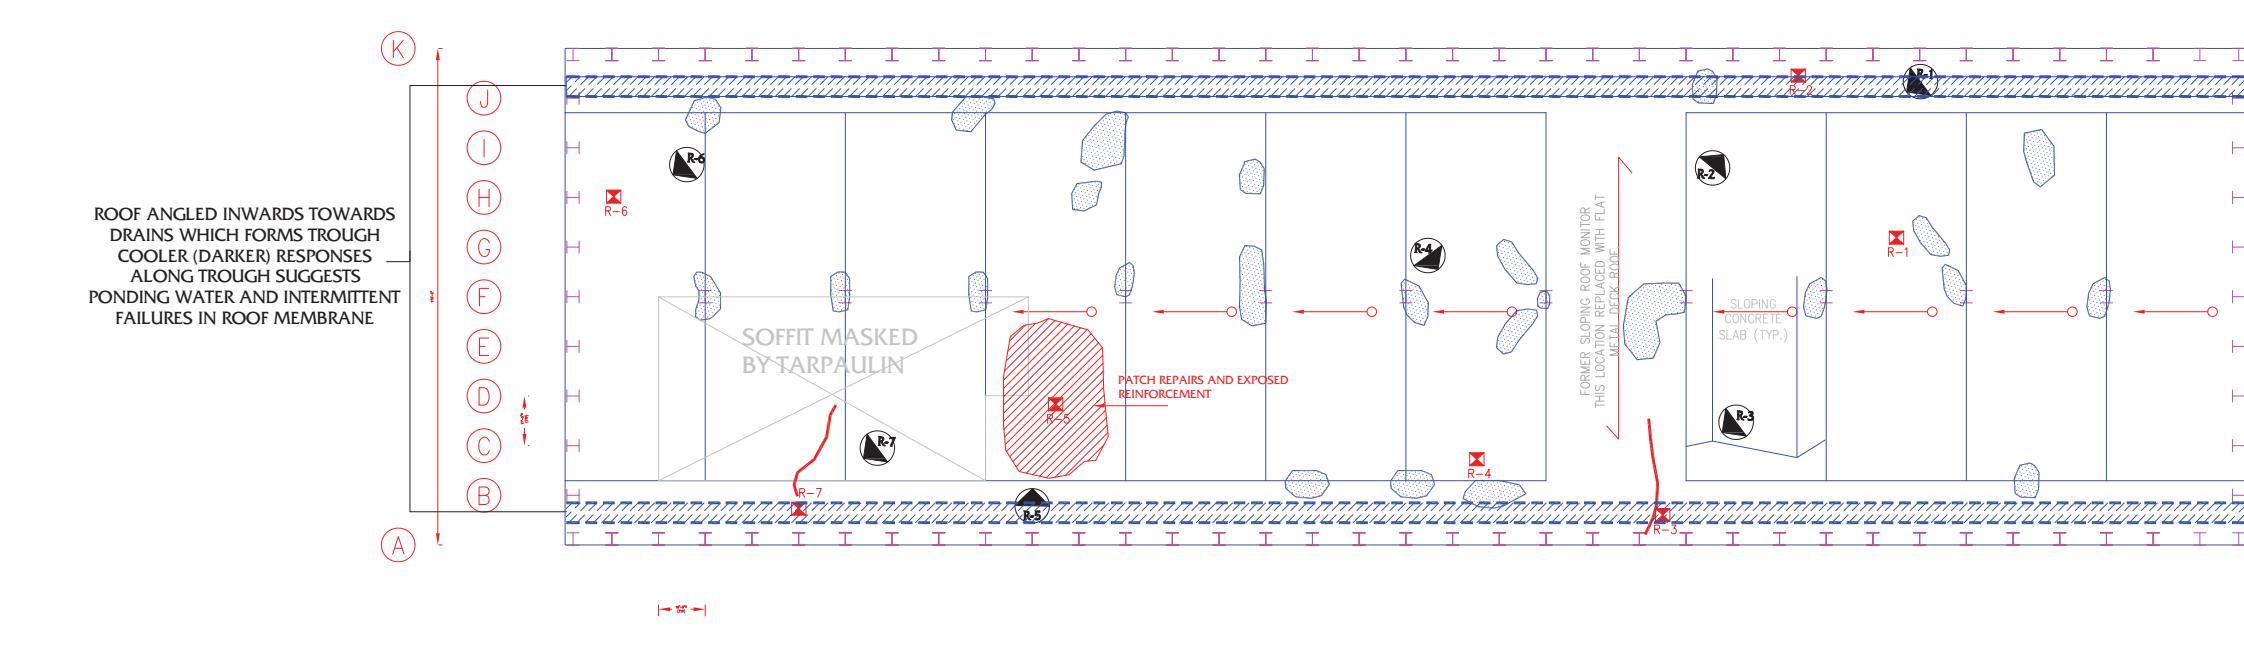
FIG.2a: RESULTS OF THERMAL ASSESSMENT AND THERMAL IMAGE LOCATIONS SCALE 12:11

An initial set of images were collected focussing only on the 7 locations (R-1 to R-7), which had been selected by RSA as potential probe locations (See Figure 2a for locations). Areas of increased moisture ingress were first mapped and a thermal image taken at each of these locations is presented and annotated on the drawings provided (See Fig 2b).

Following the initial review of the probe locations, a more general survey was undertaken of the soffit. Thermal images were collected within each of the bays from a number of vantage points in order obtain the best possible coverage of the roof slab. Due in part to the previous heavy rainfall, identification of moisture was relatively straightforward. The areas have been plotted in plan on Drawing 10-030-02, Fig 2a.

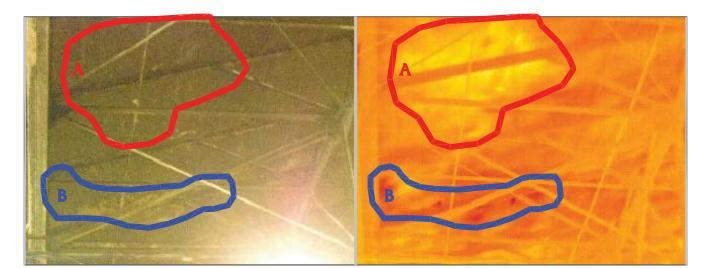
P2a: PROBE IR-1, VIEWED WEST: VISUAL AND THERMAL IMAGES HIGHLIGHTED AREAS OF LIKELY DELAMINATING CONCRETE (A) AND DAMP (B)

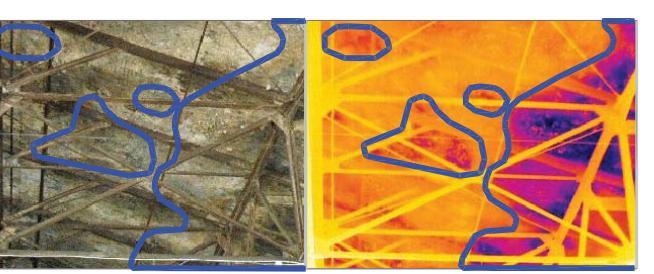
C: PROBE R-5, VIEWED EAST: VISUAL AND TH

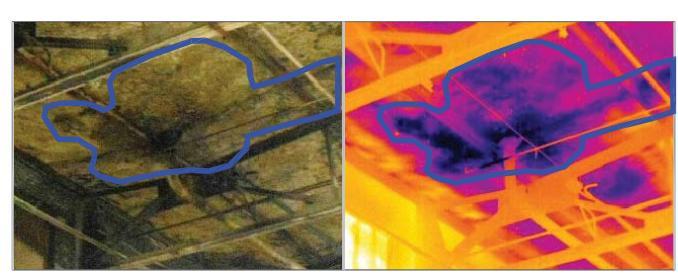
P2b: PROBE R-2, VISUAL AND TH

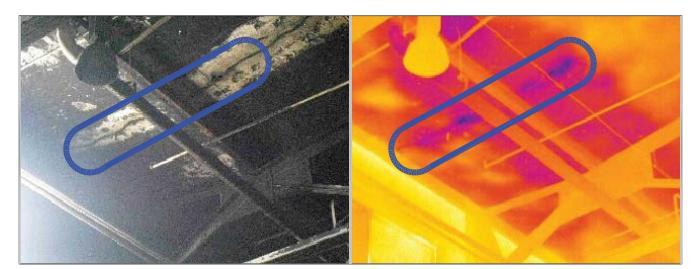
2c: PROBE R-3, VIEWED NORTH WEST: VISUAL AND TI ING AN AREA OF DAMP AROUND A CRAI

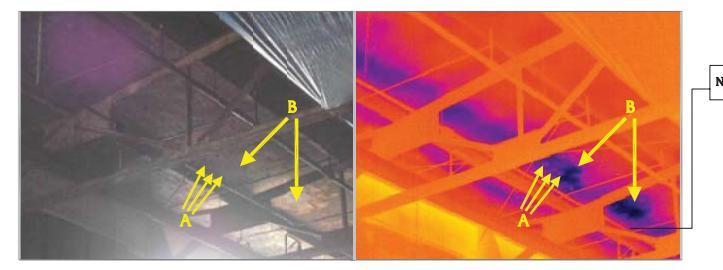
P2g: PROBE R-7, VIEWED NORTH WEST: VISUAL AND THERMAL IMAGES HID

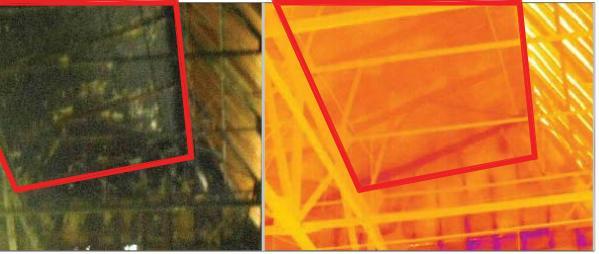
P2d: PROBE R-4, VIEWED EAST: VISUAL AND THERMAL IMAGES SHO TO THE VISIBLE STRUCTURE. NG AN AREA OF LIMITED TI

NOTE: EXTENT OF TROUGH SHOWN IN THERMAL IMAGE

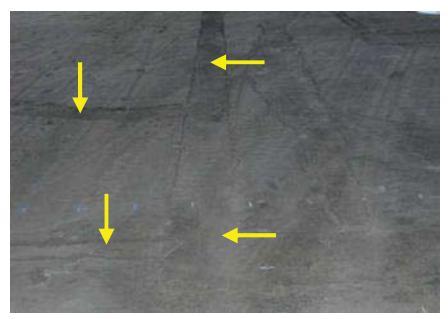
The overall floor slab construction is similar throughout; however variations in thickness and reinforcement placement were identified, which tend to relate to concrete filled service / pipe trenches (typically visible at the surface), repaired sections of slab (again typically visible at the surface), possible machine bases, changes in construction and likely pile cap locations beneath.

Visible service / pipe trenches

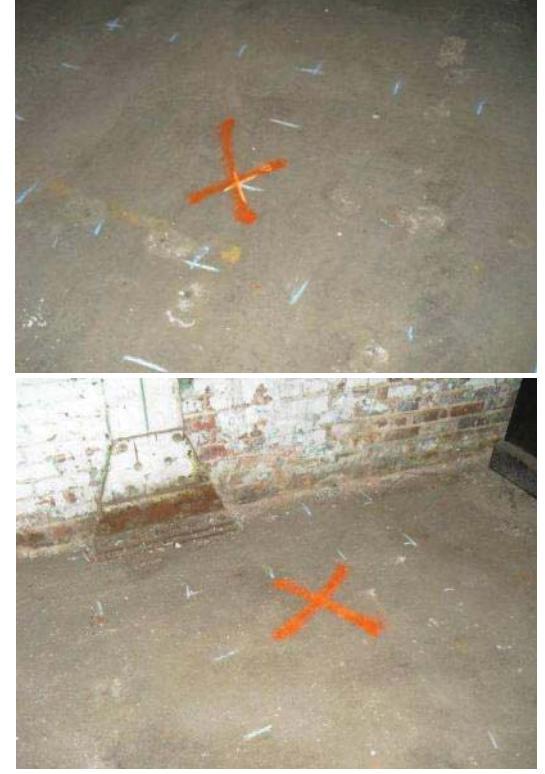
As part of this survey GBG were asked to locate pile caps; however as the pile cap design (assumed thicker concrete with timber pile beneath) is unknown, radar data was scanned for anomalies in the form of apparent localised variations in reinforcement (typically increases) or sections of slab which were thicker than others and did not appear to relate to services trenches or other construction changes / repairs.

Typical red 'X' marked on site to denote the potential location of a pile cap

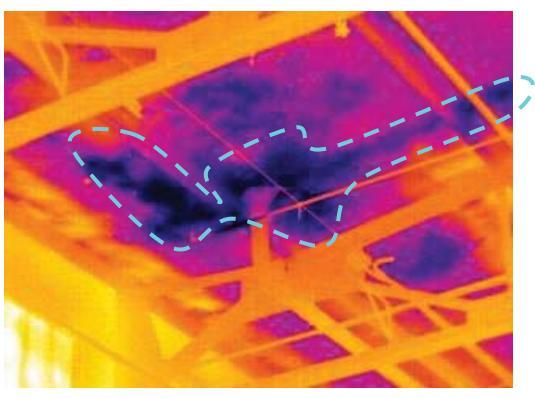
Example Thermal Image – Cooler (darker) responses across the soffit surface revealed increased moisture

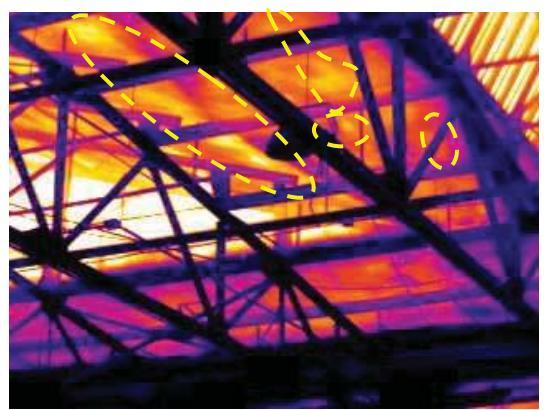
A large proportion of the images collected contained sections of localised hotter responses; which could suggest a widespread problem of spalling and delaminating concrete.

It is also possible however that the hotter responses may also relate to changes in surface coating such as the black (presumably waterproof) coatings, the small patches observed almost everywhere or even sunlight reflecting back to the soffit from steel trusses and girders.

Example Thermal Image - of numerous hotter (lighter) thermal responses that 'could' represent spalling and

As a result of the various analysis considerations explained above, our recommendation is to confirm the accuracy of the thermal imaging results collected during the probing phase. Documentation of probing and ideally localised sounding work in the area surrounding the probes will identify whether delaminating or spalling sections of concrete exists. With this information

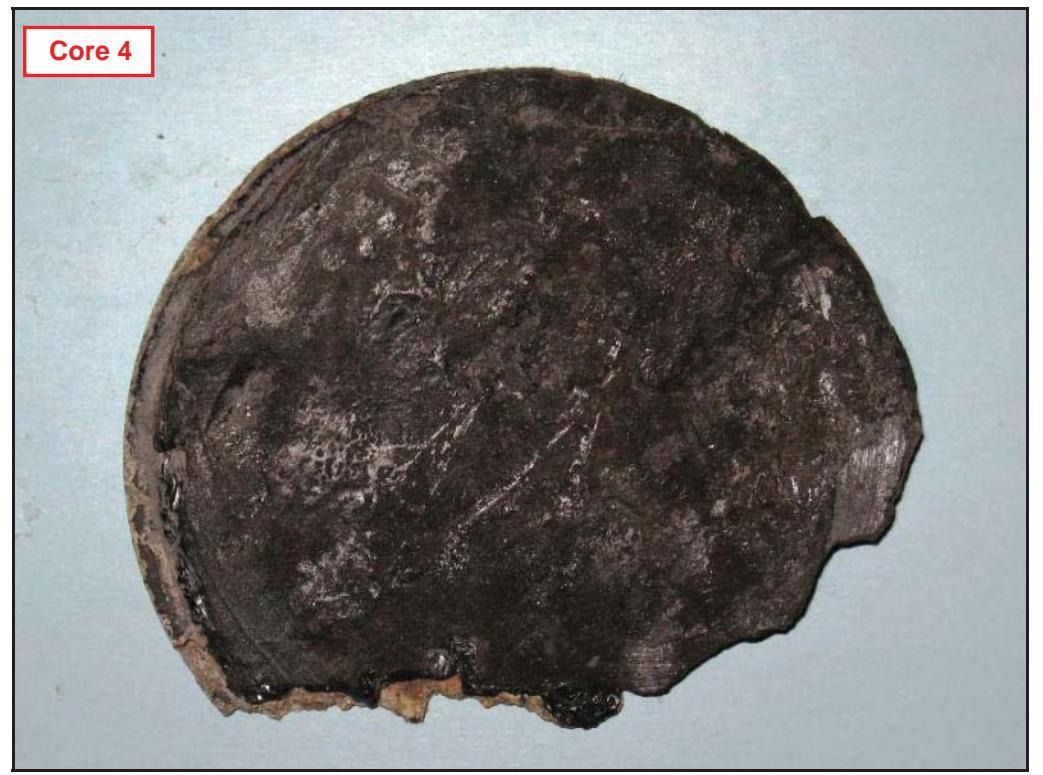
- *General:* The side of the core was labeled by others in its as received condition. The labeling indicated that the top of the core was at the end closest to the wire reinforcing inclusion. This appears to be incorrect. We observed a roof membrane on the top of one sawn end portion (Photo 3). The roof membrane indicates the top surface of the core. Beneath the roof membrane the paste of the concrete is a light tan (Photo 4). This light tan paste could be matched up with paste at the end of the core labeled as the bottom. This did not match the paste labeled as the top. As a result the sample appears labeled incorrectly. Also, it is not often that wire reinforcing is located so close to the top surface. It is typically located near the bottom of the slab. Our report will note that the end closest to the wire reinforcing is the bottom.

Photo 3. Roof membrane observed on top surface of Core 4.

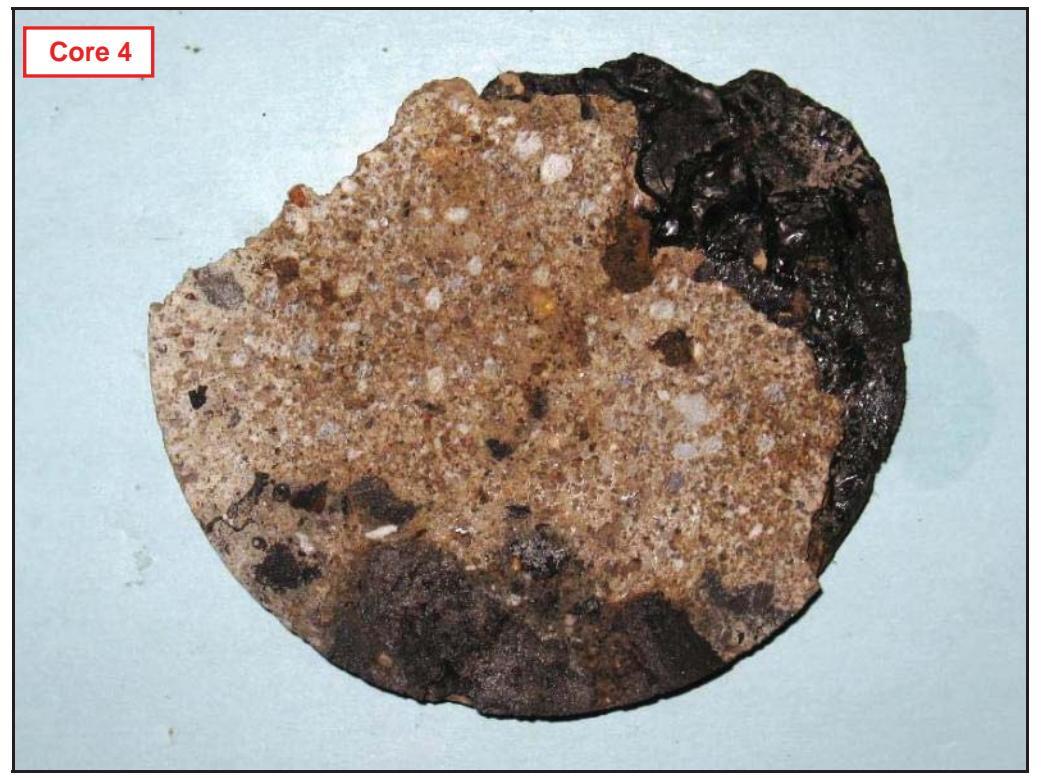
Photo 4. Light tan paste observed at underside of roof membrane.

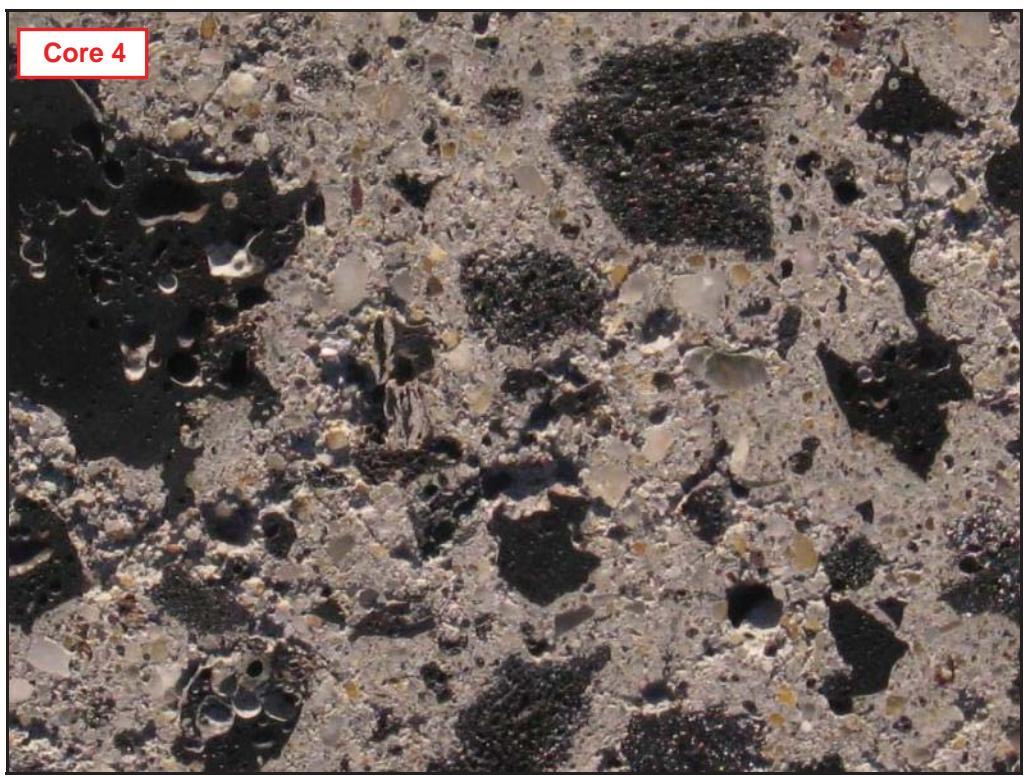
- *Coarse Agg:* The coarse aggregate was a lightweight aggregate comprised of boiler slag and bottom ash (Photo 5). Boiler slag and bottom ash were commonly used to produce lightweight concrete prior to the development of the modern lightweight shale and clay aggregates. The maximum aggregate size typically appeared to be approximately ³/₄", but we observed a 2" lightweight aggregate at the side of one core. The surfaces of the coarse aggregate varied from angular to subrounded. The coarse aggregate was evenly distributed in the cores with no indications of segregation. We observed some paste with the voids of the lightweight aggregate (Photo 6). This is an indication that the lightweight aggregate was not adequately saturated prior to mixing. We did not observe indications of deleterious aggregate reactions.

Photo 5. Boiler slag and bottom ash lightweight aggregate observed in Core 4.

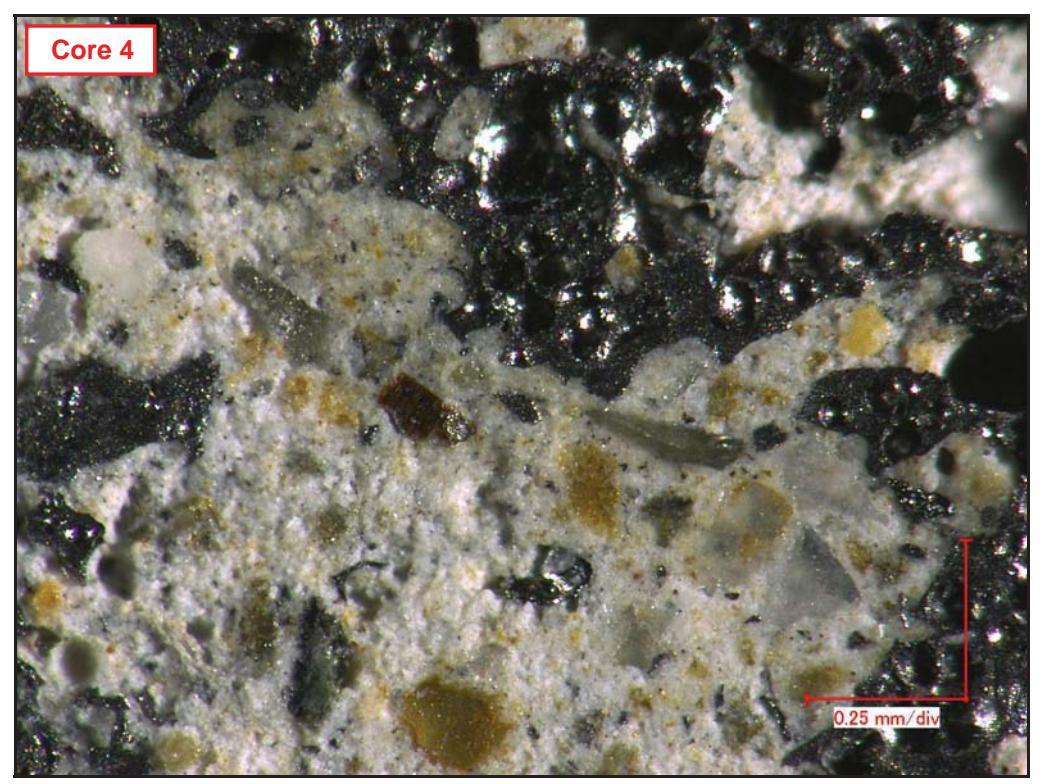
Photomicrograph 6. Paste observed within lightweight aggregate.

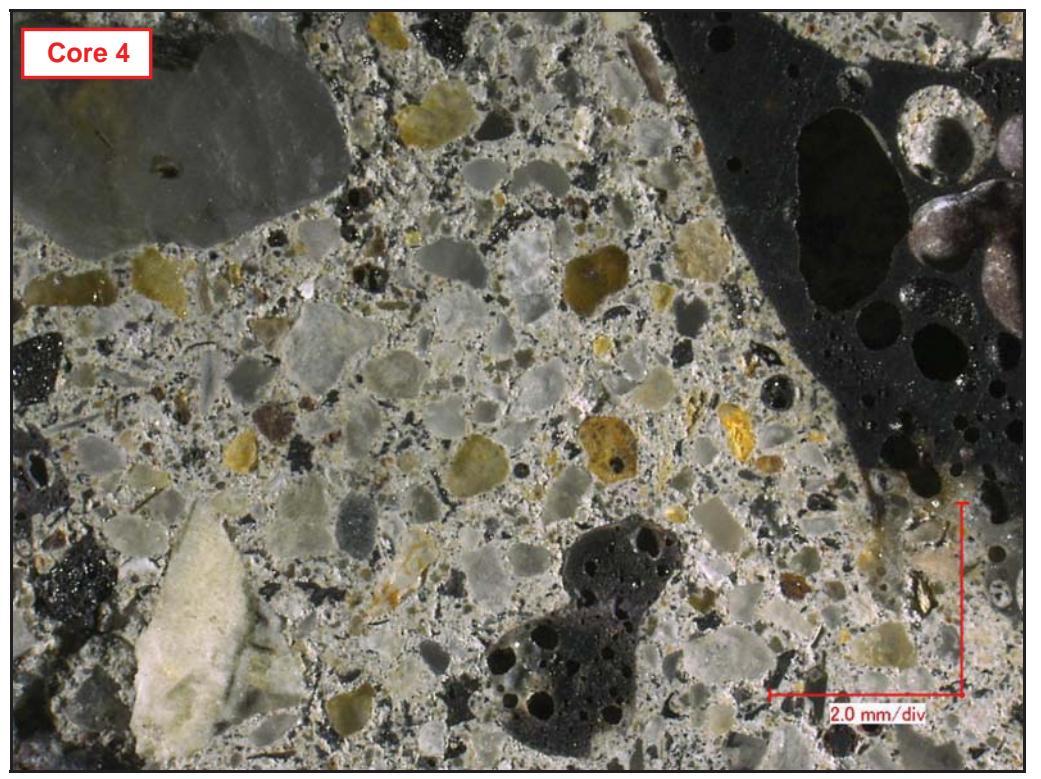
Photomicrograph 7. Light gray paste observed in Core 4.

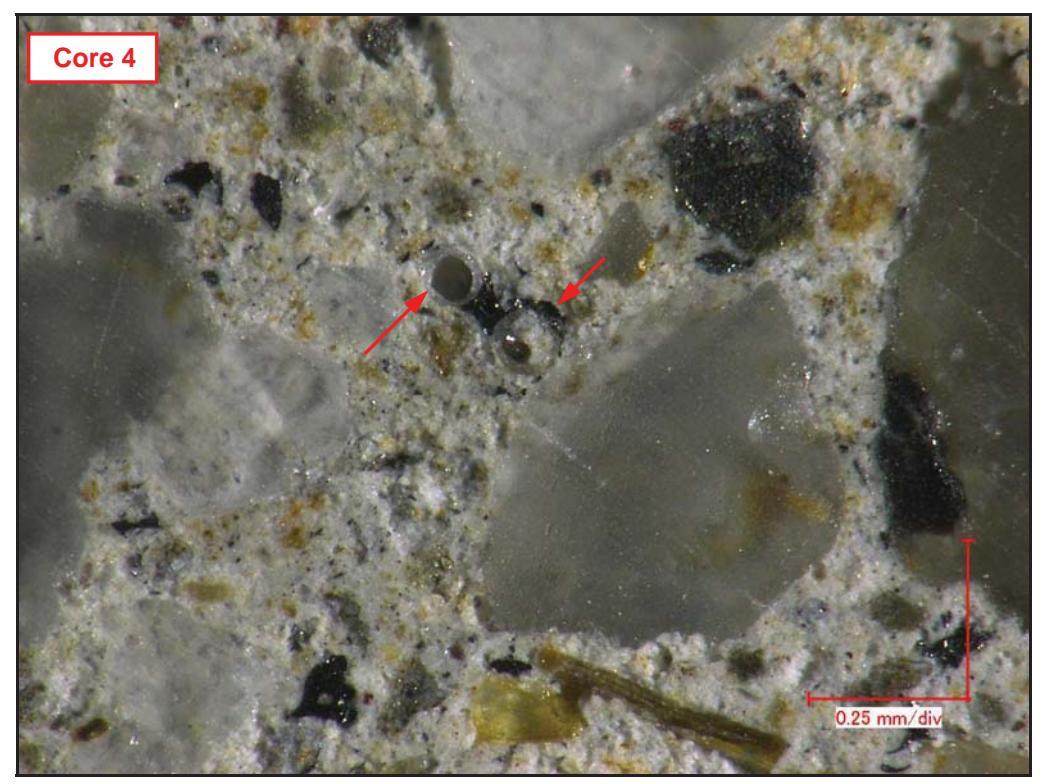
Photomicrograph 8. Fly ash cenospheres observed in paste.

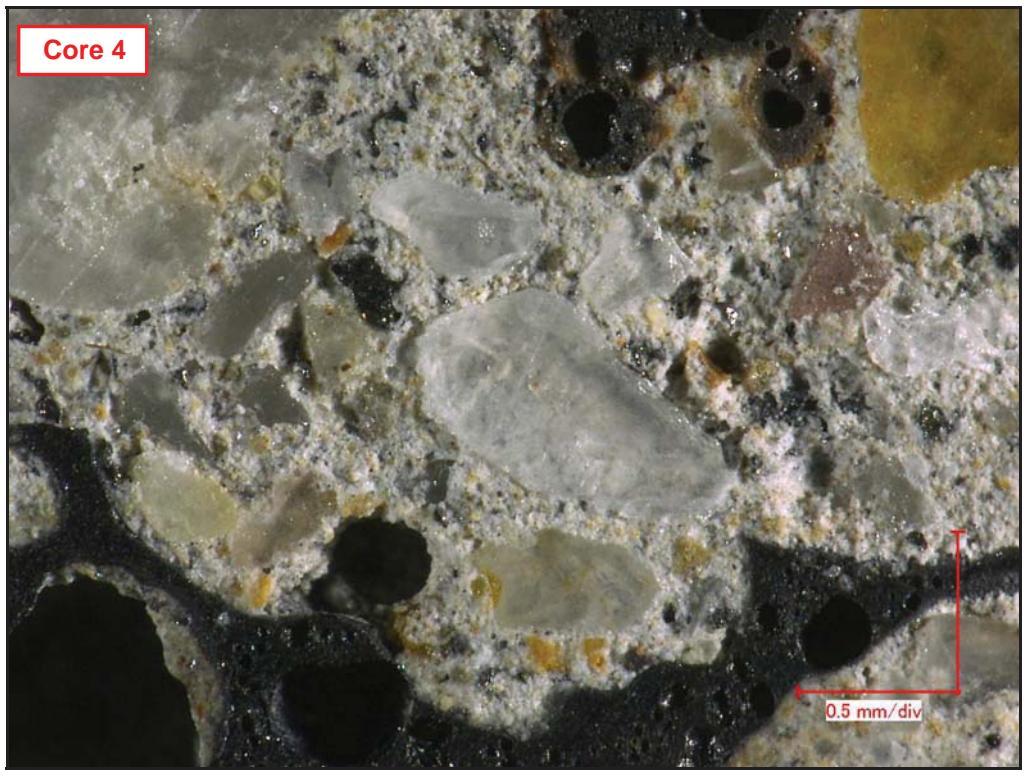
- *Paste:* The matrix does not appear to contain supplemental cementitious materials such as fly ash or slag. We observed some occasional particles resembling fly ash cenospheres, but these were likely from the bottom ash lightweight aggregate (Photo 8). The paste of the concrete was very soft as it could be easily scratched and gouged with a steel point. The paste also eroded significantly during sample preparation (Photo 9 & 10). We estimate the water to cement ratio to be in the range of 0.60 to 0.65. The porosity of the paste varied, but generally appeared to be high. The soft eroded paste appeared to simply be a result of a high water cement ratio and not some form of deterioration such as aggregate reactions or chemical attack.

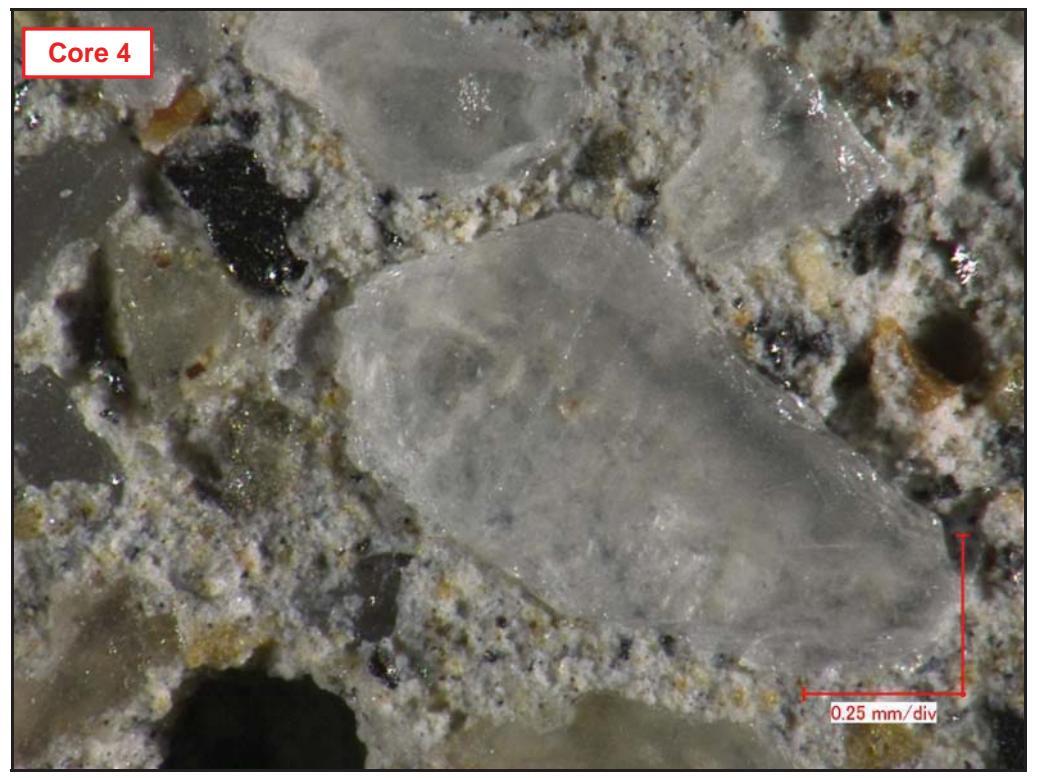
Photomicrograph 9. Eroded paste observed in Core 4.
