APPLICATION FOR BUILDING PERMIT

Building 52, located at 1 River Street, Hastings on Hudson, NY, is to be demolished while the concrete slab will remain intact. See attached narrative for details.

DECOMMISSIONING AND DEMOLITION OF BUILDING 52 NYSDEC SITE #3-60-022 1 RIVER STREET HASTINGS-ON-HUDSON, **NEW YORK**

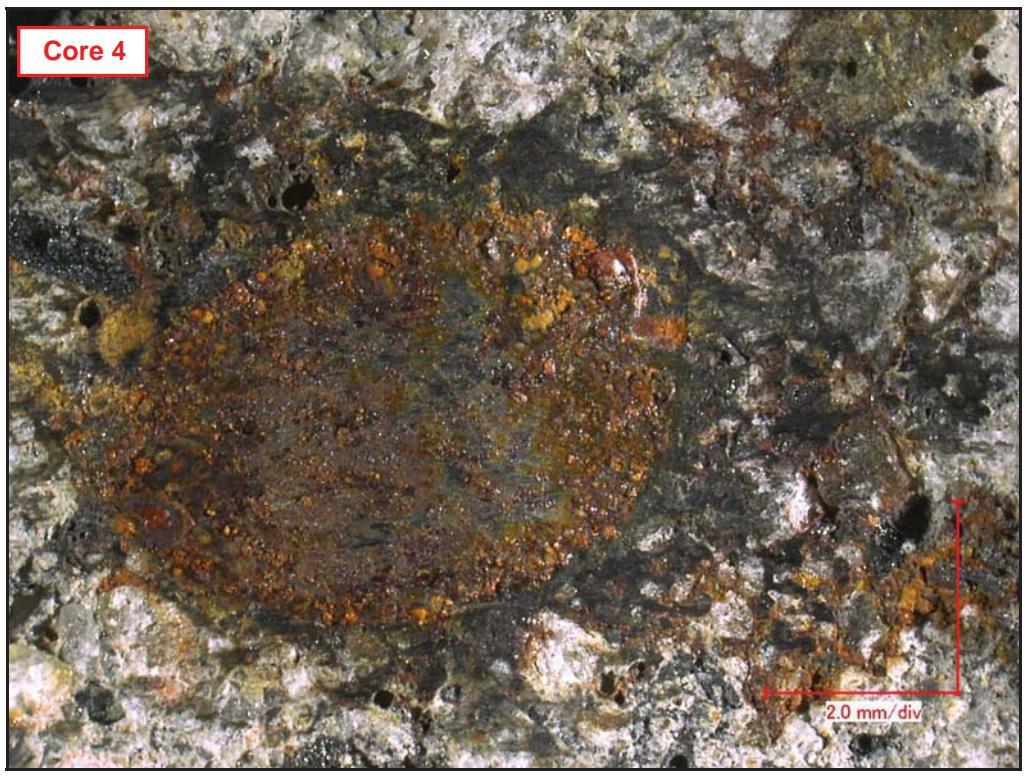
- *Void Deposits:* We observed occasional secondary deposits within the voids of the concrete. The deposits appeared to be secondary ettringite formations (Photo 12). These formations are not detrimental to the concrete and are common in concrete subjected to wetting and drying cycles. This is an indication that the roof membrane may not have been in place for the life of the structure.

Photomicrograph 12. Secondary deposits observed within void.

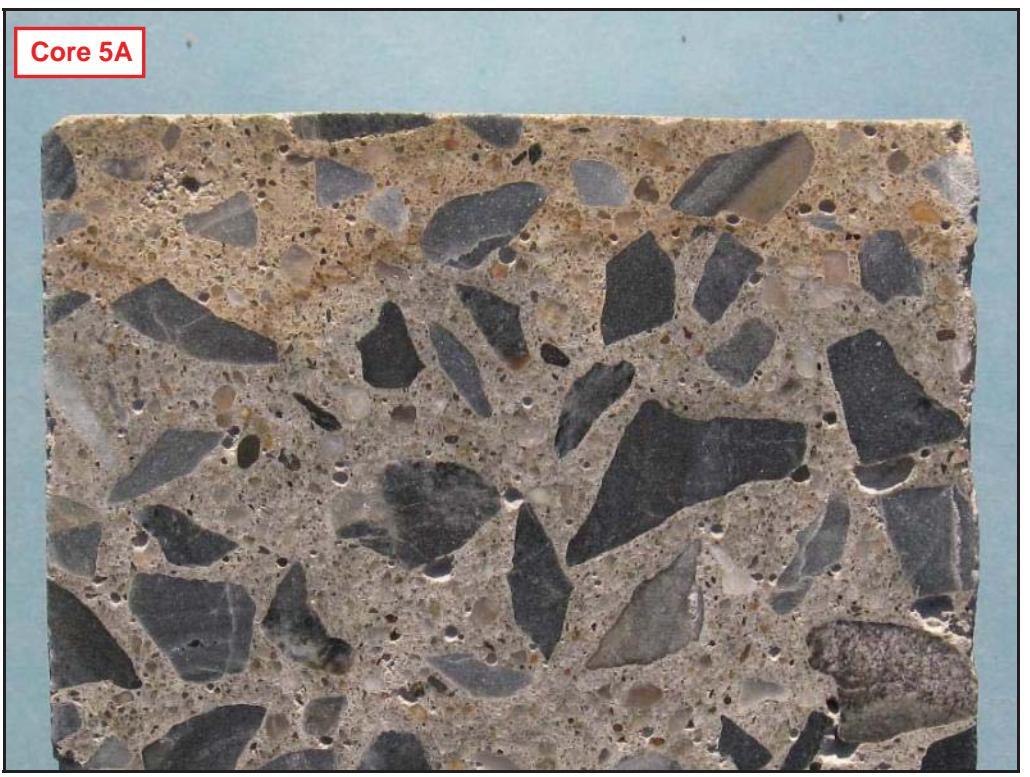
- The matrix (hardened cement paste) of the cores varied significantly in Paste: coloration. The majority of the middle portion of the core was gray, but the gray coloration was not uniform. Zones of relatively darker and lighter gray paste were observed (Photo 14). This is a result of not thoroughly mixing the concrete and is not uncommon in concrete from this era. The non-uniform paste coloration however, does not appear to have significantly affected the strength of the concrete (5380 psi AVG). Additionally, the upper ¹/₂ to ³/₄" of the paste was light tan in coloration (Photo 15). This is a result of carbonation. If we add the approximate 1/4" missing from the top surface the depth of carbonation is approximately 34 to 1" deep. This amount of carbonation is excessive and is likely a result of the manufacturing process of the factory. Utilizing phenolphthalein staining we confirmed that the carbonation ended at the transitions from tan to gray paste. We also observed isolated light tan zones within the middle of the core and near the bottom surface. The isolated zone of carbonation within the middle of the core appears to have been a result of interconnected voids providing a pathway for the carbon dioxide beneath the slab (Photo 16).

Photo 14. Uneven distribution of paste color observed.

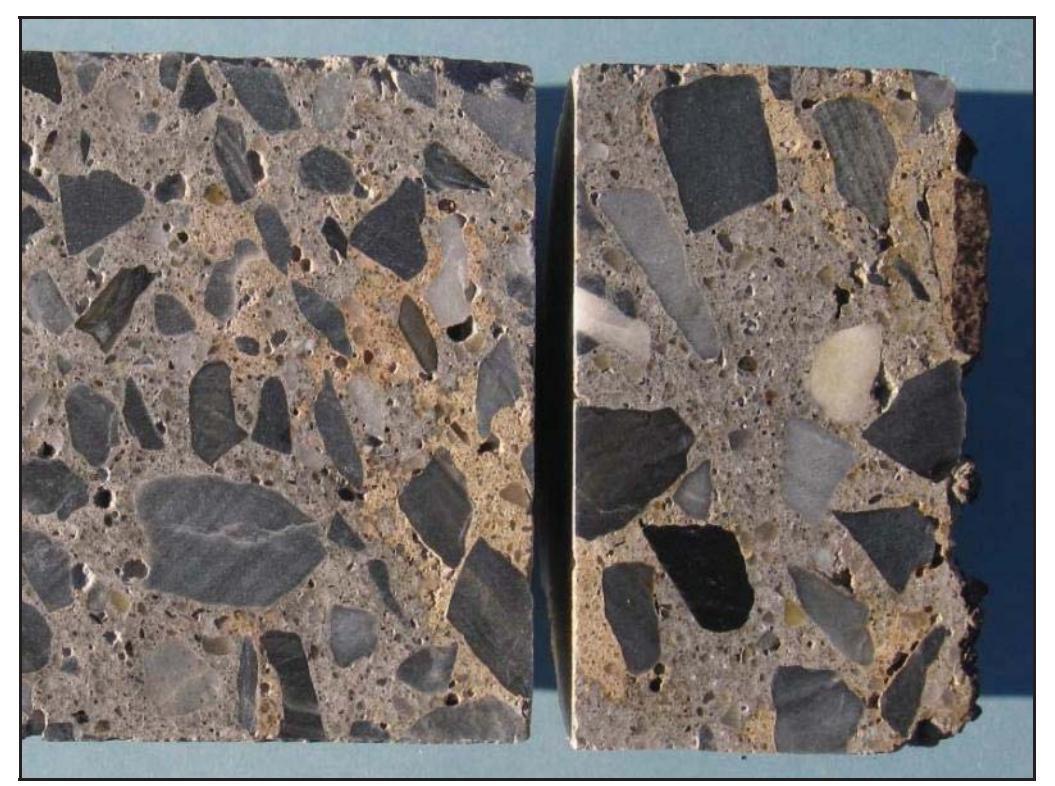
Photo 15. Depth of carbonation approximately ³/₄ to 1" deep.

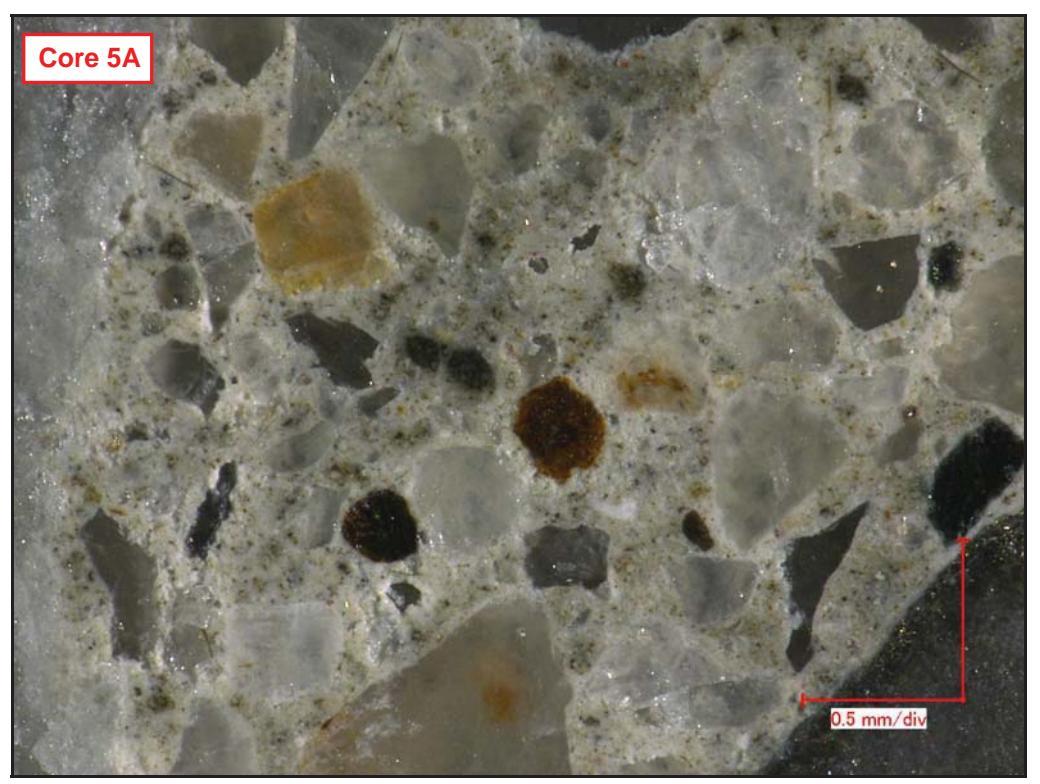
Photo 16. Isolated zone of carbonated paste observed within Core 5A.

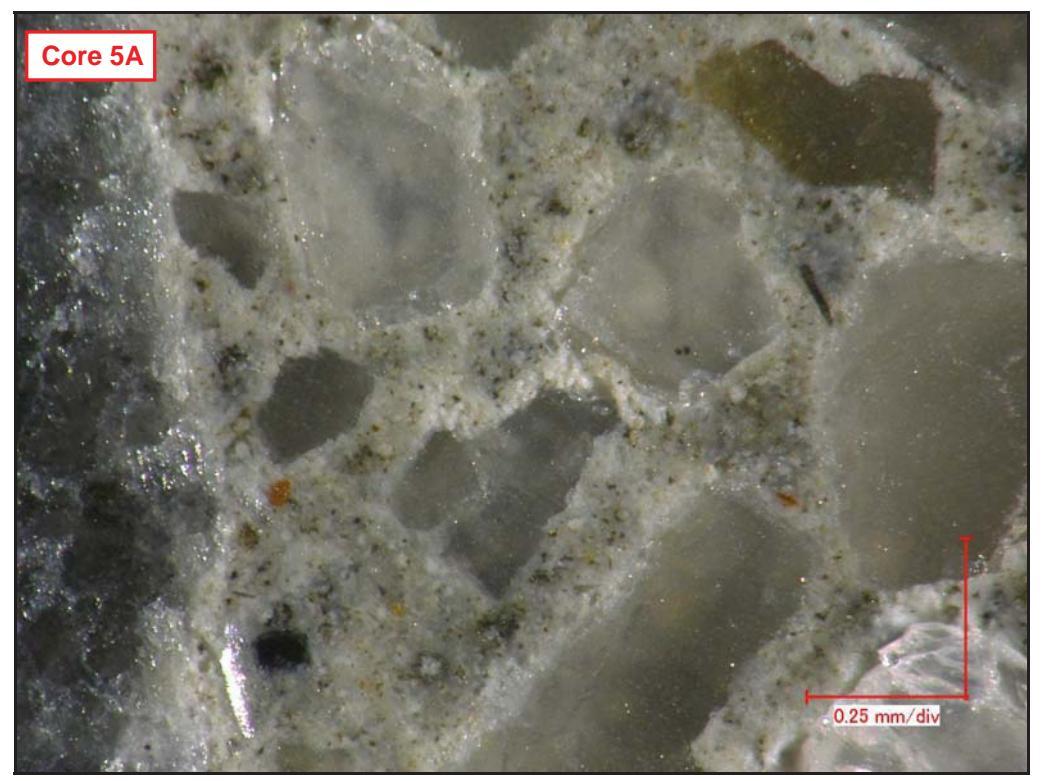
Photomicrograph 17. Paste of floor slab Core 5A.

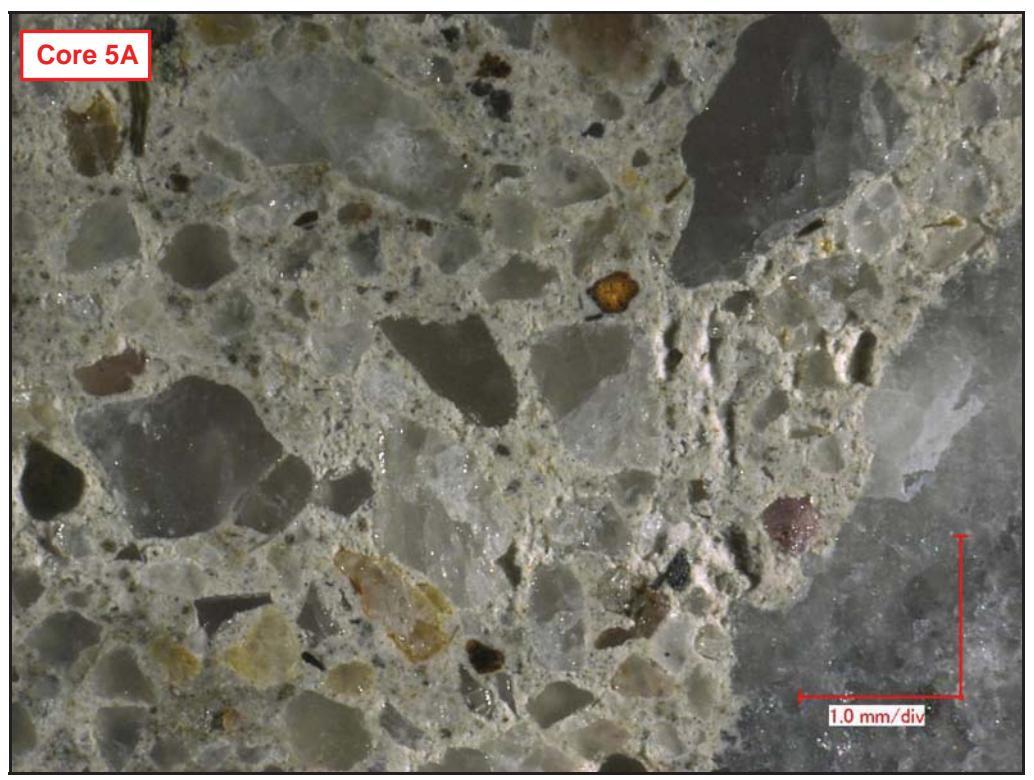
Photomicrograph 18. Paste of Floor slab Core 5A.

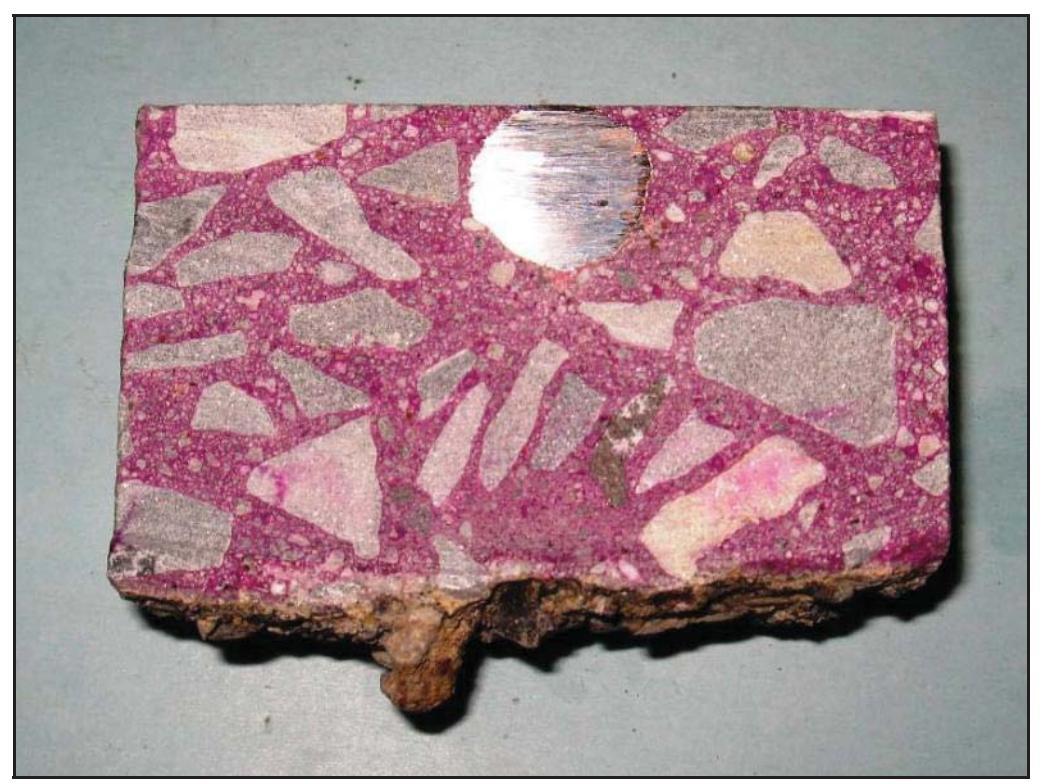
Photo 21. Excessively corroded rebar observed at bottom of core.

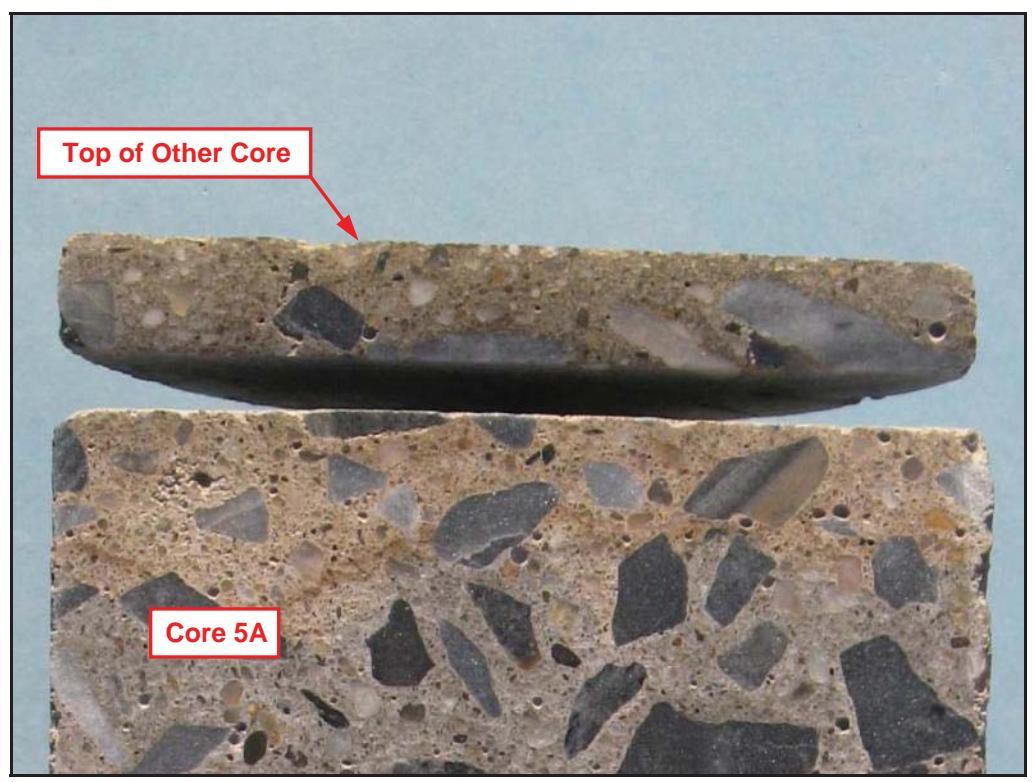
- Surfaces: The top surface of polished core was sawn, but we observed the remaining top portion of another floor slab core. Indications of minimal surface erosion were observed, but the top surface generally appeared to be in good condition considering the age and previous use (Photo 23). This top portion from another slab core was cut perpendicular to the top surface and polished (Photo 24). The portion was approximately ½" thick. We did not observe indications of freezing damage, cracking or other detrimental microstructural features. The bottom surface appeared to have been placed on a stone base.

Photo 23. Top surface of other core.
