Ground Penetrating Radar Report

Results of Geophysical Pilot Investigation Former Anaconda Wire & Cable Company 1 River Street, Hastings-on-Hudson, New York

April 29 and May 1, 2013

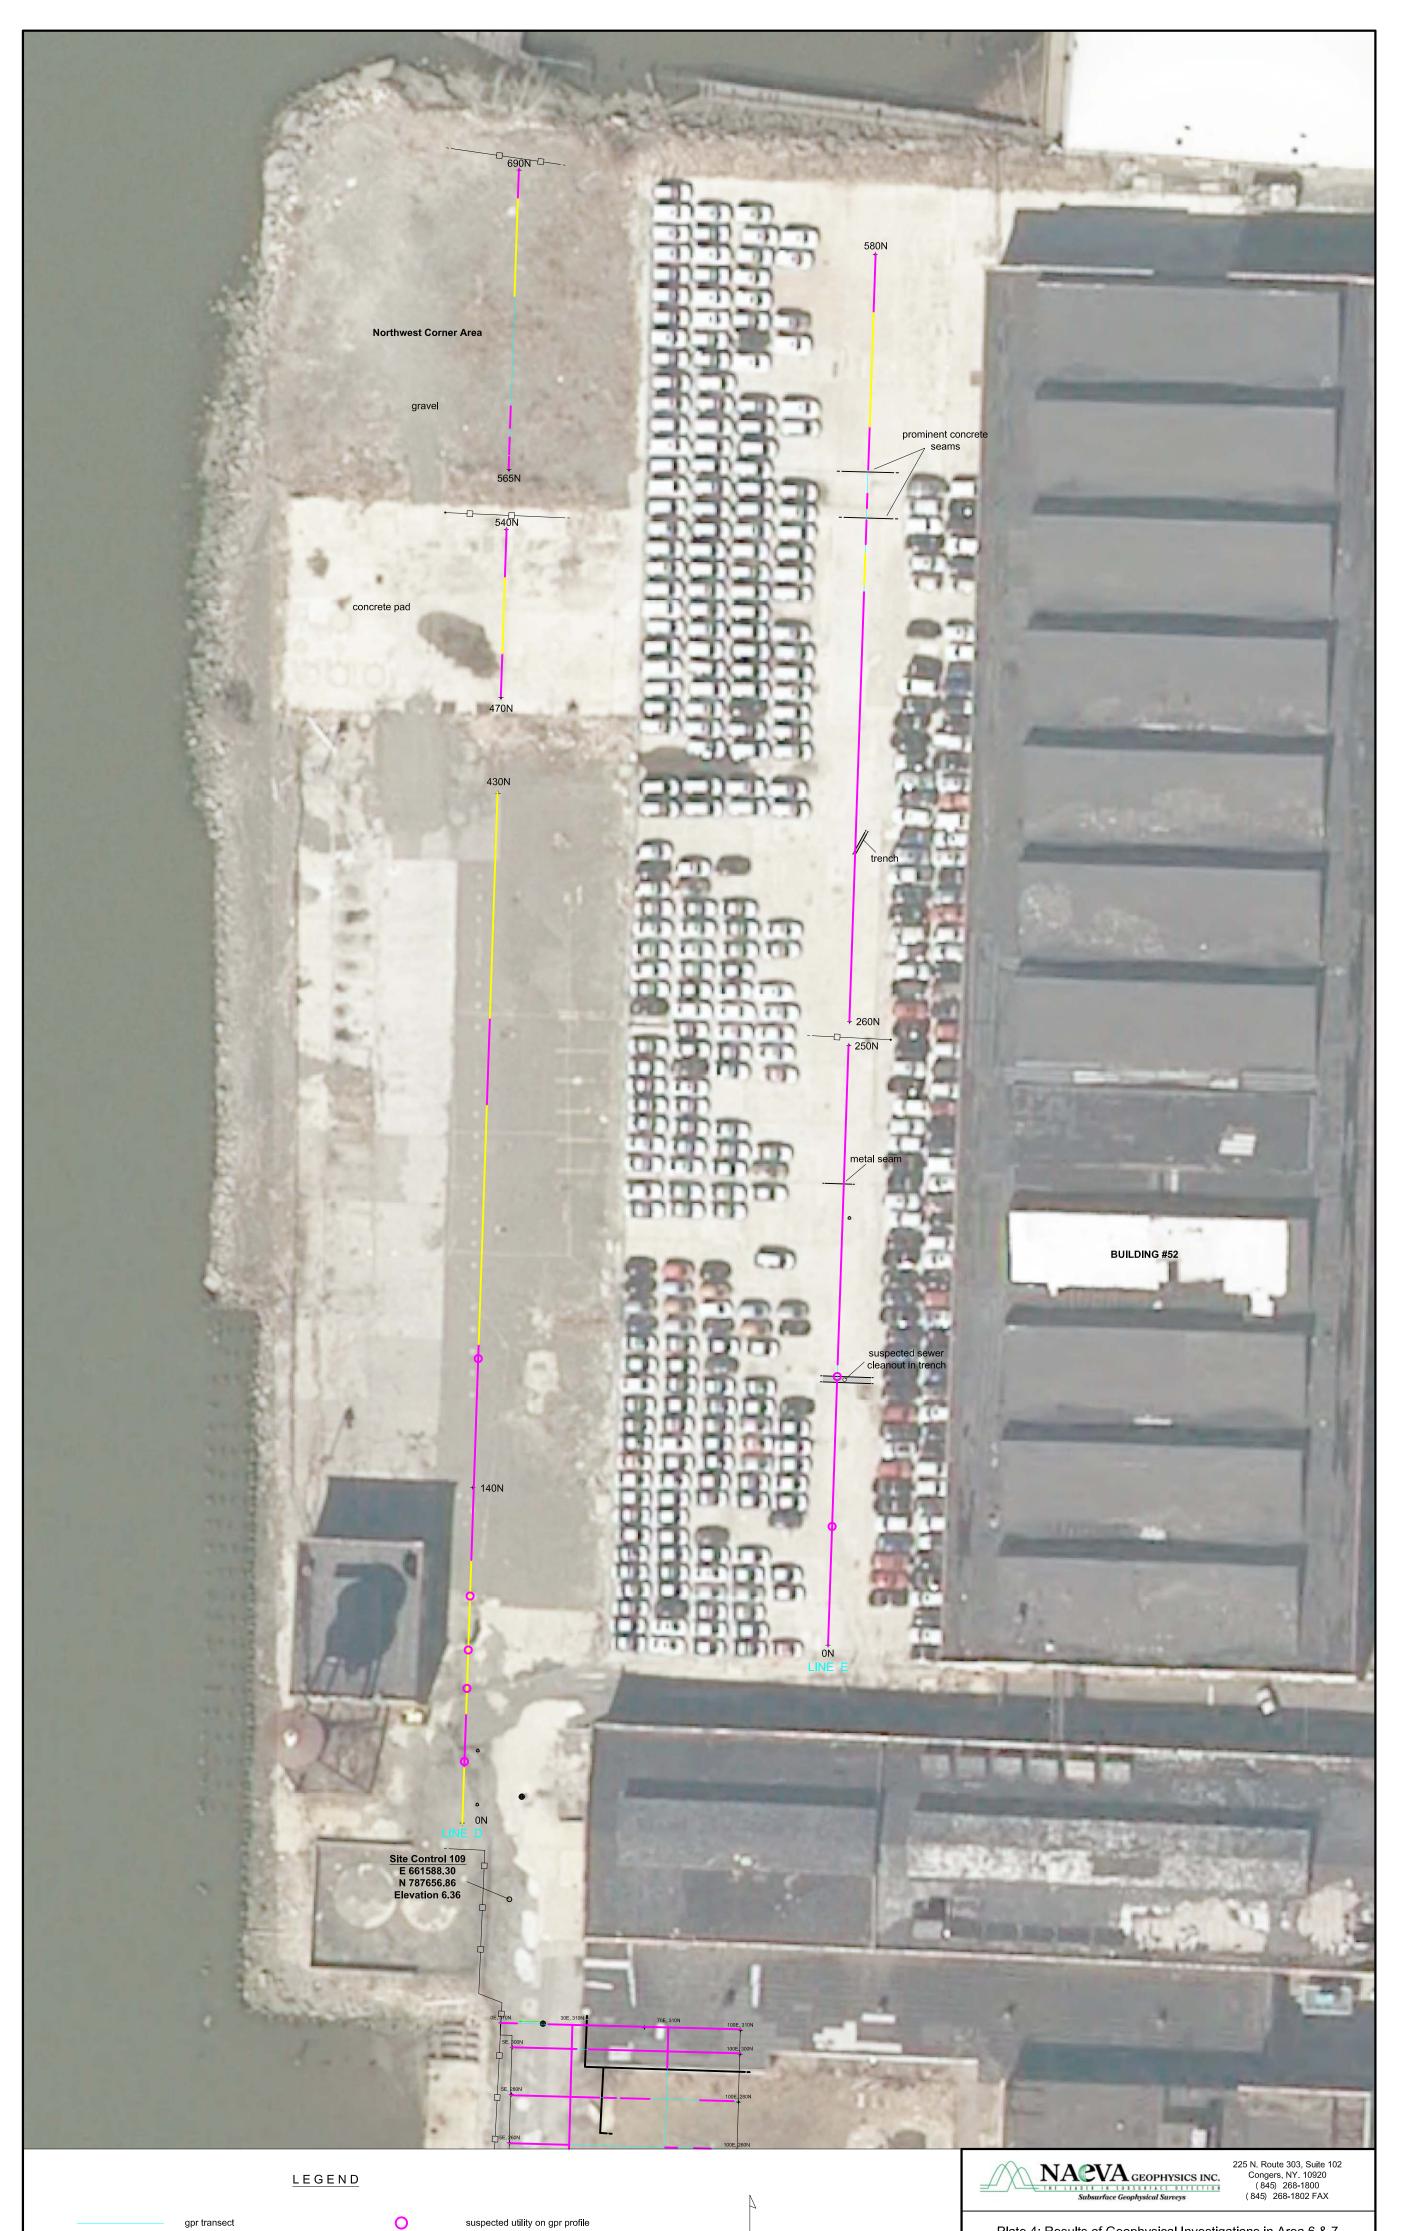
Plate 4: Results of Geophysical Investigations in Area 6 & 7
Former Anaconda Wire & Cable Company
1 River Street, Hastings-on-Hudson, New York

One north-south transect, designated Line "D", was collected across the area parallel to and about 100 feet east of the shoreline (see Plate 4). The line is 690 feet with two line breaks. The primary purpose of this investigation was to search for subsurface utilities using the GPR. The locations of suspected voids in concrete-paved areas are also indicated on the map. The area of investigation along the line had an open and smooth surface, with the exception of the Northwest Corner Area that was covered.

One north-south transect, named Line "E", was collected parallel to existing Building 52, about 50 feet west of the exterior wall (see Plate 4). The line is 580 feet long, with a line break between 250N and 260N due to the presence of a chain-link fence. The primary targets of this area are thickness of concrete slabs and the locations of voids. The area of investigation along the line had an open and smooth surface. The average thickness of concrete pavement is estimated to be about 12-inch with wire-mesh from 0N to 250N, 260N to 382N, and 471N to 488N. The locations of suspected voids are depicted on the map.
